Florida Department of
Environmental Protection
Hazardous Waste Inspection Report

Facility Name: Bay Line Railroad LLC

Complaint Inspection for Used Oil facility

Complaint Inspection for CESQG (<100 kg/month) facility

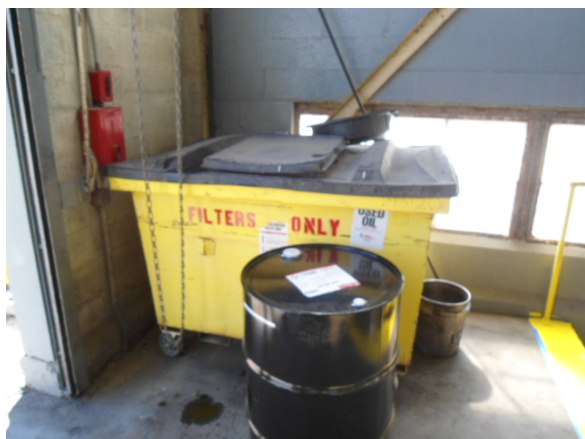
BLR stores used oil filters in a covered dumpster container inside the service facility that is protected from the weather. The container was labeled and inside the secondary containment provided by the building. BLR generates used oil from servicing locomotives and withdrawal operations mostly are done outside at a track station where hoses connect the pup to the locomotive oil sumps and pumps to the used oil tank in the nearby tank farm. Used oil tank was labeled, closed and in secondary containment exceeding requirement. Temporary transfer pans for small used oil jobs lacked labeling as required. BLR since 2006 has added a oil water separator which removes oil from storm water areas and from containment areas to the storage tank and water to the sewer lift station. In the outside paint shed a 5-gallon container of what looked like used oil was present without labeling or secondary containment.

Used oil filter container

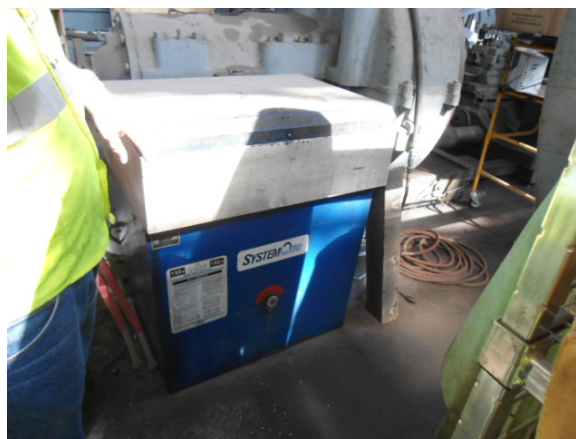
Old System 1 Parts washer

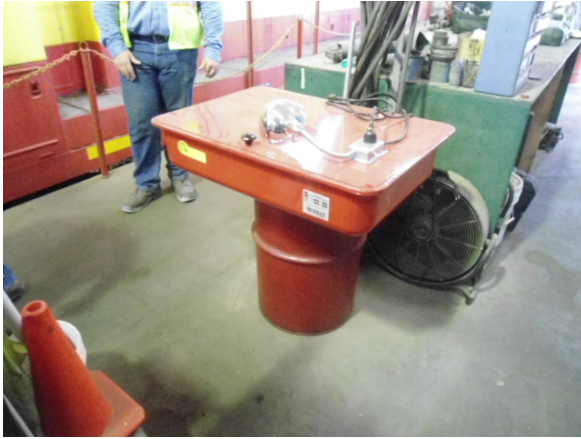
BLR generates used oil, used oil filters and oil contaminated media (rags, oily water, oil dri and oil absorbent pads). Used oil and used oil filters are picked up by Aaron Oil (ALD983180233) and records were reviewed with no deficiencies noted. Used oil pickup has occurred twice so far in 2012 for a total of 6,371 gallons and an average per pickup of 2,125 gallons. Used oil filters are typically picked up every two weeks and seven shipping receipts were reviewed with no deficiencies noted. Crystal Clean (ILR000130062) serviced one System One parts washer twice in 2011. The manifest showed the solvent to be with an estimated generation rate of 19 pounds per month. Safety Kleen services two solvent parts washers that use Premium Gold Solvent (Flash Point 148 deg F).

New SK Parts washer

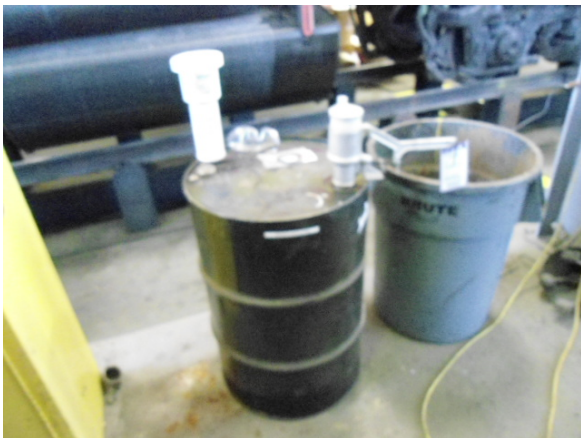
BLR is now utilizing an aerosol can puncture assembly with an attached drum for accumulation of evacuated waste paint liquids. A Department Guidance document for management of aerosol cans was given to BLR following the inspection. BLR intends to either accumulate Locomotive spray paint wastes in a separate container or transfer wastes to this common container attached to the puncturing device. Punctured cans are stored outside in the scrap metal container destined for a local metal dealer. No shipment of wastes from aerosols has been performed. Proper management options discussed with facility personnel to include current proper management of HW rags, alternative product substitution for solvent on rags or using contracted servicing of solvent bearing rags and ongoing hazardous waste management.

Aerosol can puncturer

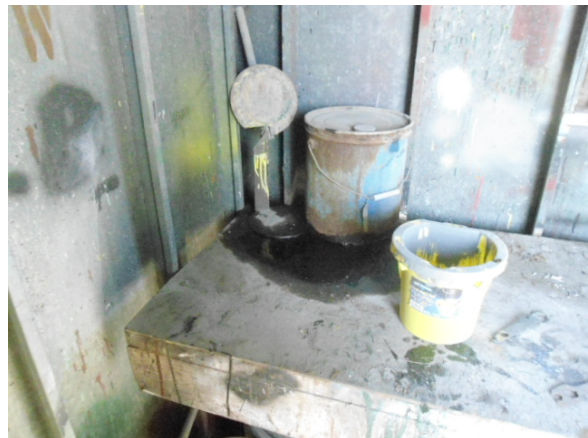
Type: Violation
 Rule: 62-710.401(6)

Explanation: One five-gallon container of used oil in the paint shed was not labeled or within required secondary containment.

Used oil in paint shed

Corrective Action: BLR needs to manage used oil in compliance with Chapter 62-710.401(6) which states, "No person may store used oil in tanks or containers unless they are clearly labeled with the words "used oil" and are in good condition (no severe rusting, apparent structural defects or deterioration) with no visible oil leakage. If tanks or containers are not stored inside a structure, the contents shall be closed, covered or otherwise protected from the weather. If tanks or containers are not double-walled, they shall be stored on an oil-impermeable surface such as sealed concrete or asphalt, and must have secondary containment which has the capacity to hold 110% of the volume of the largest tank or container within the containment area."
