Florida Department of
Environmental Protection
Hazardous Waste Inspection Report

Facility Name: Safety-Kleen Systems Inc
On-Site Inspection Start Date: 03/12/2012 **On-Site Inspection End Date:** 03/12/2012
ME ID#: 40794 **EPA ID#:** FLD984171165
Facility Street Address: 600 Central Park Dr, Sanford, Florida 32771-6690
Contact Mailing Address: 3003 W Breezewood Lane, Neenah, Wisconsin 54957-0368
County Name: Seminole **Contact Phone:** (800) 558-5011

Routine Inspection for TSD Facility Unit Type(s)

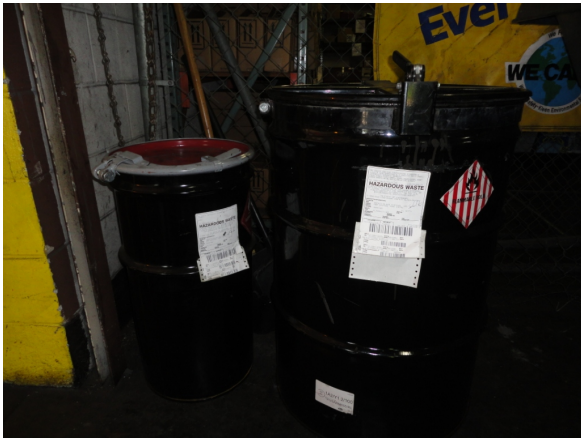
Fig 1: Aerosol & Debris Drums

In the area were several empty containers ready to go out to customers, three 55-gallon drums of non-hazardous material, one 15-gallon satellite drum for Safety-Kleen's aerosol cans, and a 55-gallon drum for debris from trucks and the warehouse (Figure 1). All of the drums were properly labeled and dated (if appropriate).

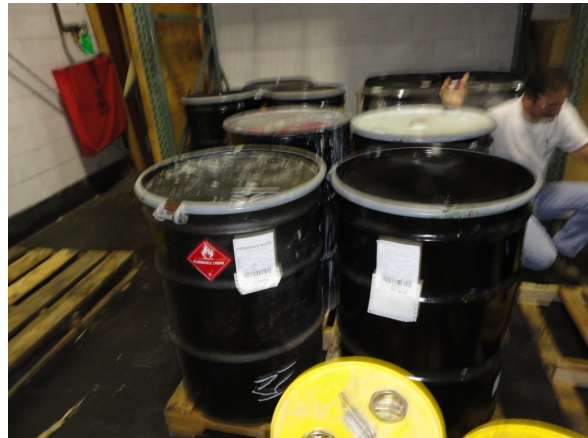
Fig 2: 10-Day Area

The 10-day transfer facility accumulation area is located next to the container storage area. There were three pallets of waste containers in the area (Figure 2).

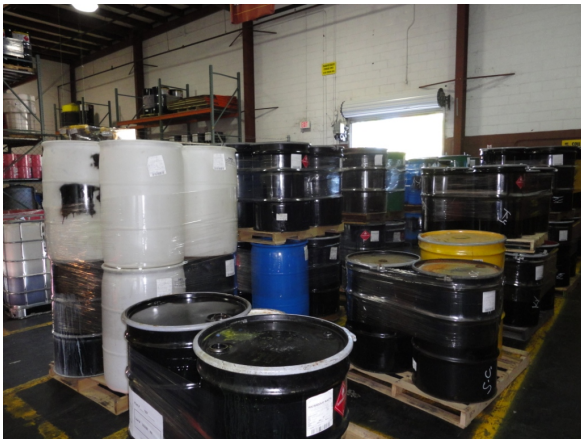
Fig 3: Storage Area

All containers were organized according to compatibility, and were stored with adequate aisle space at a maximum height of two containers. The containers were marked with the date the waste entered the transfer area, labeled hazardous waste (if appropriate) and closed (Figures 3).

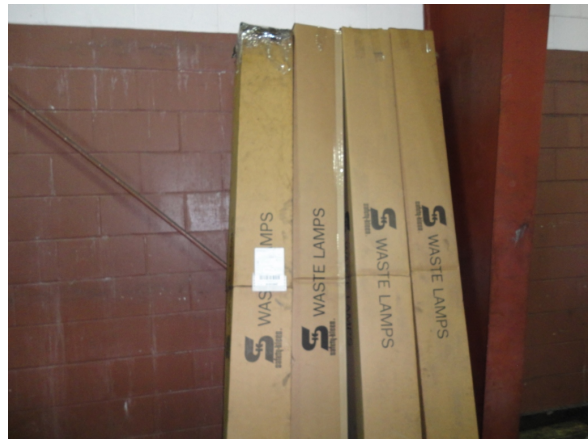
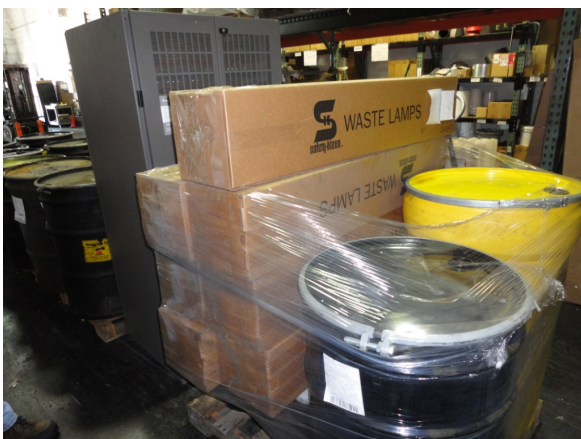
Spent mercury lamps, and electronic waste, and waste batteries stored in the area were properly labeled and containerized (Figures 4 and 5).

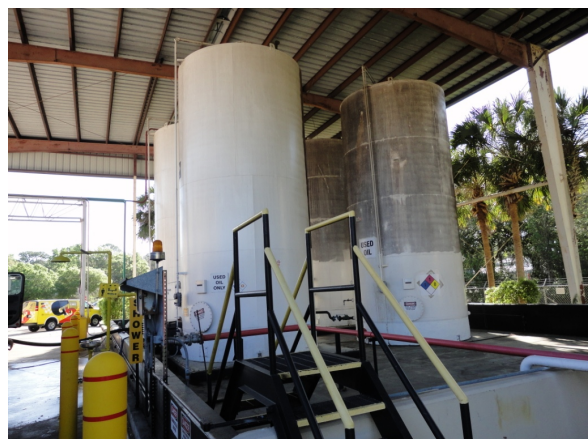
Fig 6: Above Ground Storage Tanks

There were four above ground storage tanks within secondary containment on-site (Figure 6). Each tank is permitted to store 20,000-gallons, but Safety-Kleen considers the tanks full at 19,000-gallons. One tank is used for hazardous waste solvent, one is used for product solvent, and two are used for used oil. Next to the containment area, there was a 17,000 gallon waste antifreeze tank (Figure 7). At the time of the inspection, all tanks were properly labeled and the containment area was dry and appeared free of cracks. A sign with the words "Danger No Smoking" was located in this area.
