**Re: Ring Power Corporation
EPA/DEP ID: FLD 981 480 205
Taylor County – Hazardous Waste**

**Florida Department of
Environmental Protection
Hazardous Waste Inspection Report**

Facility Name: Ring Power Corp

On-Site Inspection Start Date: 09/16/2013

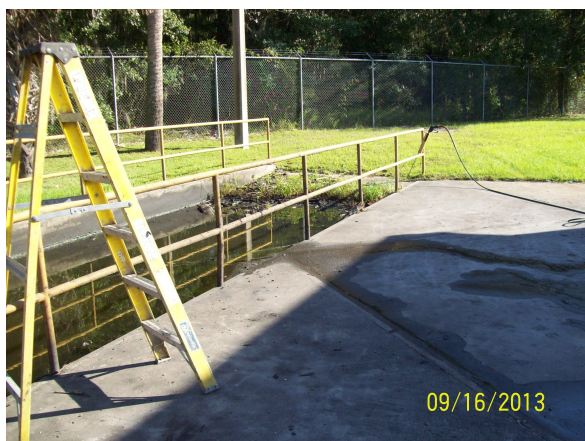
Photo 1

When equipment is returned from rental use, it is taken to the Washrack to be cleaned (Photo 1). Dirt is removed from the equipment using a pressure washer with water. The dirt is shoveled into an adjacent shed where it is accumulated and after testing for RCRA heavy metals, the non-hazardous dirt is incinerated or sent to a landfill (Photo 2). The facility test and disposes of this waste stream once every four to five years.

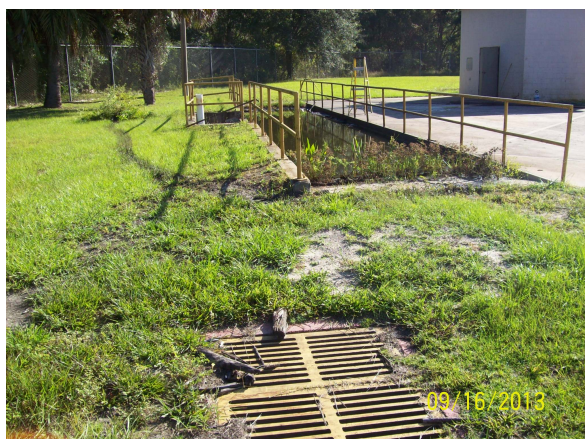
Photo 3

After dirt has been removed, the equipment is washed using a non-hazardous soap to remove grease and oil from the equipment. The oily washwater is directed to an adjacent sump where the water is evaporated (Photo 3). During a heavy rainfall event, overflow water is directed to a nearby detention pond. This is an area of concern because of the potential for a used oil release to the ground. DEP Inspectors, Joseph Emery and Kyle Watson, from the Department's Wastewater section met with Dave Strickland, Environmental Manager, and Johnny Batton, Shop Leadman, on-site to discuss whether the washrack system required a permit or other Best Management Practices (BMPs). The concern was forwarded to the Suwannee Water Management District for their review.

Dirt in the sump is occasionally removed and placed into the shed where it is tested prior to being incinerated or sent to a landfill as described above.

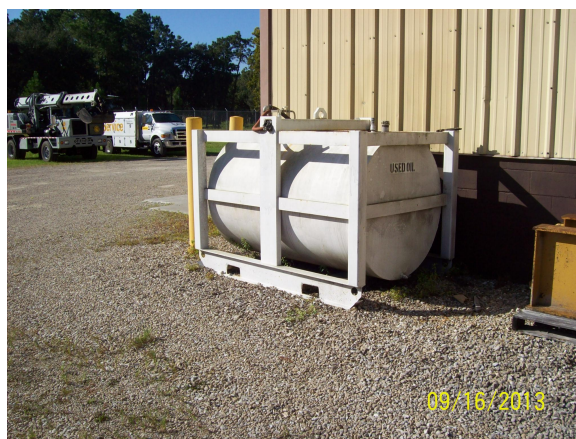
Photo 4

In the Maintenance Shop, routine maintenance and repairs are performed on customer equipment, rental equipment, and facility equipment. Used oil generated from routine maintenance is collected in used oil catch pans and pumped into the facility's 500-gallon double-walled used oil tank. The tank was labeled "Used Oil" (Photo 4).

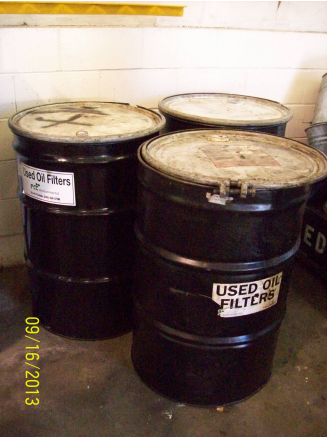
Photo 5

Used oil filters are drained into a used oil container and then placed into a 55-gallon drum for accumulation. Three 55-gallon drums were accumulating, and all were properly labeled with the words "Used Oil Filters" (Photo 5). Used oil and used oil filters are recycled through FCC Environmental. Spent antifreeze is collected in a 250-gallon tote, and it is recycled through FCC Environmental. The facility has three 30-gallon Safety Kleen petroleum naphtha parts washers (Photo 6). The parts washers are serviced by Safety Kleen every eight weeks under Safety Kleen's continued use program.

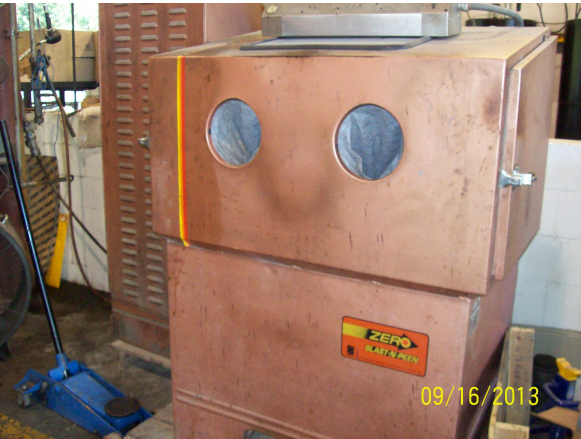
Photo 7

The facility has one glove box sand blasting unit that has bag filters (Photo 7). This unit is used approximately once per month to blast rust and staining from small parts and tools. Glassbeads are used as blast grit, and the filter bags have not yet been changed. The facility should perform a Toxicity Characteristic Leaching Procedure (TCLP) for RCRA metals on waste generated from this blasting unit and manage the waste based upon the determination.

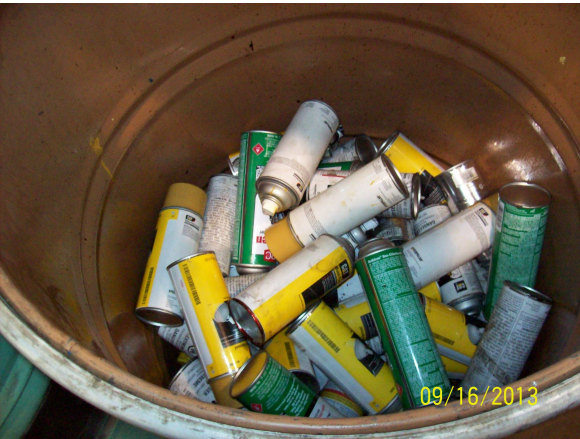
Photo 8

The facility collects aerosol cans in 55-gallon drums for recycling as scrap metal (Photo 8). If a can is not empty, but is not usable, the facility sends the can to the Tallahassee facility for puncturing and draining. This is an area of concern, because the Tallahassee facility is not authorized to accept CESQG hazardous waste. Subsequent to the inspection, the facility implemented a plan to collect spent aerosol cans for recycle as scrap metal. Waste aerosol cans that are not spent will be managed as hazardous waste.

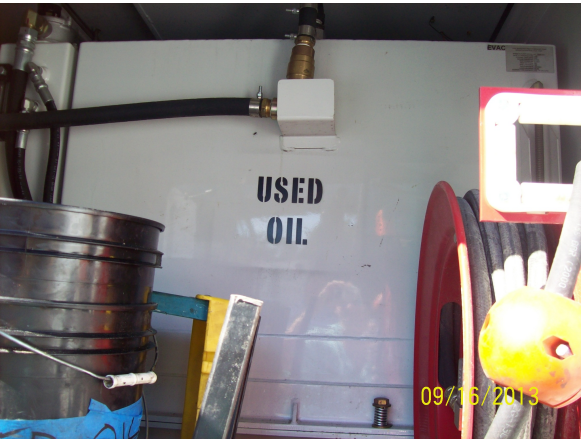
Photo 9

The facility services equipment in the field and transports the used oil back to the Perry location in a truck that has a 90-gallon used oil tank. The facility labeled the tank Used Oil during the inspection (Photo 9). The facility's registration was up to date, it's used oil transporter registration certificate was displayed, and it maintains proof of financial responsibility according to 62-170.600(2)(e), FAC. All used oil transportation is logged and this log is kept up to date. Used oil generated in the field is added to the facility's 500-gallon double-walled used oil tank.
