**FLORIDA DEPARTMENT OF
ENVIRONMENTAL PROTECTION**

**Re: Ring Power Corp
EPA/DEP ID: FLR 000 119 347
St. Johns County – Hazardous Waste**

**Florida Department of
Environmental Protection
Hazardous Waste Inspection Report**

Facility Name: Ring Power Corp

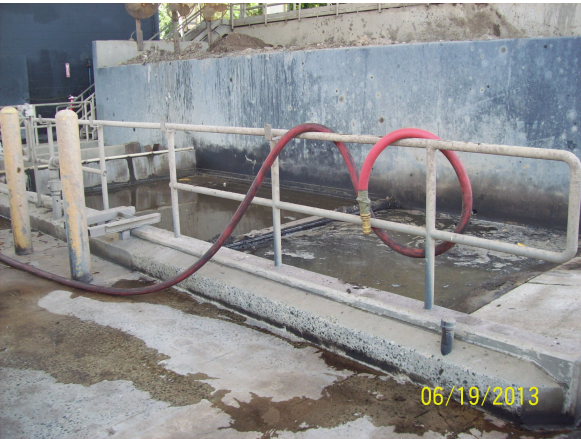
Photo 1

When equipment is returned from rental use, it is taken to the Washrack to be cleaned (Photo 1). Dirt is removed from the equipment using a pressure washer with water. After dirt is removed, the equipment is washed using a non-hazardous soap. The washwater is filtered and processed with

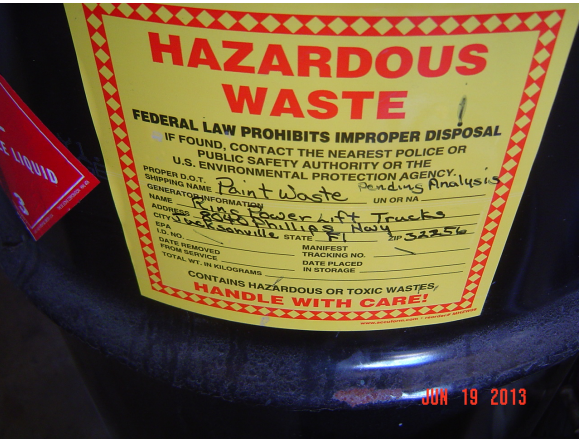
Photo 2

Near the Washrack, the facility has a storage shed. There was one 55-gallon drum of paint waste that was labeled hazardous waste (Photo 2). The label indicated that the drum was generated at the Ring Power in Jacksonville on Philips Hwy and was pending analysis. Subsequent to the inspection, the facility properly disposed of the waste. The facility is reminded that as a Small Quantity Generator, it is not approved to transport hazardous waste.

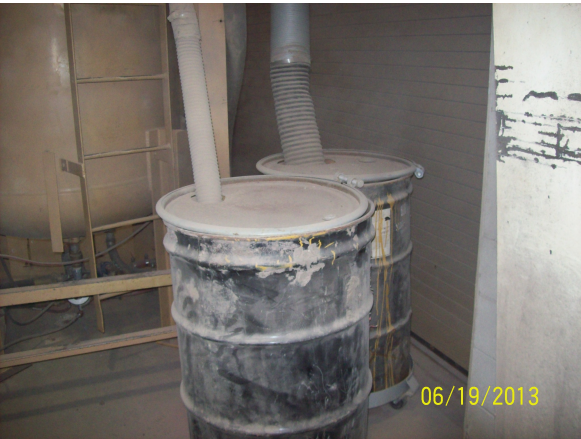
Photo 3

The facility repairs and paints CAT equipment in the Blasting and Paint Shop area. The facility blasts equipment inside a blasting room using silica sand. The spent blast grit is collected in two 55-gallon drums via a vacuum system (Photo 3). The facility tests this waste stream regularly and it is non-hazardous.

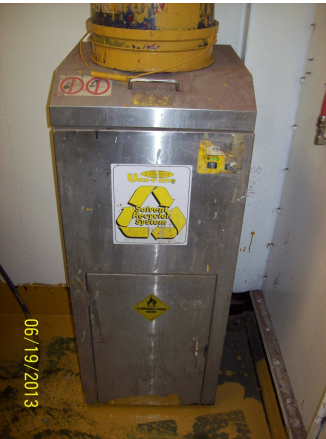
Photo 4

The facility uses gravity-fed guns to paint larger equipment. The gun lines and nozzles are cleaned using Grow Automotive HET 1501 thinner, which contains 10-30% methyl alcohol, 10-30% toluene, and has a flashpoint of six degrees Fahrenheit, which generates a D001/F003/F005 hazardous waste liquid when spent. Spent paint and thinner is recovered in the facility's on-site still, located in the paint mixing room (Photo 4). The facility estimated that it recovers approximately four and a half gallons per five gallons of spent paint and solvent placed in the still. The facility distills the solvent two to three times per week and generates a still bottom from each distillation. These F005 hazardous waste still bottoms are placed into a 55-gallon satellite drum that was properly labeled (Photo 5).

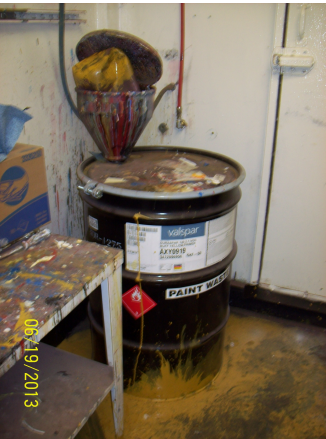
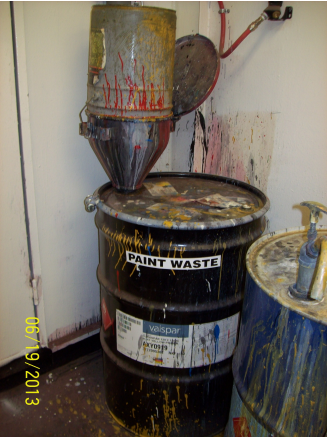
Photo 6

Some spent paint is accumulated in two 55-gallon satellite drums in the paint mixing room (Photos 6 and 7). At the time of the inspection, the facility had less than 55-gallons of spent paint in the satellite area, however the facility is reminded that it should not accumulate more than 55-gallons of hazardous waste in one satellite area. Dave Strickland, Environmental Manager, stated the facility would only use one 55-gallon drum in the satellite area moving forward.

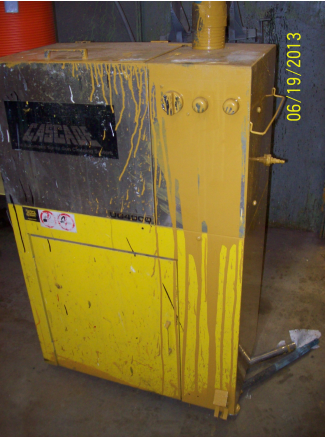
Photo 8

For painting smaller equipment, the facility uses pot-guns. These guns are cleaned in the facility's gunwasher using HET 1501 (Photo 8). Spent paint and thinner is collected in a 5-gallon container in the gunwasher. The facility removes the D001/F003/F005 spent paint and solvent from the gunwasher quarterly and places it into a 55-gallon hazardous waste accumulation drum for disposal as hazardous waste. The accumulation drum was properly labeled, dated, and had been accumulating for less than 180 days at the time of the inspection (Photos 9 and 10).

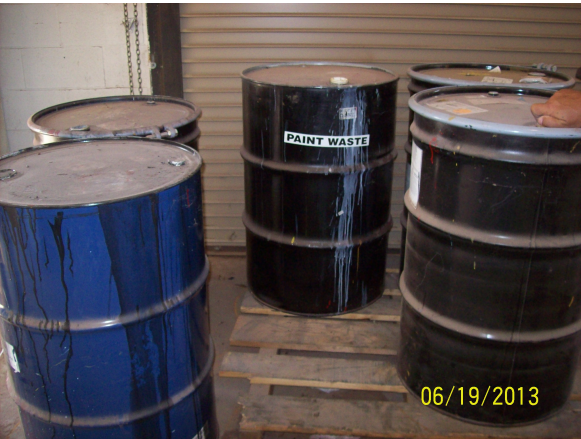
Photo 11

Outside of the paint mixing room, the facility has one hazardous waste accumulation area (Photo 11). In the accumulation area, the facility had two 55-gallon drums of spent paint, one 55-gallon drum of still bottoms, two 55-gallon drums of off-spec paint, one 55-gallon drum of F005 hazardous waste PPE and rags, and one empty drum. The two 55-gallon drums of off-spec paint

were closed, but they were not labeled or dated [40 CFR 262.34(a)(3), 40 CFR 262.34(a)(2)]. The facility labeled and dated these drums during the inspection. All other drums were closed, properly labeled, dated, and had been accumulating for less than 180 days. The facility also had one 55-gallon satellite drum for aerosol cans in this area. The drum was closed and labeled.

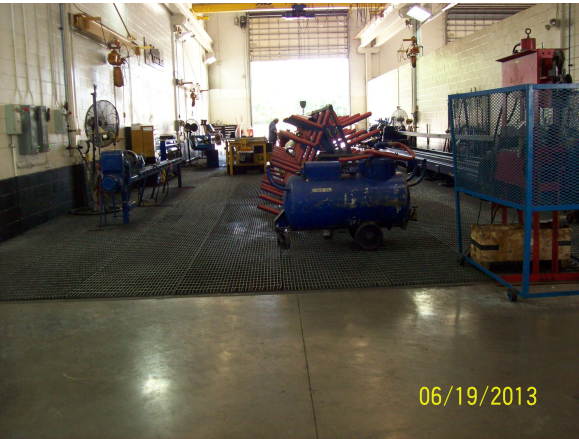
Photo 12

In this area, engines are dismantled and washed in parts washers for repairs. The used oil drains from engines through grates onto large pig mats. FCC disposes of the pig mats as used oil absorbents every two to four weeks. Shallow pans below the pig mats catch any used oil that is not absorbed in the pig mats. Below the pans is a sealed sump that serves as secondary containment for the pans. The facility empties the pans into the sump when FCC or Safety Kleen is on-site to pump the used oil. The used oil drains by gravity to one corner of the sump where FCC or Safety Kleen is able to pump the used oil out of the sump. The sump is approximately six inches deep, and covers the length of the work area (approximately 20' x 40') (Photo 12). The floor around the sump was labeled "Used Oil." Mr. Strickland estimated that it takes approximately one year to generate enough used oil to pump out of this area.

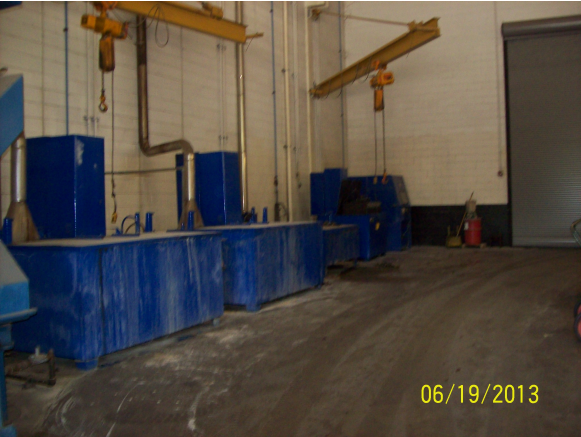
Photo 13

After engines are drained, they are cleaned in one of three immersion parts washers. The facility has two 600-gallon mineral spirits parts washers that are managed by FCC on its continued use program (Photo 13). The facility also has one 900-gallon aqueous immersion parts washer that is managed by Safety Kleen as non-hazardous waste (Photo 14). The parts washers are serviced bi-annually.

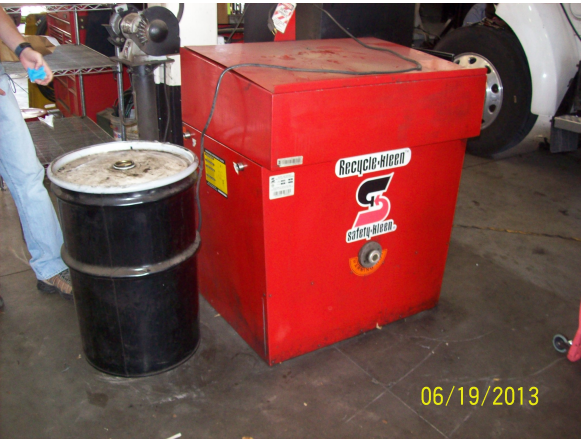
Photo 15

The facility has these additional maintenance and repair shops on-site: Truck Shop, Generator Building, Crane Shop, Undercarriage Reconditioning Shop, Steel Fab Shop, Clean Room, and a Heavy Equipment Shop. Between these shops, the facility has 24 30-gallon System One Safety Kleen Parts Washers. These parts washers are serviced quarterly and generate a D006/D007/D008 sludge that is accumulated in a 30-gallon satellite drum near each parts washer (Photo 15). All drums were properly labeled.

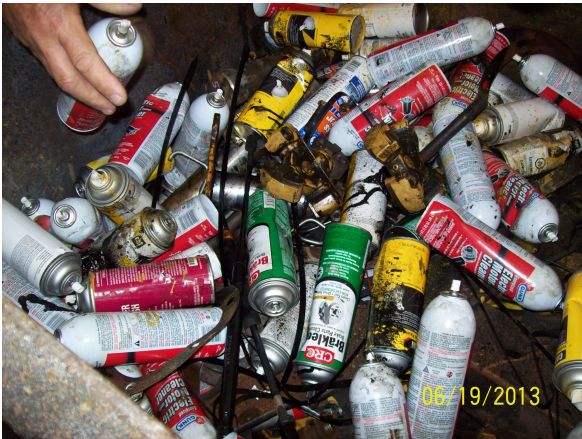
Photo 16

The facility generates aerosol cans in each shop. The facility's standard operating procedure is to accumulate cans for puncturing and draining into a satellite 55-gallon drum and then dispose of the empty cans as scrap metal. In the Heavy Equipment Shop, the facility was accumulating spent aerosol cans in a hopper (Photo 16).

There was some liquid from aerosol cans accumulating in the bottom of the hopper, and the hopper was open, allowing the hazardous waste to evaporate [40 CFR 262.20(a)]. The Heavy Equipment Shop is also a major producer of the facility's used oil. Used oil is collected in containers, and it is then pumped through above ground pipes to the tank farm.

Type:	Violation
Rule:	262.20(a)
Explanation:	The facility accumulated D001 spent aerosol can liquid in an open hopper, allowing the waste liquid to evaporate.
Corrective Action:	No further action is required. The facility returned to compliance per a June 26, 2013, email.
<hr/>	
Type:	Violation
Rule:	262.34(a)(2)
Explanation:	Two 55-gallon drums of off-spec paint were not marked with the accumulated start date.
Corrective Action:	No further action is required. The facility returned to compliance during the inspection.
<hr/>	
Type:	Violation
Rule:	262.34(a)(3)
Explanation:	Two 55-gallon drums of of-spec paint were not labeled "Hazardous Waste."
Corrective Action:	No further action is required. The facility returned to compliance during the inspection.
<hr/>	
Type:	Violation
Rule:	265.37
Explanation:	The facility did not make arrangements with local authorities.
Corrective Action:	No further action is required. The facility returned to compliance per a June 26, 2013, email.

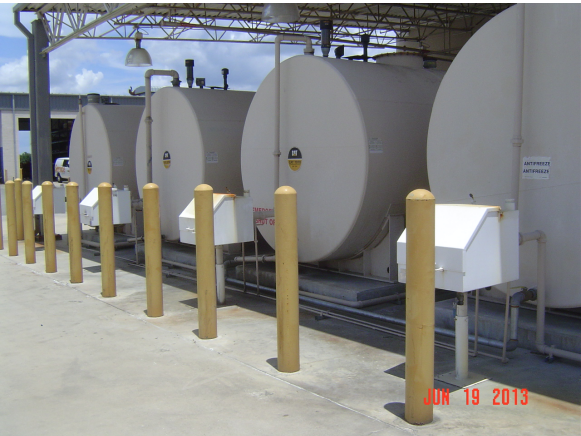
Photo 17

The Tank Farm is located near the Truck Shop and Heavy Equipment Shop (Photo 17). The facility has four 10,000-gallon double-walled tanks. Tanks one and three contain product oil. Tank two is divided and contains 2,500 gallons of used oil and 7,500 gallons of product hydraulic oil. Tank four is divided and contains 5,000 gallons of product antifreeze and 5,000 gallons spent antifreeze. The tanks were properly labeled.
