SUBJ: Resource Conservation Recovery Act (RCRA) Compliance Evaluation Inspection (CEI)
Triumvirate Environmental, Inc. (EPA ID #: FLD 980 559 728)

**United States Environmental Protection Agency (EPA)
Region 4, Atlanta, Georgia
Compliance Evaluation and Inspection Report**

Triumvirate Environmental, Inc.
10100 Rocket Boulevard
Orlando, Florida 32824
EPA ID #: FLD 980 559 728
NACIS Code:

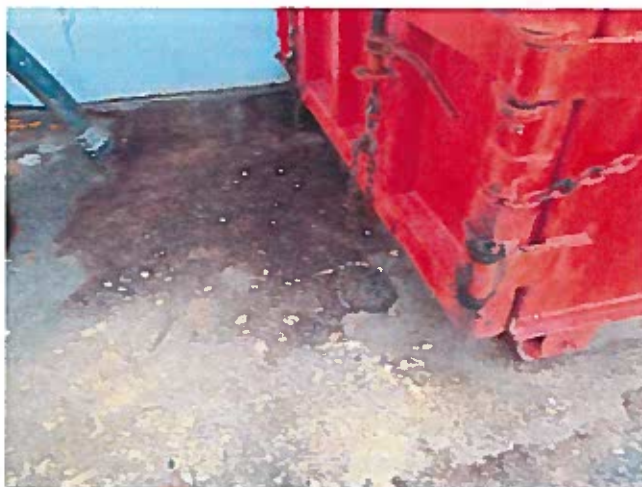
Inspectors observed a roll off container staged under the roof immediately to the west of the Loading Dock. Mr. Vick informed the inspectors that the container was for the disposal of solid waste intended for RCRA Subtitle D Landfill disposal. At the time of the inspection the container was covered with a tarp. The asphalt on the North end of the container was observed to be stained (Figure 2)

Figure 2: The asphalt surrounding the dumpster.

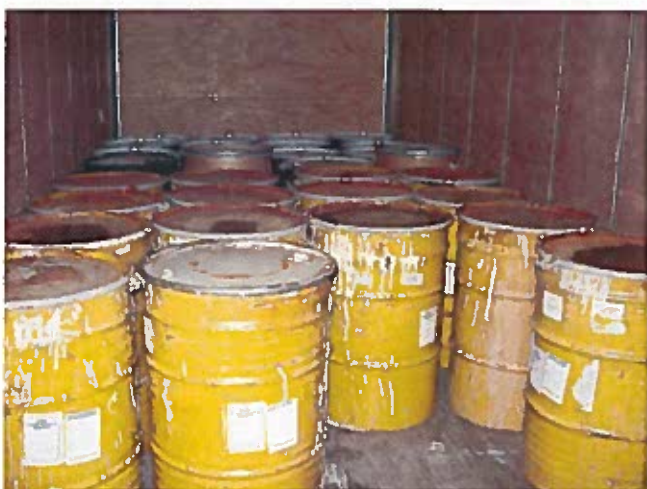
At the time of the inspection the fire suppression system in the permitted storage area had not been upgraded to meet the requirements of the fire code. Therefore, TEFI could not store flammable material in the permitted storage area. In an attempt to continue to manage flammable waste a trailer had been placed at one of the loading bays. This container was intended to serve as a 10 day transfer facility. At the time of the inspection the trailer was observed to hold 12 containers that had not been processed into the facility and 31 which had been processed in, for a total of 43 containers. Most of the containers were 55-gallon drums (Figures 3-8).

Figure 3: Waste in rear of AES Trailer.

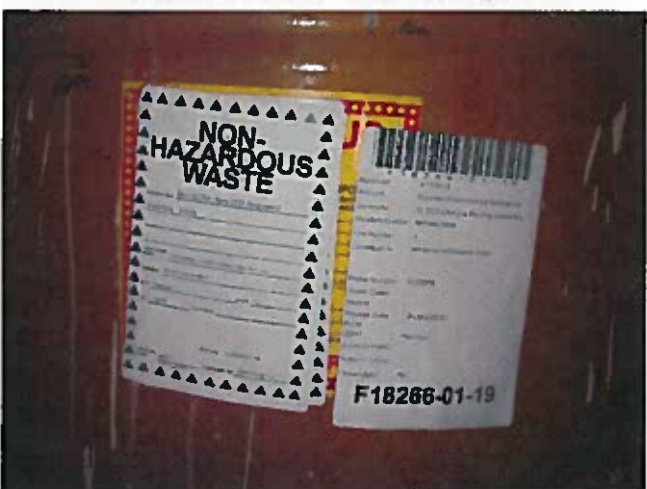
All of the containers, except one, that had not yet been processed into the facility, were from Halifax Health. The 31 containers that had been processed in to the facility that were stored in the rear of the trailer were stored with no space between the containers. This made it difficult to properly inspect the containers. The containers that had labels that were visible had non-hazardous labels. At least four of these containers appeared to have been relabeled as non-hazardous. The non-hazardous labels that were observed on 3 of the relabeled containers indicated that TEFI was the generator (Figures 5-8).

Figure 5: F18266-01-19 Nonhazardous label on top of hazardous label.

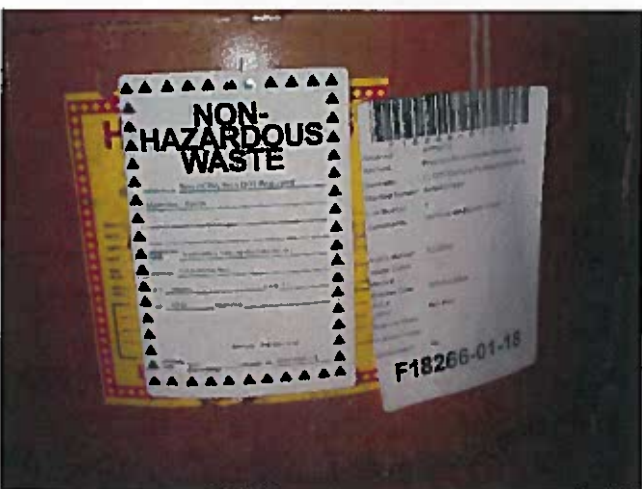
Figure 6: F18266-01-18 Nonhazardous label on top of hazardous label.

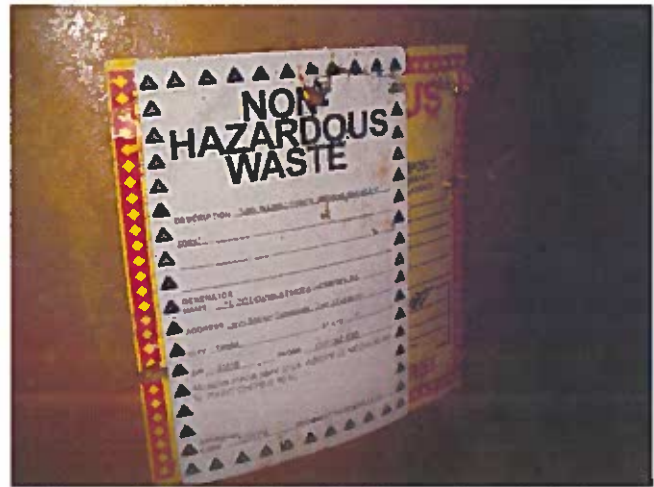
Figure 8: F18266-01 Nonhazardous label on top of hazardous label.

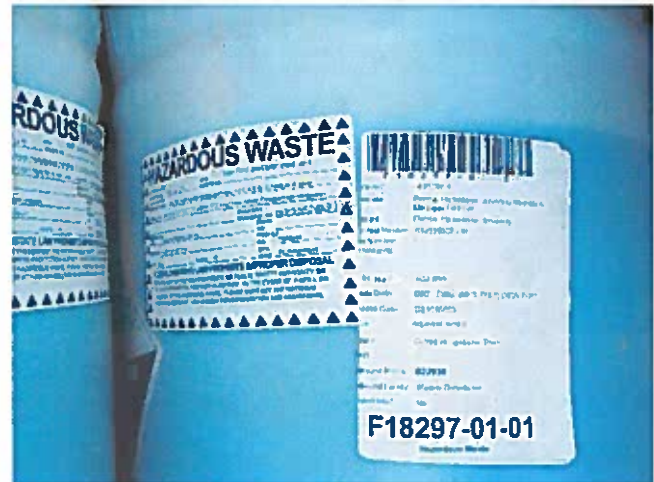
Container F18297-01-01 (Figure 10) had been characterized as a flammable hazardous waste and was stored in the container storage area.

Figure 10: F18297-01-01 which had been characterized as D001 waste.

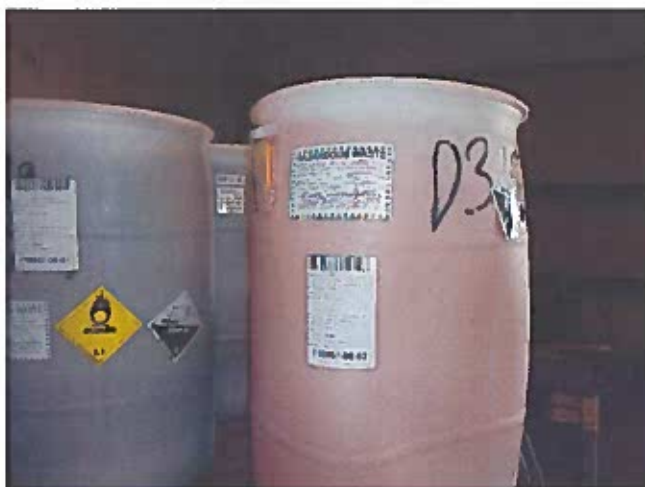
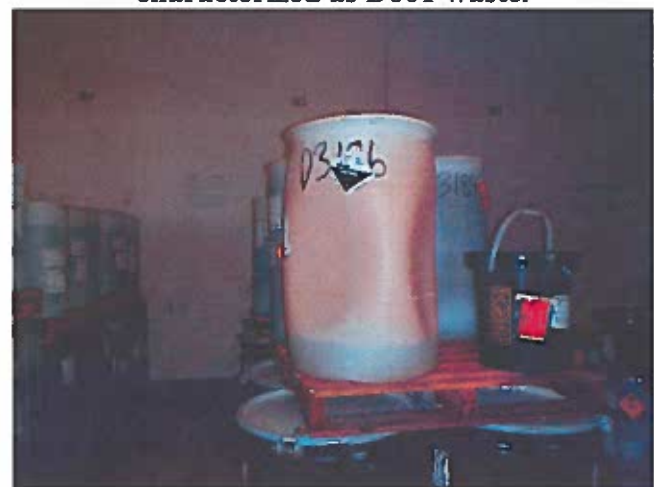
Row 303 (Figures 11 and 12) Inspectors observed a 55-gallon drum stored in Row 303 which was under a negative pressure. The labels on the drum indicate that the drum was received at TEF1 on 6/30/2014 from Florida Atlantic University, FLD982150658, on manifest number 012355473JJK.

Figure 11: Container under negative pressure.

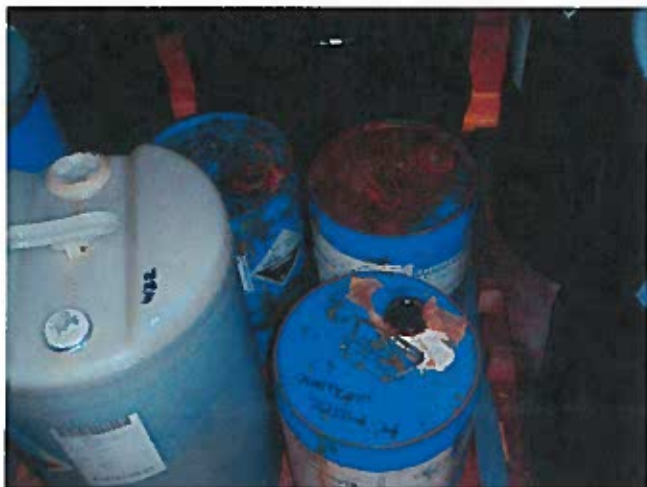
Inspectors observed three 5-gallon container of hazardous waste that shown signs of corrosion and deterioration. (Figures 13 and 14)

Figure 13: Condition of containers.

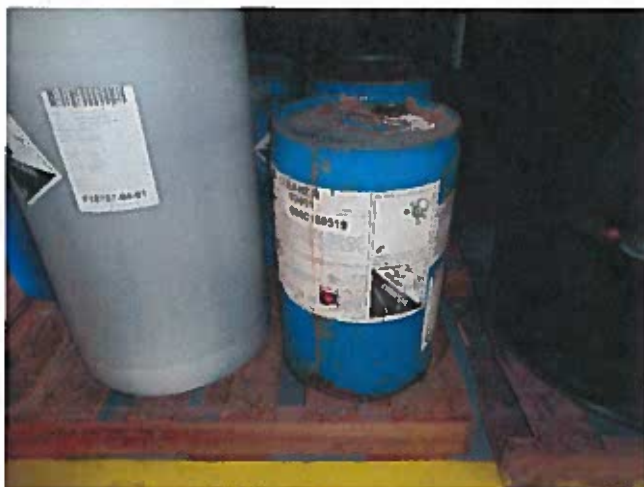
Figure 14: Condition of container.

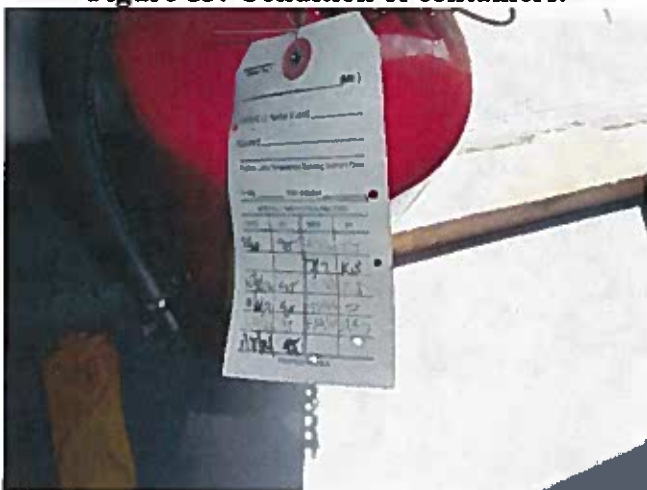
Inspectors observed the fire extinguisher, emergency shower and eye wash test/inspection record which indicated that the equipment had not been inspected since 6/20/2014 (Figure 15).

Figure 15: Inspection tag on fire extinguisher.

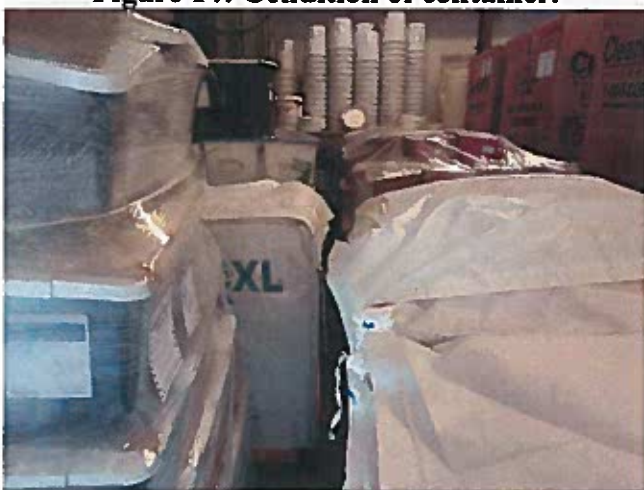
Inspectors observed the waste Consolidation Area to contain five pallets of hazardous/universal pharmaceutical waste in black containers, one pallet of containers with blue lids that had two black hazardous waste containers on top of it (Figure 16), eleven super sacks, and two pallets of red biomedical waste containers. Many of the containers were not properly closed and the lack of aisle space did not allow unobstructed movement in the area.

Figure 16: Aisle space in Consolidation Area.

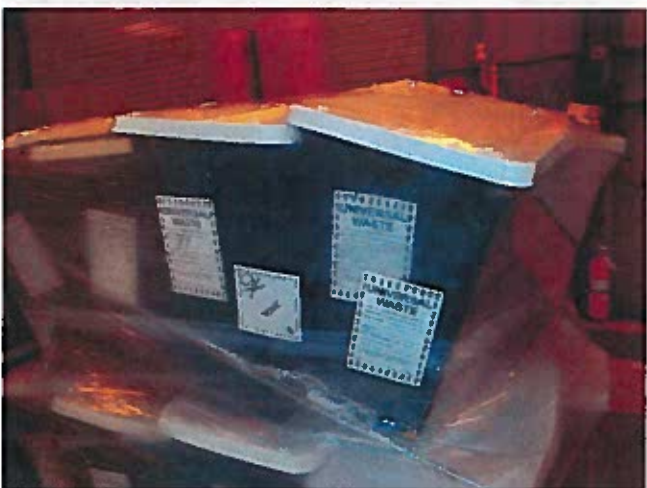
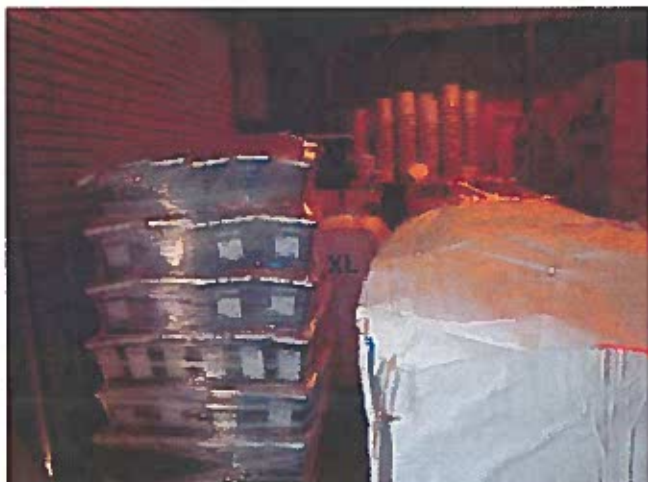
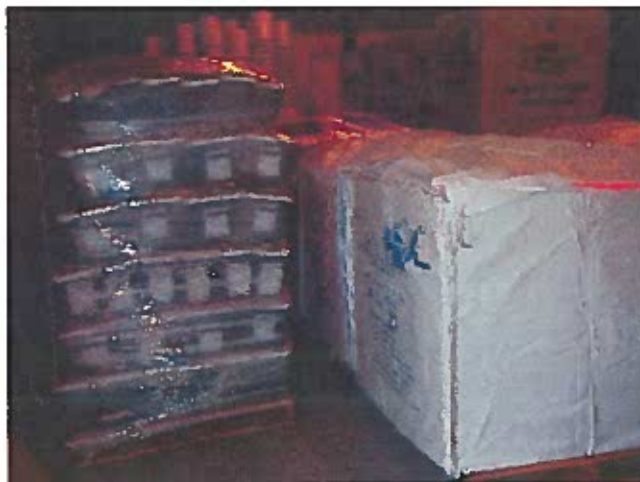
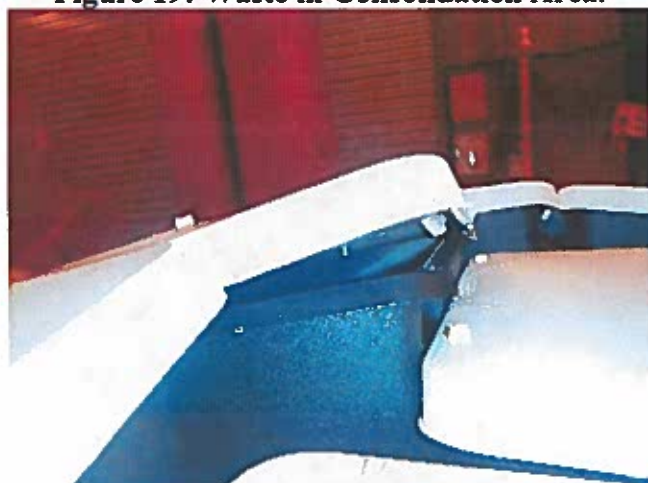
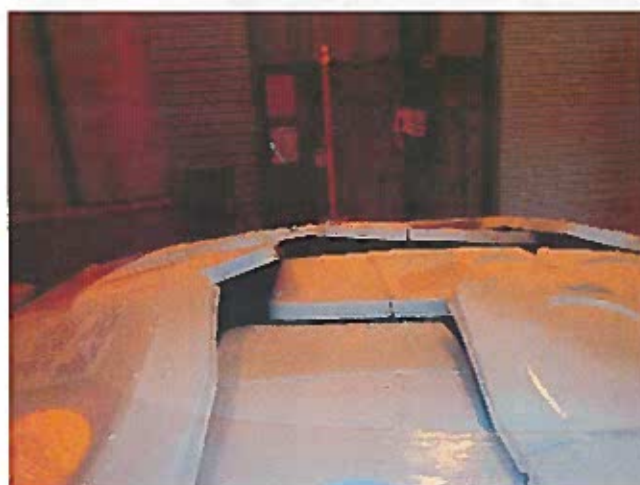
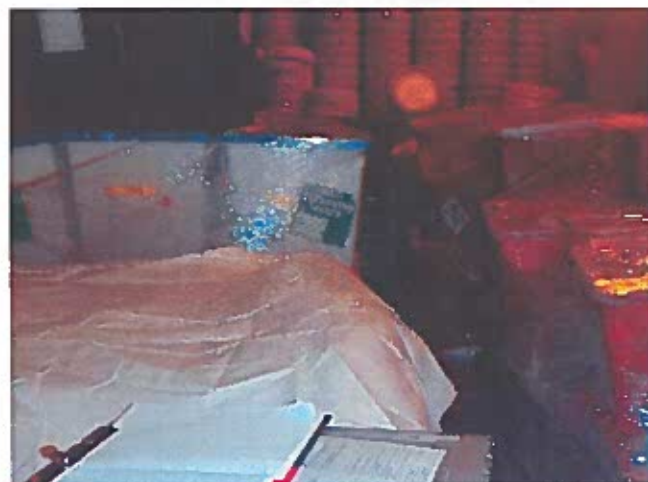
Inspectors asked Mr. Vick about the consolidation processes that take place in the area. Mr. Vick explained that the facility’s standard operating procedure was to open the containers of hazardous/universal pharmaceutical waste and separate out the solid waste. The solid waste components including needles, IV lines, bags and tubing, paper towels, gloves, and other wastes that the generator had determined to be hazardous wastes. These wastes were removed from the black containers and combined in with solid waste or biomedical waste (Figures 17-24). Inspectors obtained a SOP for the separation/consolidation procedure.

The facility personnel do not appear to have sufficient knowledge of the use and potential contamination of the waste through a visual examination of the material to determine if the waste would meet the definition of hazardous waste, whether by characteristic or listing. Furthermore, the generator is responsible for making hazardous waste determinations at the point the waste is generated. The generator has already made the determination that the waste in the black containers is a hazardous waste and sent it for management and disposal, as such. The further reclassification of the waste and subsequent shipment of the reclassified waste as a non-hazardous solid waste, or biomedical waste without the required documentation to a facility that is not permitted to manage the waste is problematic. The universal pharmaceutical waste standards found at Fla. Admin. Code Ann. r. 62-730.186 require very specific criteria and management standards to be met in order to manage the waste as a universal pharmaceutical waste. TEFI does not appear to be meeting these criteria or management standards. Therefore, pursuant to Fla. Admin. Code Ann. r. 62-730.186(3) the hazardous waste pharmaceuticals not managed as universal waste in accordance with this section shall be managed in accordance with Chapter 62-730, Fla. Admin. Code, and shall be disposed of at a permitted hazardous waste treatment, storage or disposal facility.

Figure 17: Waste in Consolidation Area.

Figure 21: Open container of waste in Consolidation Area.

Figure 24: Oncology waste in Consolidation Area.

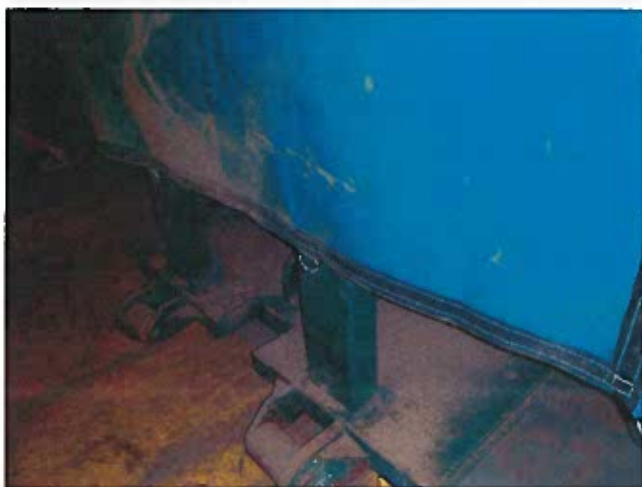
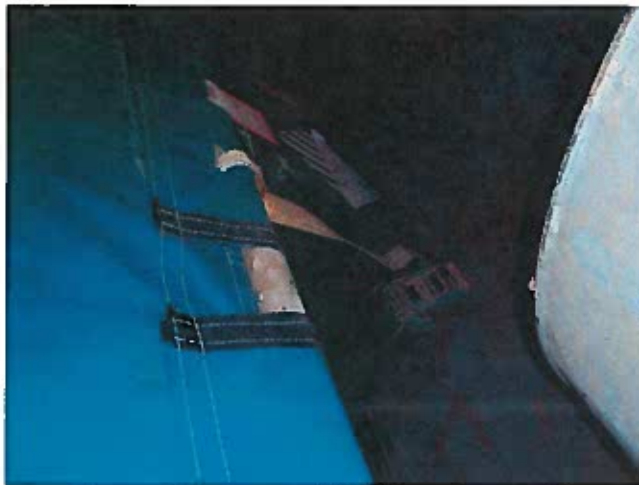
At the time of the inspection the inspectors observed a 30-cubic yard roll off container in the Waste Consolidation/Stabilization Area. At the time of the inspection the tarp covering the roll-off container was not secure. The container was labeled “Hazardous Waste.” The label indicated that the container held sand blast media that was characteristically hazardous waste due to the lead content. However, the description of the waste appearing on the labels was improperly or inconsistently completed. Inspectors observed what appeared to be spilled material on area around the container (Figures 25-27).

Figure 25: Waste in Stabilization Area.

Figure 26: Open container of waste in Stabilization Area.

Figure 27: Open container of waste in Stabilization Area.

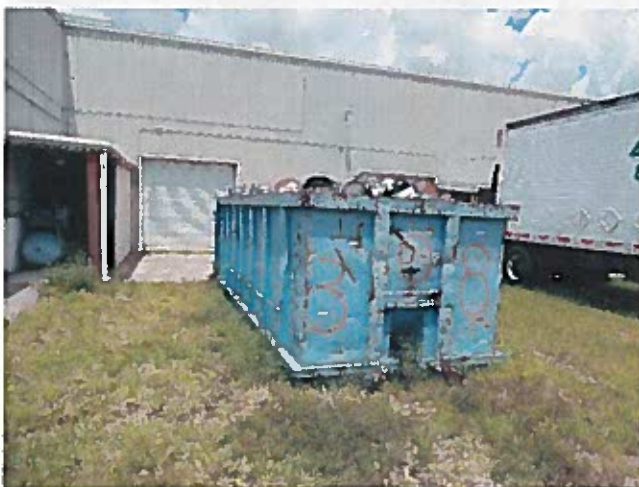
Figure 28: Roll off

Inspectors observed a 30-cubic yard roll off container in the rear of the Consolidation and Stabilization Area. This container held contained crushed 5-gallon cans, punctured aerosol cans, empty 1-gallon cans, drum lids, and aluminum frames from totes. (Figure 28)

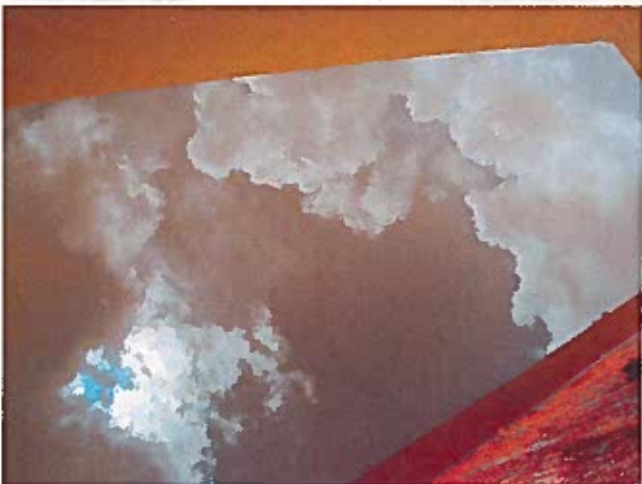
Figure 29

Inspectors observed another five roll-off containers staged on the east side of the building in the dirt lot. Several of these containers held standing liquid that appeared to have been allowed to accumulate over time. No mosquito larva were observed in the liquid in any of the containers. This appeared to be unusual for standing rain water in July in Florida. In one of the containers plant life was observed but not in the others. (Figures 29-32) Inspectors asked the Mr. Vick about the containers there current and previous contents and if any mosquito prevention had been utilized. Mr. Vick speculated that the containers held rainwater.

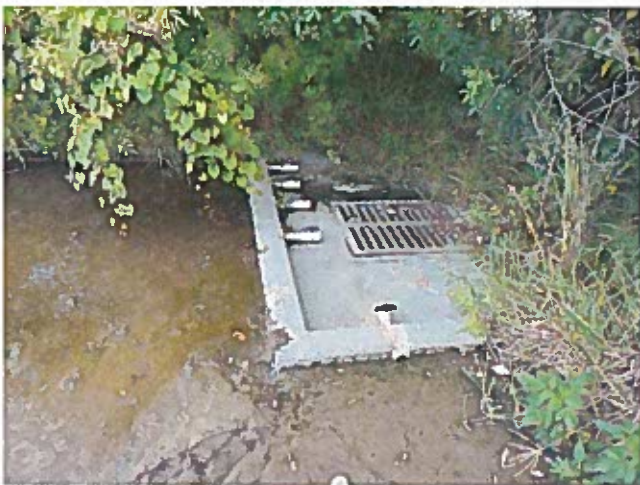
Figure 33

Inspectors observed the storm water drain on the north-west corner of the fenced facility area. The drain was surrounded by a small berm approximately 2" high and 6" wide which contained PVC piping with shut-off valves. At the time of the inspection valves were observed in the open position. Standing water was observed on the south side of the berm. (Figure 33) This water contained tad polls, mosquito larva and vegetative growth.

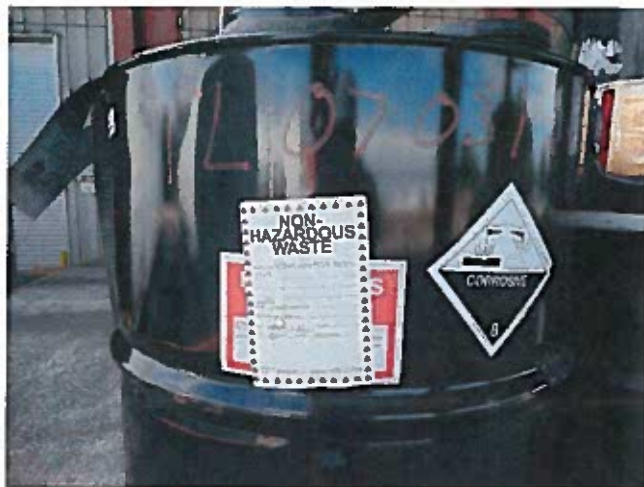
Inspectors observed one of the 55-gallon drums generated by the University of South Florida, dated 7/9/2014, which held formaldehyde solution. This container had a non-hazardous waste label placed on top of a hazardous waste label.

Figure 37: Nonhazardous label over a different label.

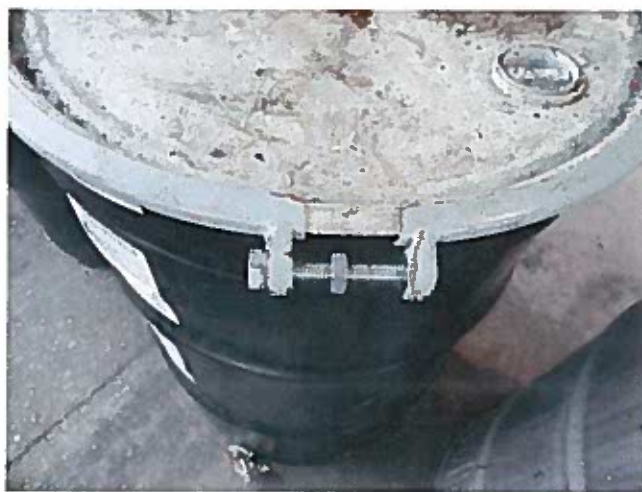
The nuts and bolts intended to secure the rings on the 55-gallon drums were observed to be improperly tightened.

Figure 38: Nut and bolt closure on drum ring.

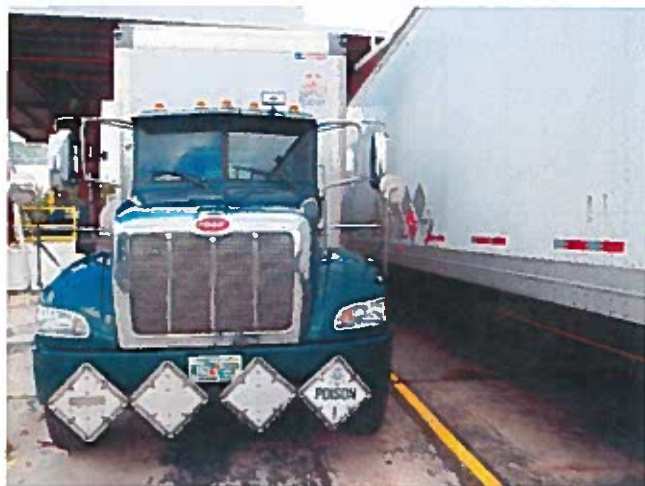
Figure 39: Truck next to AES Trailer.
