SUBJ: AERC.com, Inc.  
RCRA Compliance Evaluation Inspection Report  
EPA ID Number: FLD984262782

**United States Environmental Protection Agency (USEPA)  
Region 4, Atlanta, Georgia  
Compliance Evaluation Inspection Report**

AERC.com, Inc.  
4317-J Fortune Place  
Brevard County  
West Melbourne, FL 32904  
EPA ID No.: FLD984262782  
NAICS No.: 562111

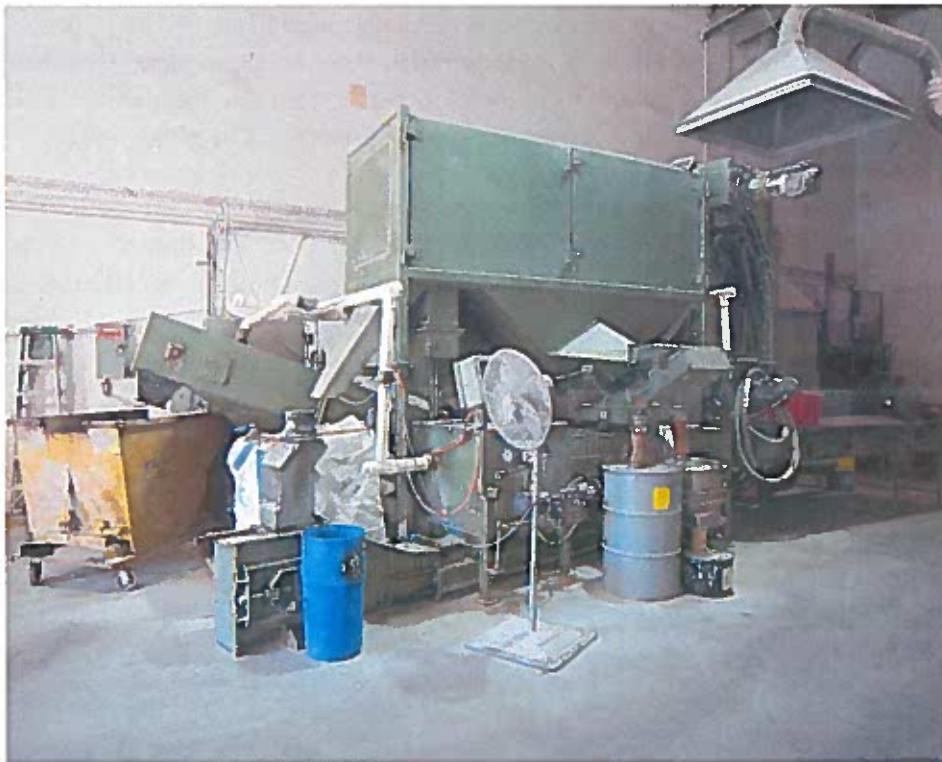
The lamp recycling machine (LSS-1) was not in operation at the time of the inspection (Photograph 1). Phosphor powder generated from lamp crushing in the LSS-1 is collected in a satellite accumulation container marked "Hazardous Waste" prior to transport to the 90-day

Photograph 1 – Lamp recycling machine (LSS-1).

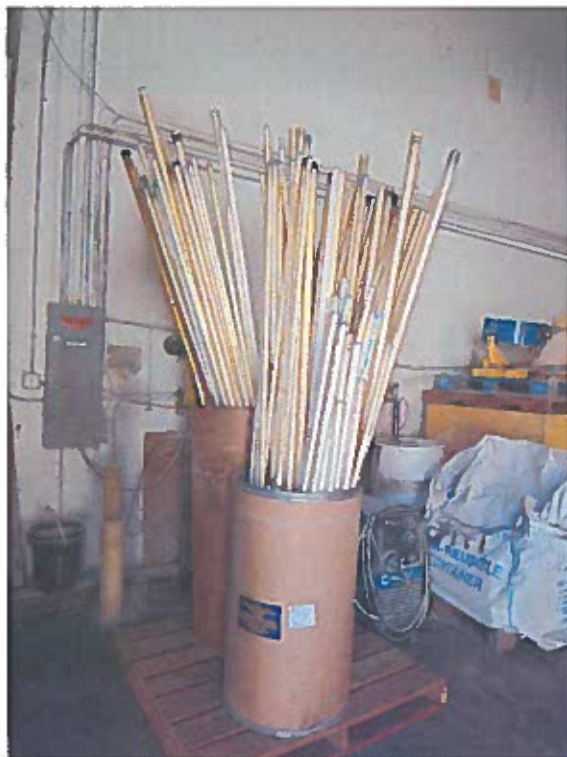
The inspectors observed approximately 200 lamps coated with a plastic shatter shield were stored in two open tube boxes near the LSS-1 processing area (Photograph 2). Employees remove the shatter shield prior to processing the lamps. **AERC appears to be in violation of F.A.C. Chapter 62-737.800(9), Permit Application Requirements and General Permitting Standards for Mercury Recovery and Mercury Reclamation Facilities, which states that owners and operators shall store processed and unprocessed materials in closed containers; and for broken or damaged unprocessed lamps and devices, and residuals, store these in closed, covered and sealed containers or in enclosed areas of the facility conforming to paragraph 62-296.417(1), F.A.C., to prevent mercury emissions. AERC appears to be in violation of F.A.C. Chapter 62-730.185(1) (40 C.F.R. § 273.33(d)(1)), which states that containers or packages of lamps must remain closed. The inspectors informed AERC to keep all boxes/containers closed prior to processing.**

Photograph 2 – Open containers of lamps.

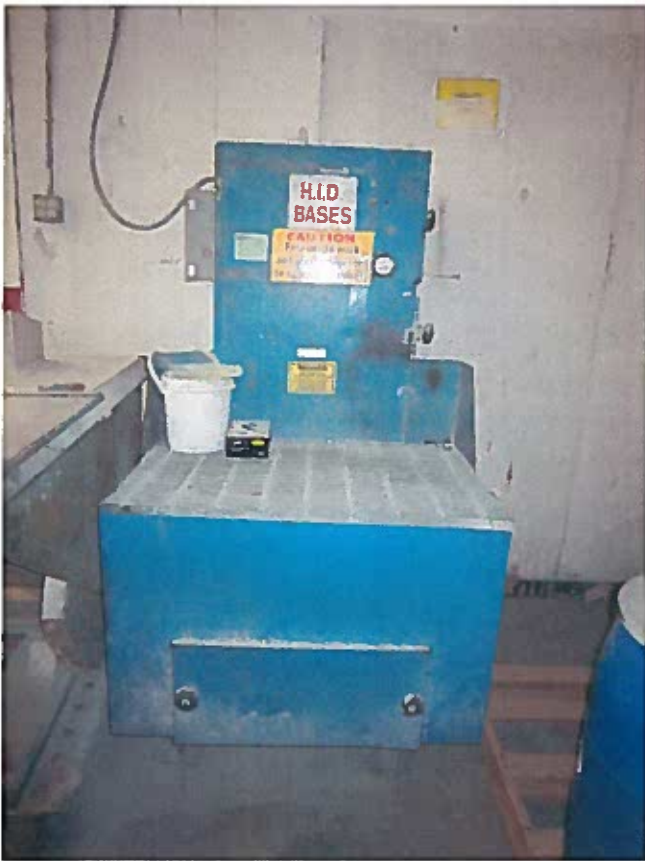
HID lamp base removal area is located in a corner of the warehouse. HID lamps are broken in a covered rectangular shape shaker (Photograph 3). Mercury contained ampoules are removed from the HID lamp bases and placed in a 55-gallon satellite accumulation container. A 30-gallon container held HID lamps waiting to be processed. The inspectors observed a 55-gallon container of ampoules closed and labeled "Hazardous Waste." The mercury ampoules are shipped off-site for reclamation.

Photograph 3 – HID Lamp Shaker.

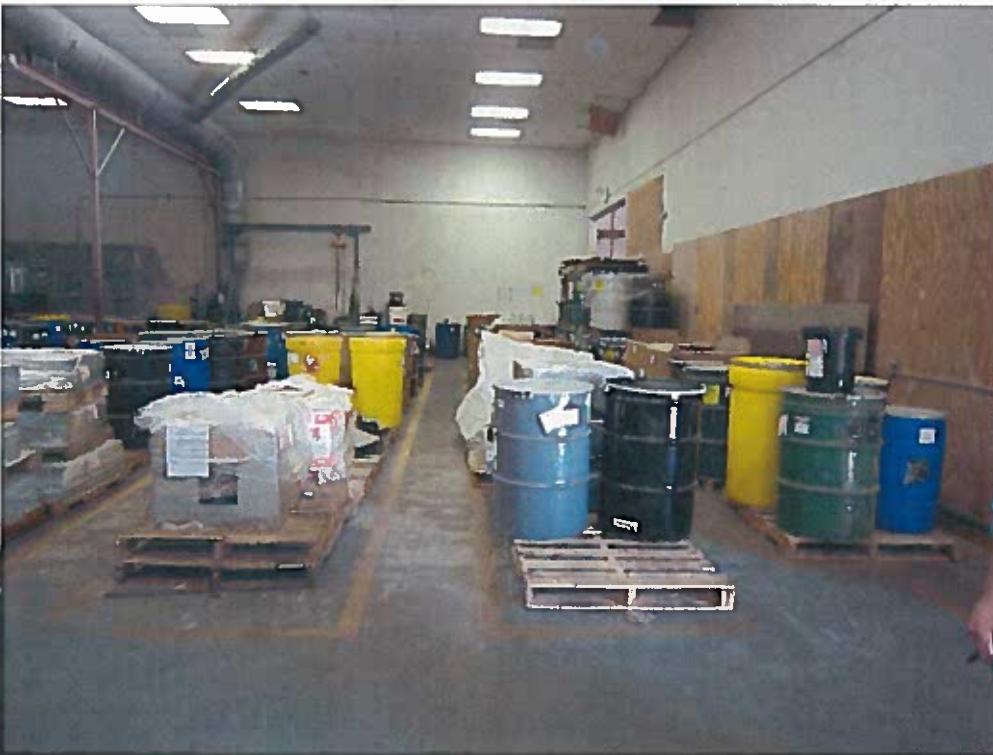
The Bulb and Battery Staging area takes up the majority of the warehouse area and consisted of ten rows of waste and recyclable materials (Photographs 4-5). During the inspection, Row 1 consisted of HID lamps, compact bulbs, and water meters; Row 2 consisted of batteries and lamps; Rows 3-8 consisted of different types of batteries, Row 9 consisted of non-PCB ballasts, capacitors, and batteries; and Row 10 consisted of PCB ballasts, non-PCB ballasts, capacitors, and transformers.

Photograph 4 – Bulb and battery staging area.

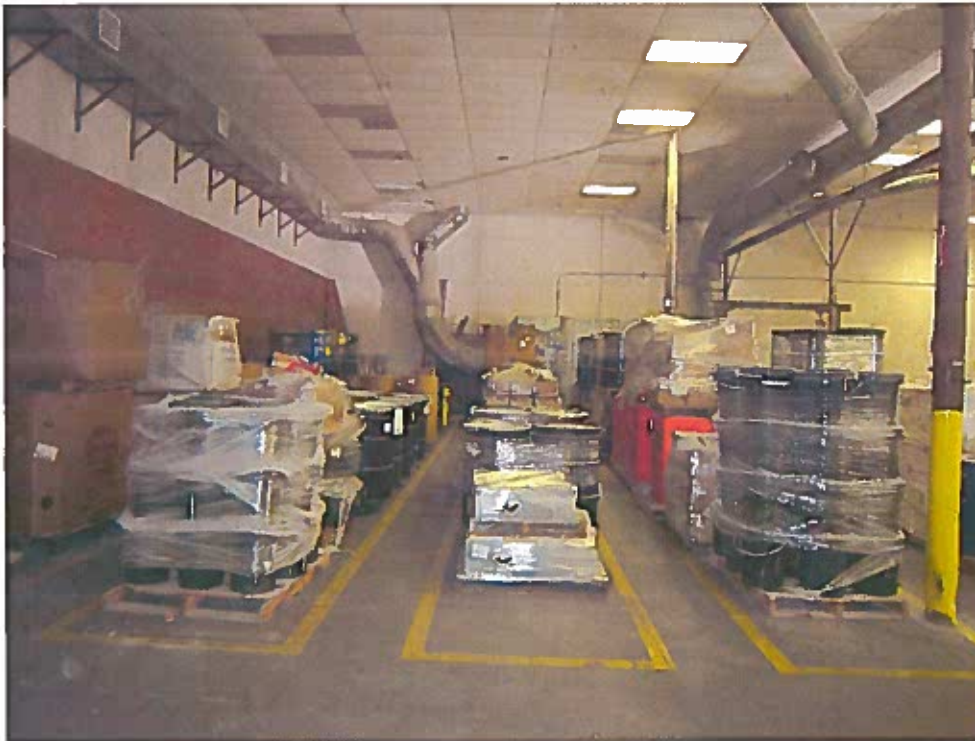
Photograph 5 – Bulb and battery staging area.

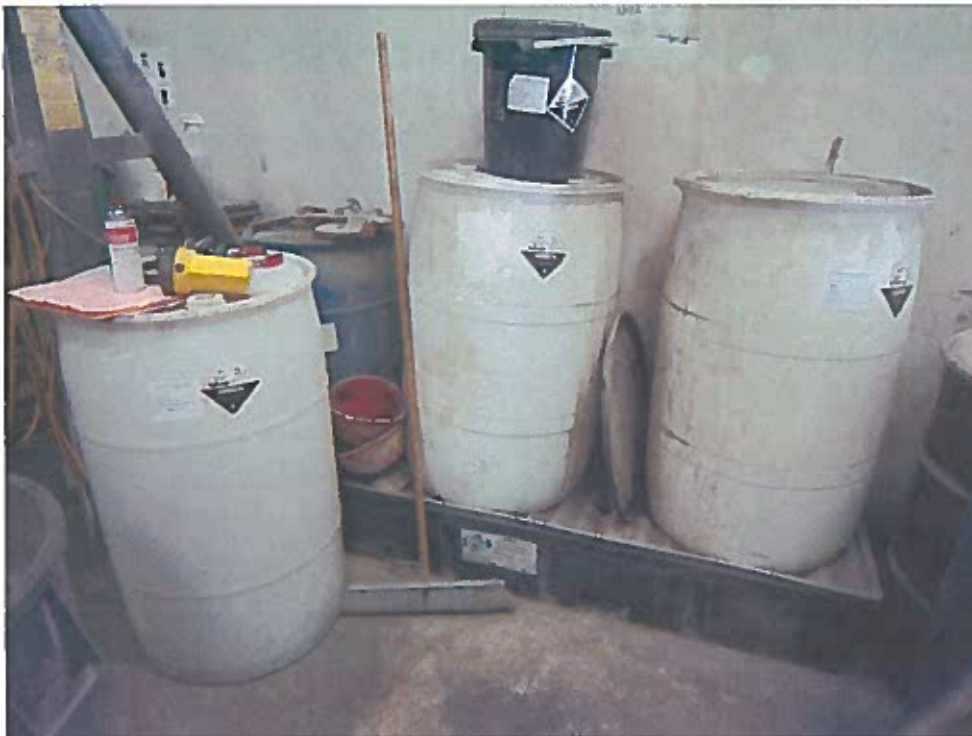
Located on the east side of the warehouse, between the battery processing area and universal waste battery storage area, is the wet battery processing area (Photograph 6). AERC accepts lead-acid, lithium ion, nickel metal hydride, nickel cadmium, and alkaline batteries for recycling. Currently, alkaline batteries are shipped to Metal Conversion Technology, Georgia.

Photograph 6 – Wet battery processing area.

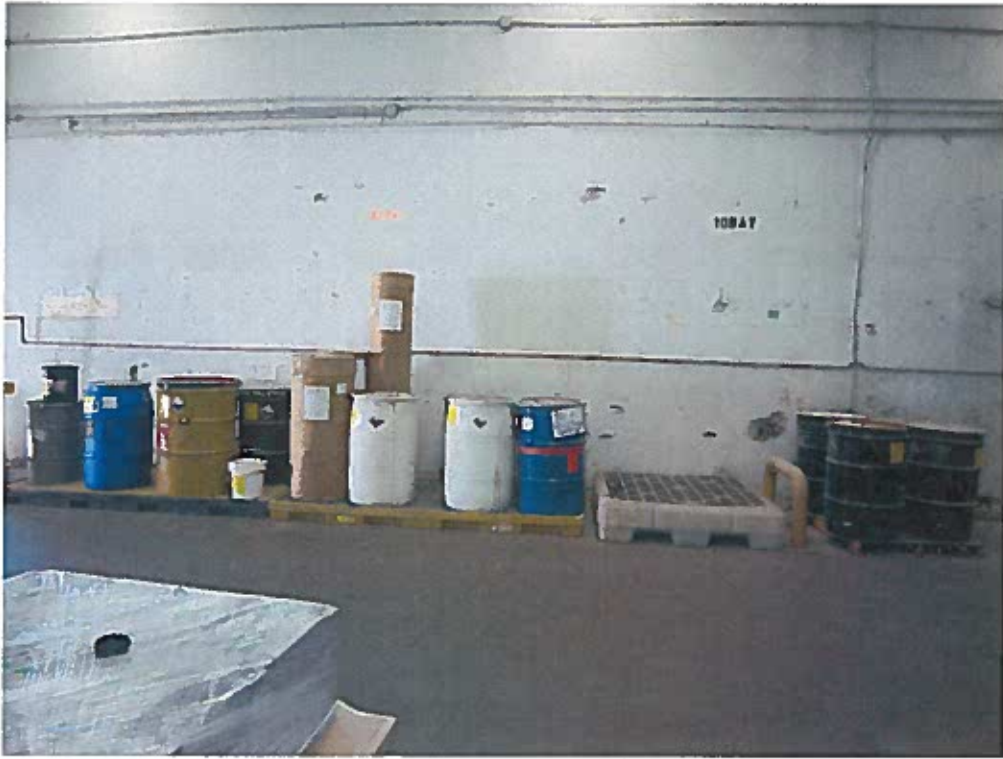
According to AERC, materials in the 90-day hazardous waste storage area goes to the AERC Pennsylvania facility for disposal and/or to be disassembled and treated by thermal retort. The following containers in the 90-day hazardous waste storage area (Photograph #7) were marked "Hazardous Waste" or Universal Waste" and had accumulation start date:

Additionally, four 55-gallon drums of waste phosphor powder (processed from the LSS-1 machine) were stored in the 90-day storage area. The four drums were marked "Hazardous Waste" and two drums were not marked with accumulation start date. The facility representative marked two drums with accumulation start date of "12/17/13" during the inspection. **Therefore, AERC appears to have failed to adhere to condition for exemption from Section 403.722 of the Florida Statutes, F.S. § 403.722 (Section 3005 of RCRA, 42 U.S.C. § 6925), given in F.A.C. Chapter 62-730.160(1) (40 C.F.R. § 262.34(a)(2)), which allows a generator to accumulate hazardous waste on-site for 90 days or less without a permit or without having interim status, provided that the date upon which each period of accumulation begins is clearly marked and visible for inspection on each container. AERC failed to mark the beginning date of accumulation on two 55-gallon drums of hazardous waste (D009) located in the 90-Day Hazardous Waste Accumulation Area.**

Photograph 7 – 90-Day hazardous waste storage area.
