**Re: Ring Power Corporation**  
**EPA/DEP ID: FLD 984 206 854**  
**Columbia County – Hazardous Waste**

**Florida Department of  
Environmental Protection  
Hazardous Waste Inspection Report**

**Facility Name:** Ring Power Corp

Inspection Date: 08/02/2016

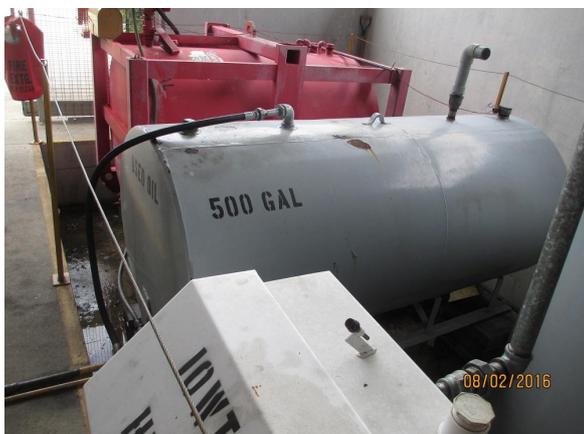
Photo 1

RPLC has one 500-gallon double-walled used oil tank located within a containment structure (Photo 1). The structure has a drain that can be opened to allow the released of accumulated rainwater (Photo 2). The drain was closed at the time of the inspection, and no oily sheen was observed on the rainwater in the containment structure. The tank was closed and labeled with the words "Used Oil."

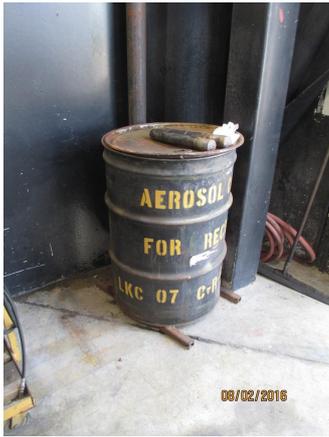
Photo 3

The facility has implemented a scrap metal recycling collection plan for spent aerosol cans. Waste aerosol cans containing liquid are accumulated in 55-gallon drums that are closed and labeled "Aerosol cans for recycling" (Photo 3). Cans are then taken to the satellite aerosol can puncturing area that consists of one 55-gallon drum to accumulate the liquid waste. Empty waste aerosol cans are then placed into a scrap metal roll-off container (Photo 4).

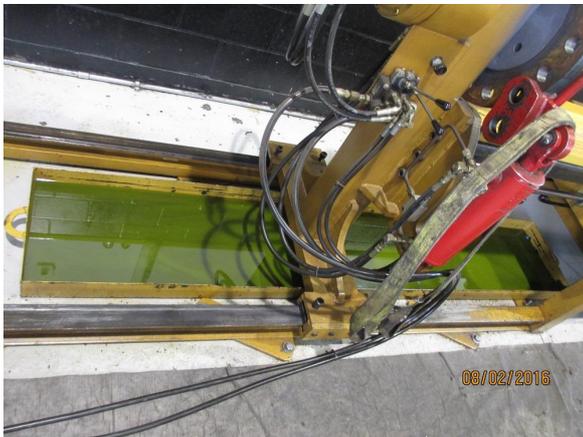
Photo 5

The Heavy Equipment Shop performs routine repairs, and parts instillation on heavy equipment. In this shop one bay is dedicated for servicing specific system parts and hydraulic cylinder bench work. The used oil accumulation pan for the hydraulic cylinder bench was not marked clearly with the words "Used Oil" (Photo 5) [40 CFR 279.22(c)(1)]. The facility labeled the accumulation pan during the inspection (Photo 6). Generated used shop towels are accumulated in one 31-gallon container that was closed, and labeled "Excluded Solvent Contaminated Wipes" (Photo 7). Spent rags are collected and laundered by Cintas weekly.

Type: Violation  
Rule: **279.22(c)(1)**  
Explanation: 1. In the Heavy Equipment Shop the used oil accumulation pan for the hydraulic cylinder bench was not marked clearly with the words "Used Oil."  
2. In the Truck Shop two 55-gallon drums were not properly labeled with the words "Used Oil."  
Corrective Action: No further action is required. The facility labeled the containers during the inspection.

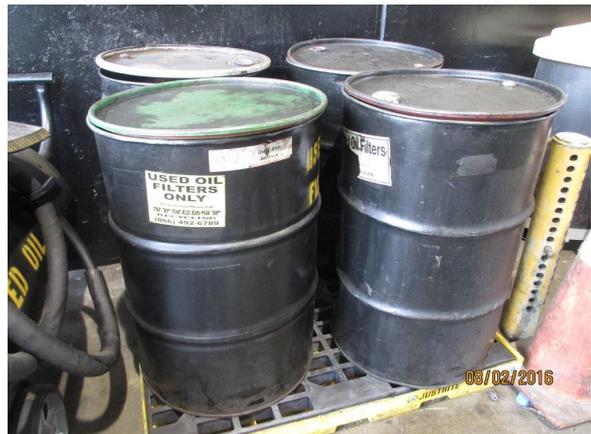
Photo 8

Used oil generated at the transmission bench is vacuumed into a 200-gallon used oil tank which is transferred into the facility's 500-gallon used oil tank daily (Photo 8). All used oil containers and both used oil tanks were properly labeled with the words "Used Oil." Used oil filters are drained into a used oil container and then placed into a 55-gallon drum for accumulation. Two 55-gallon drums were accumulating, and both were properly labeled with the words "Used Oil Filters" (Photos 9 and 10). Used oil and used oil filters are recycled through Synergy.

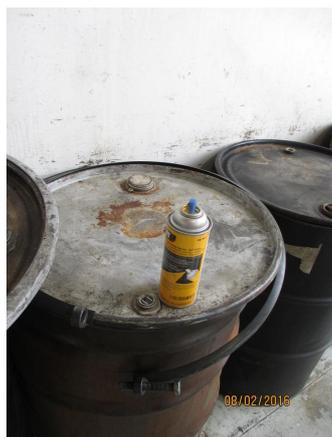
Photo 14

In the Track Shop, the facility no longer performs new equipment tracks installation. At the time of the inspection, one 55-gallon drum was accumulating waste paint chips (Photo 14) from this process. The drum was closed and properly labeled "Waste Paint." The drum will be sent off-site for proper disposal as hazardous waste. The facility had a current weekly container log on display. One 5-gallon container of shop towels was closed, but not labeled "Excluded Solvent Contaminated Wipes." The facility labeled the container during the inspection.

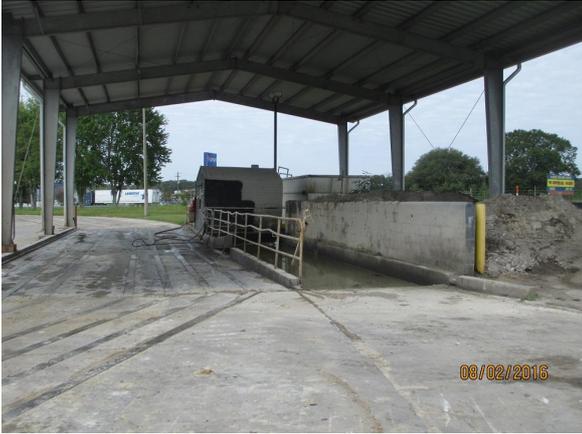
Photo 15

The HEWA is a 100% closed loop recycling system for high pressure washing of equipment (Photo 15). Approximately two to four vehicles are washed in this area per week. The facility occasionally uses an alkaline soap (Hydrosolve 4165) in this area which is sprayed on prior to vehicle pressure washing. Wastewater flows from a concrete wash pad to a collection area which filters solid materials and directs the wastewater to an oil-water separator. The solid material is removed and dried in accumulation area adjacent to the HEWA. The filters are pressure washed annually to remove build up, and the sludge is added to the accumulation area. Solids from the HEWA are transported approximately every six months to a solid waste landfill. The waste was analyzed July 30, 2015, and has been found to be non-hazardous. Wastewater generated from the HEWA is diverted to an oil-water separator. The oil-water separator is serviced by Safety Kleen.

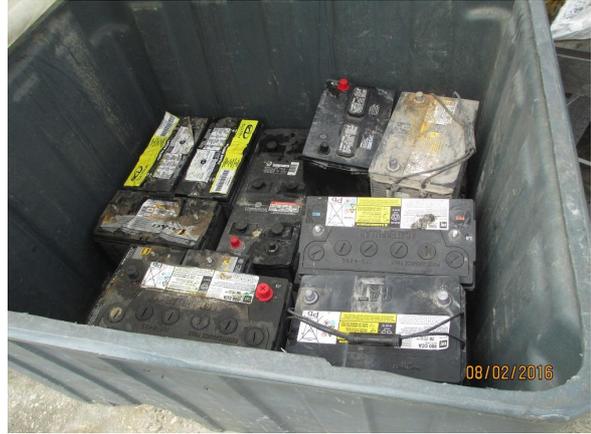
Photo 16

The Outside Holding Area is a temporary staging area for equipment parts and facility materials. Spent lead-acid batteries are accumulated in a large closed plastic container for pick-up and recycling (Photo 16).
