Re: AERC.Com  
HW Facility ID FLD984262782  
Brevard County

**Florida Department of  
Environmental Protection  
Hazardous Waste Inspection Report**

**On-Site Inspection Start Date:** 07/27/2016      **On-Site Inspection End Date:** 07/27/2016

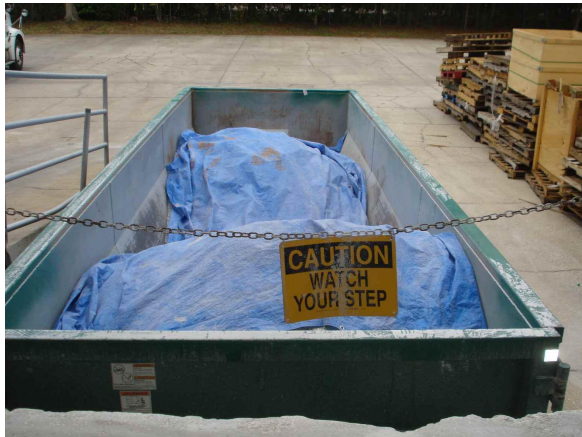
13. Processed glass roll-off

Outside the processing area bay door is the staging area for the roll-off container accumulating processed glass. The container stores glass generated by the lamp processing equipment. Once sampling of the glass has documented the glass does not exhibit a hazardous waste characteristic of toxicity, the glass is disposed of at a Subtitle D, non-hazardous waste landfill. The tarp that is supposed to completely cover the roll-off container was not adequate and did not meet the requirements of permit condition Part II Subpart B, Specific Operating Conditions Number 1 which requires compliance with Rule 62-730.800(9), F.A.C., which requires containers be closed, covered, and sealed. The tarp was just laying over the glass in the roll-off container (Figure 13). At one end of the roll-off is a door that goes top to bottom and side to side, a gap was visible around the door which would allow rain water to drain out (Figure 14).

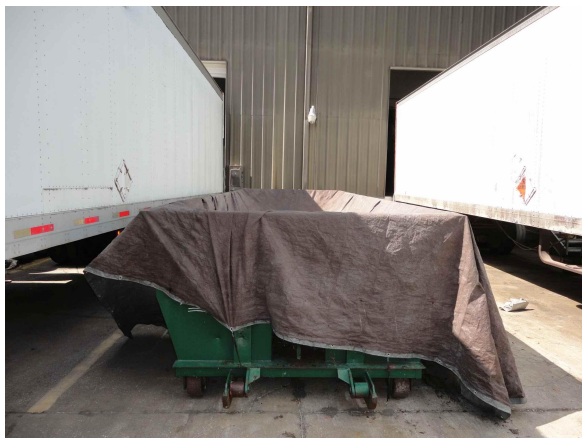
15. Processed glass roll-off container

A second roll-off of crushed glass was noted to the east of the first (Figure 15). The second roll-off was covered with a black tarp but the tarp was stretched and sagging into the roll-off and had multiple holes that will allow water to enter (Figure 16). The tarp was not adequate and did not meet the requirements of permit condition Part II Subpart B, Specific Operating Conditions Number 1 which requires compliance with Rule 62-730.800(9), F.A.C. Storm drains near the loading dock and roll-offs were inspected and no signs of glass were noted entering the stormwater conveyance.
