Re: Ring Power Corporation
EPA/DEP ID: FLD 981 480 205
Taylor County – Hazardous Waste

**Florida Department of
Environmental Protection
Hazardous Waste Inspection Report**

Facility Name: Ring Power Corp

On-Site Inspection Start Date: 09/15/2016

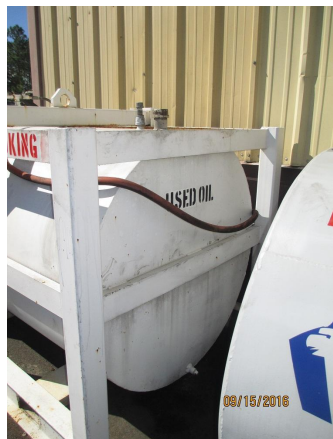
Photo 1

Used oil generated from routine maintenance is collected in used oil catch pans and pumped into the facility's 500-gallon double-walled tank. The tank was closed and properly labeled "Used Oil" (Photo 1). Used oil filters are drained into used oil containers and then placed into a 55-gallon drum for accumulation. Two 55-gallon drums were accumulating, and both were closed and properly labeled with the words "Used Oil Filters" (Photo 2). Used oil and used oil filters are recycled through Synergy. Generated spent antifreeze is collected in a 250-gallon tote, and it is also recycled through Synergy.

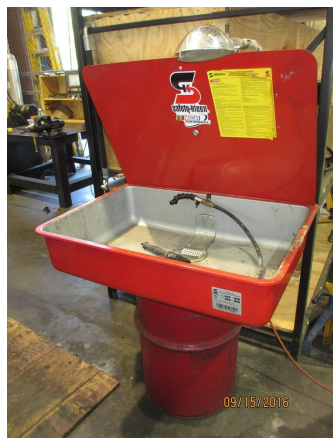
Photo 3

Located in each maintenance area is one 30-gallon Safety Kleen petroleum naphtha parts washer (Photo 3). The three parts washers are serviced every eight weeks under Safety Kleen's continued use program. Used shop towels generated by maintenance practices are accumulated in one 30-gallon container located in each maintenance area that are closed and labeled "Excluded Solvent Contaminated Wipes" (Photo 4). All three spent towels containers are collected and laundered by Cintas weekly.

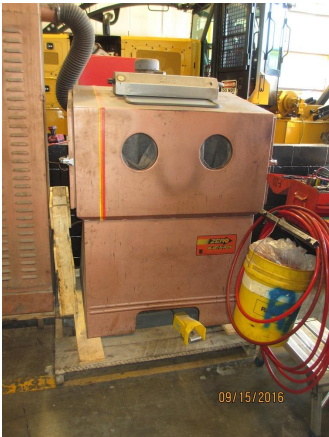
Photo 5

All three maintenance areas share one glove box sand blasting unit that has bag filters (Photo 5). This unit is used approximately one to two times per month to blast rust and staining from small parts and tools. At the time of the inspection the bag filters had not accumulated enough blast grit to require disposal. No waste has been generated from the glove box. The glove box generates glass bead blast grit that accumulates inside a sealed filter container. The facility should perform a Toxicity Characteristic Leaching Procedure (TCLP) for RCRA metals on waste generated from this blasting unit and manage the waste based on the TCLP determination.

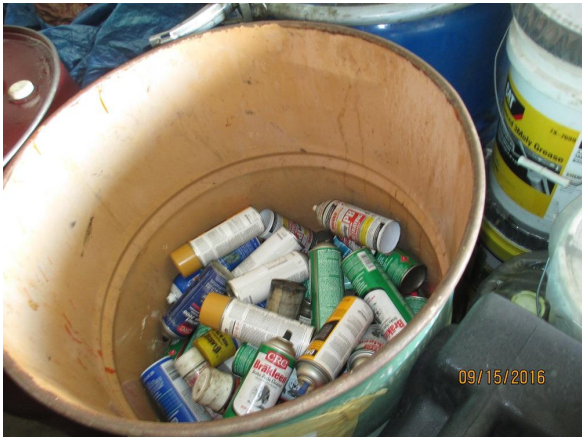
Photo 6

The RPP facility has implemented a scrap metal recycling collection plan for spent aerosol cans. Waste aerosol cans containing liquid are accumulated in a 55-gallon drum (Photo 6). Cans are then taken to the satellite aerosol can puncturing area that consists of one 55-gallon drum to accumulate the liquid waste. Empty waste aerosol cans are then placed into a scrap metal roll-off container (Photo 7).

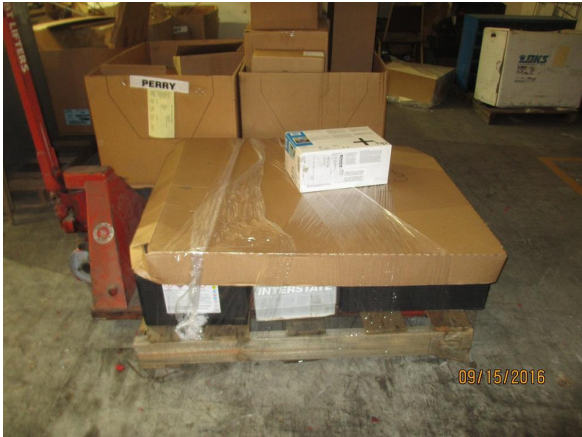
Photo 8

RPP accumulates its spent lead-acid batteries on pallets inside the main building on the second-floor supply loft (Photo 8). Once two pallets are accumulated, the spent lead-acid batteries are recycled by East Penn Manufacturing Co., Inc.

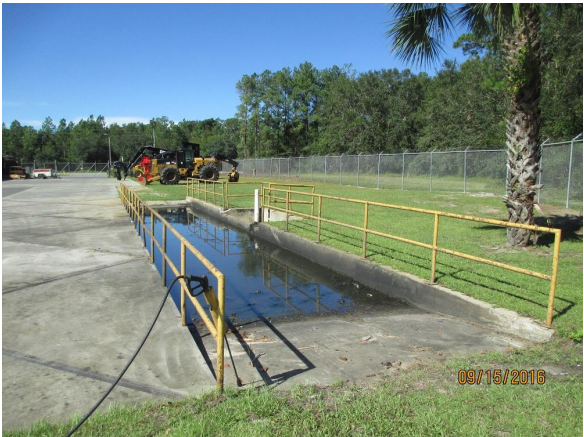
Photo 9

The HEWA is where returning rental equipment is cleaned after use (Photo 9). The dirt is removed from the equipment using a pressure washer with water. The facility occasionally uses an alkaline soap (Hydrosolve 4165) in this area, which is sprayed on prior to vehicle pressure washing. Wastewater flows from a concrete wash pad to a collection area with an adjacent oily wastewater evaporation sump. Solid material is removed and dried in the covered accumulation area adjacent to the HEWA (Photo 10).

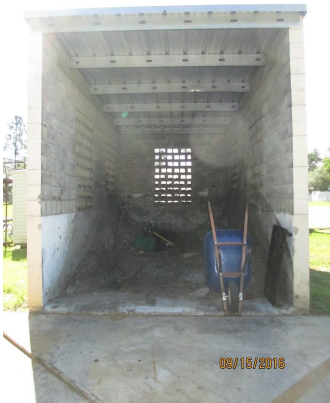
Photo 10

Solids from the HEWA are transported approximately once every four to five years to an incinerator or to a solid waste landfill in Valdosta Ga. The waste dirt was analyzed on July, 07, 2008 for RCRA heavy metals and was been found to be non-hazardous.
