**Florida Department of
Environmental Protection
Hazardous Waste Inspection Report**

Facility Name: Ring Power Corp

Routine Inspection for Used Oil Transporter facility

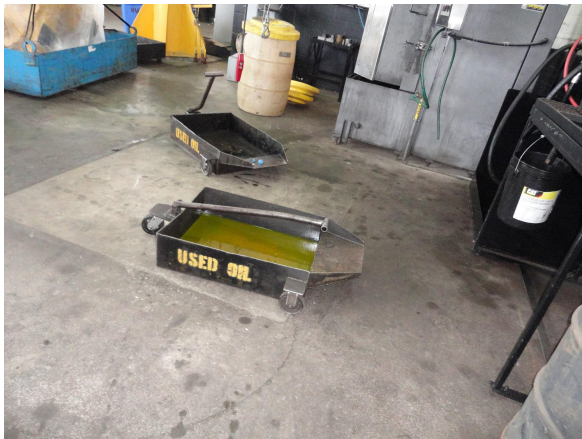
1. Used Oil Sled

In the heavy equipment shop rolling pans and 5-gallon size pails are used to collect used oil removed from equipment (see figure 1). All equipment used to collect used oil was labeled "Used Oil." Containers used to collect spent antifreeze are labeled as such. A 55-gallon drum staged inside the shop was accumulating used oil filters. The drum was labeled "Used Oil" and inspectors asked the facility to include the word "filter" of the label (see figure 2). This was done immediately.

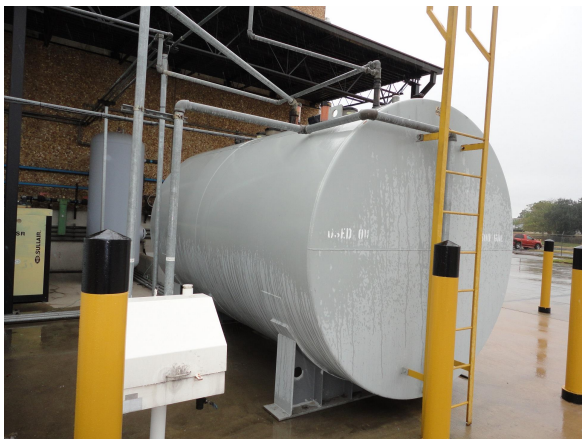
3. Used Oil Storage

The used oil and antifreeze collection containers are pumped out at a pumping station and directed to holding tanks. Located outside the heavy equipment shop is a 2,500-gallon above ground used oil collection tank (see figure 3). The tank is double-walled and was labeled "Used Oil."

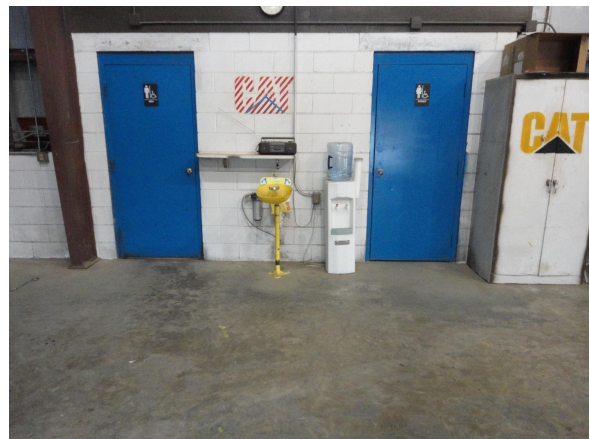
4. Eye Wash Station

The facility operates one large paint booth for painting heavy equipment. An eyewash station is located near the paint booth (see Figure 4). Located just outside the paint booth, along an inside wall to the paint shop, were three 55-gallon drums for waste accumulation. One drum for "Paint Waste" was dated 6-11-16 and was staged on a containment pallet. The drum was equipped with a closed funnel. Mr. Lusher was asked to replace the device with a funnel that has a gasket. A second drum, also staged on a containment pallet, was equipped with an aerosol can puncturing device and filter (see Figure 5). The drum was labeled with a "Hazardous Waste" label and dated 4-25-16. The filter was marked with the date it was installed. There was evidence of paint splatter on the wall and floor around the drums. Mr. Lusher was asked to have the wall painted so he will be able to identify new releases immediately. The third drum was equipped with a flip-top lid and was labeled "Excluded Solvent Contaminated Wipes." The drum contained disposable wipes that were to be managed as hazardous waste and not as excluded solvent contaminated wipes under either of the exclusions in 40 CFR 261.4(a)(26) or 261.4(b)(18) (see figure 6).

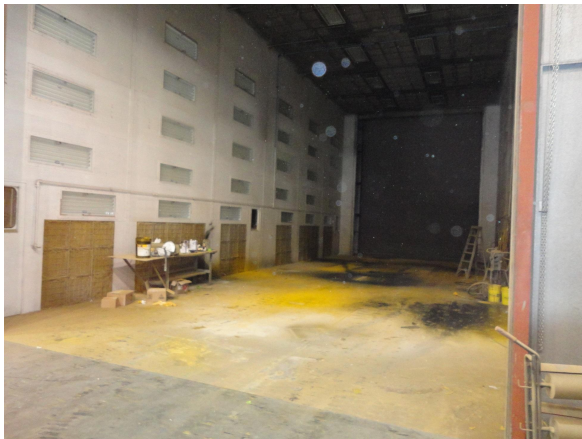
7. Painting Bay

Paint booth filters are disposed of in the trash as non-hazardous waste (see Figure 7). Inspectors discussed the issue of the requirement for testing of the solvent contaminated wipes to ensure they meet the requirements of the exclusion and paint booth filters for hazardous waste characteristics identified in 40 CFR Part 261 Subpart C. Mr. Lusher indicated the facility has tested the paint booth filter in the past; however, he was not sure how long ago this was. The facility ships waste paint related material off-site with the waste codes for non-halogenated (F003/F005) listed solvents and the waste codes for barium (D005), cadmium (D006), and chromium (D007). The wipes that are laundered under the exclusion and spent paint booth filters cannot exhibit a hazardous waste characteristic for heavy metals.

On December 2, 2016, John White spoke with Brian Brown, Environmental Manager for Ring Power Corp. regarding sampling requirements. Mr. Brown indicated he would verify when the last testing of waste was done at the facility and retest if necessary.

On February 6, 2017, Brian Brown, Environmental Manager for Ring Power Corp. submitted new determination results for the waste paint and spent paint booth filters. The results indicated the waste paint and the paint booth filters did not exhibit characteristics identified in 40 CFR part 261 Subpart C and were nonhazardous.
