Re: Water Recovery, LLC
EPA/DEP ID: FLR 000 069 062
Duval County – Hazardous Waste

**Florida Department of
Environmental Protection
Hazardous Waste Inspection Report**

Facility Name: Water Recovery LLC

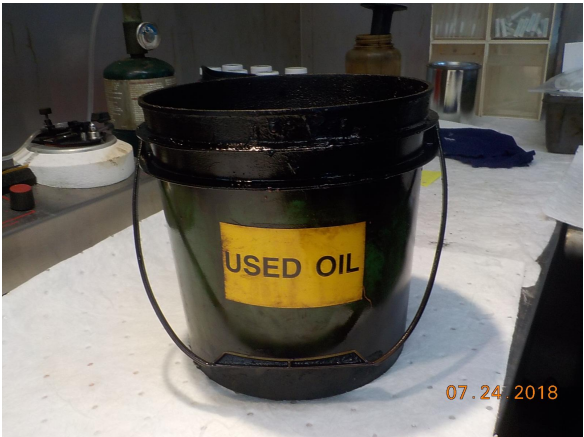
Photo 5

The facility collects used oil and oily wastewater generated from samples in a container (Photo 5). It was properly labeled. The facility has a trash can labeled "oily waste" for collection of wastes contaminated with oil. The waste is disposed of in a non-hazardous waste roll-off. There were several small containers of oily liquids observed in the trash can. The facility is reminded that liquid used oil may not be disposed of in landfills and should be collected in the used oil container.

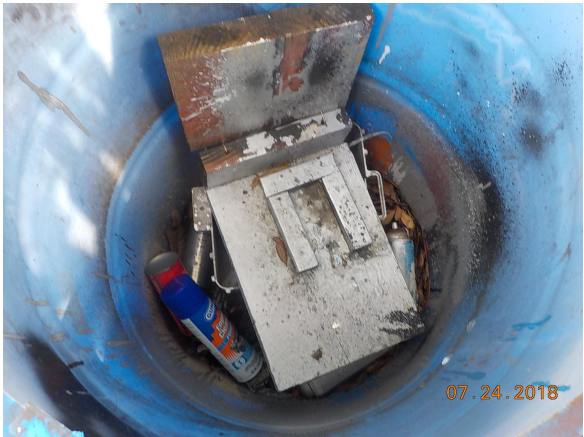
Photo 6

The Dry Storage Area is a roofed structure where equipment is stored. A homemade aerosol can puncturer was observed in this area (Photo 6). The cans are punctured, but any residual liquids are not collected and are allowed to evaporate [40 CFR 262.14(a)(5)].

Type:	Violation
Rule:	262.14(a)(5)
Explanation:	Aerosol cans are being punctured using a homemade device that does not collect can contents or residues.
Corrective Action:	No further action is required. The facility returned to compliance via an email dated 10/2/18 which included an invoice for the purchase of an AeroVent can puncturing device with filter and collection drum. The facility stated in the email dated 10/2/18 that waste aerosol cans would be collected until receipt of the device and that following receipt of the device, the cans would be punctured and residues managed as hazardous waste.
Type:	Violation
Rule:	279.52(a)(2)(iii)
Explanation:	Used oil processing facility permit application attachments depict two fire extinguishers located adjacent to the maintenance shed and two fire extinguishers located in the heater system area. There was only one fire extinguisher present adjacent to the maintenance shed and no fire extinguishers in the heater system area.

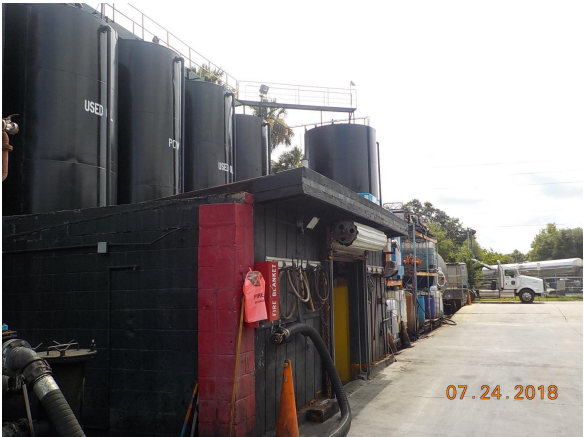
Photo 9

The facility receives shipments of used oil and PCW by tanker truck. The Used Oil Processing Area is a tank farm of ten black-painted aboveground storage tanks and a heater (Photos 9 and 10). Used oil and oily wastewater is accepted and transferred to black side tanks that store or conduct stationary settling for hours or several days to separate the used oil and wastewater. The 2-P tank uses heat, or chemical additives and heat to aid in the separation process. Separated wastewater and debris are piped to the wastewater treatment green side tanks described below for further treatment. The used oil is transferred between tanks as necessary to achieve a marketable "batch" of used oil product. PCW is recovered by stationary separation and accumulated only in the aboveground 7-P tank. Decanted wastewater and debris are piped to the green side wastewater treatment tanks for further treatment. The facility analyzes the PCW solids for metal, volatile and semi-volatile Toxicity Characteristic Leaching Procedure (TCLP) constituents each time solids are

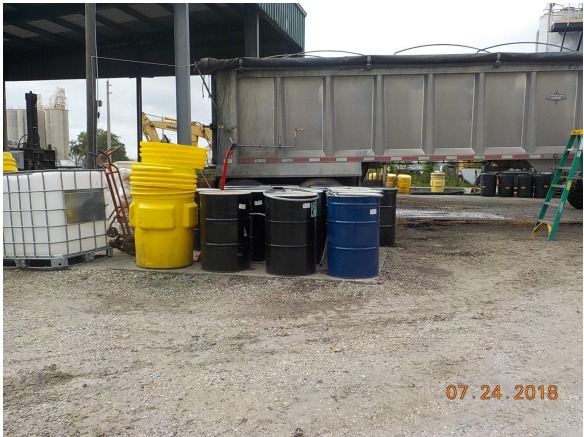
Photo 19

The Wastewater Processing Area is a tank farm of eleven green-painted cone-bottom batch tanks and a plate-and-frame filter press (Photo 19). The main green tank farm is numbered 1-W to 9-W, and is aligned in consecutive order tank pairs, 1-W/2-W, 3-W/4-W, 5-W/6-W, 7-W/8-W, with 9-W closest to the main office. Green tanks 10-W and 11-W are adjacent to the plate-and-frame filter press. The estimated capacities for the tanks are as follows: 1-W to 9-W, 7,000 gallons each; 10-W and 11-W, 50,000 gallons each. The green tank system is a unilaterally interconnected loop, with wastewater piped to tank 9-W receiving the most treatment.

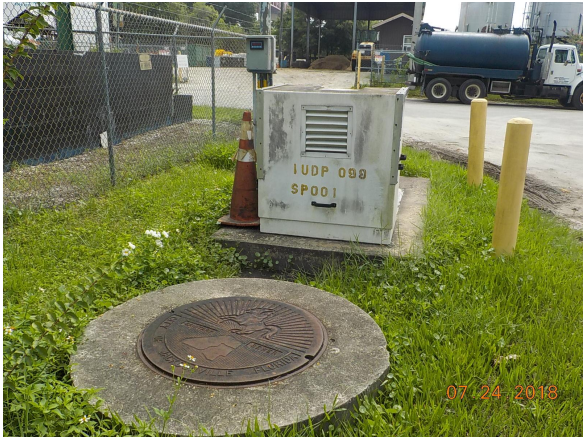
Photo 21

The treated wastewater is then pumped through an American Petroleum Institute (API) oil/water separator. Separated oil is piped to the black side tank 2-P for heat and chemical treatment. Next, the DAF unit performs continuous chemical precipitation and solids removal. Finally, treated wastewater is accumulated in tank 10-W, tested and discharged to the city sewer. There are two city sewer compliance sampling points located outside the main security fence at the corner of East Bryan Street and Albert Street (Photo 20) and in a small building adjacent to the north side of the used oil processing black tank farm (Photo 21).

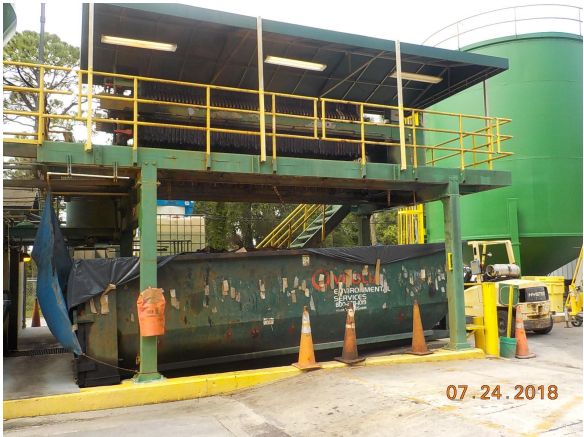
Photo 22

The sludge, residue and by-products that are generated from this process are accumulated in a plate-and-frame filter press and dewatered. The filter media is Perlite. The generated filter cake is then accumulated in a roll-off container (Photo 22) and added to the solidification pits before being sent off-site as non-hazardous waste for disposal to a landfill in Valdosta, Georgia or Chesser Island Landfill. The facility currently analyzes the filter press solids quarterly for Toxicity Characteristic Leaching Procedure (TCLP) metal, semi-volatile, and volatile constituents. Results have indicated the waste is non-hazardous.

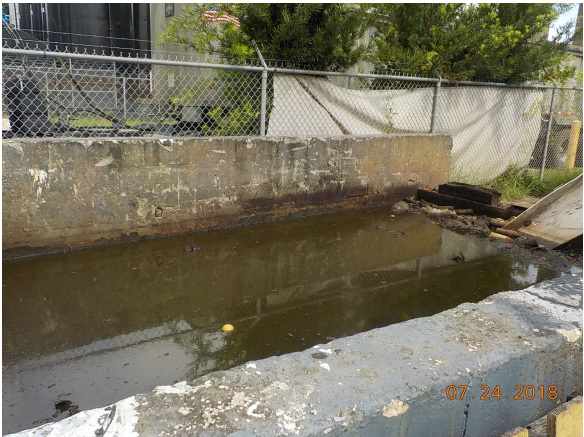
Photo 23

A Truck Clean-out Holding Pit is located across East Bryan Street (Photo 23). Customers can clean-out their trailers of non-hazardous waste into the holding pit for disposal by WR. The liquid is pumped to the other side of the street for processing. The solids are added to the solidification pits before being sent off-site as non-hazardous waste for disposal to a landfill in Valdosta, Georgia or Chesser Island Landfill. The facility currently analyzes the truck clean-out solids quarterly for Toxicity Characteristic Leaching Procedure (TCLP) metal, semi-volatile, and volatile constituents. Results have indicated the waste is non-hazardous.

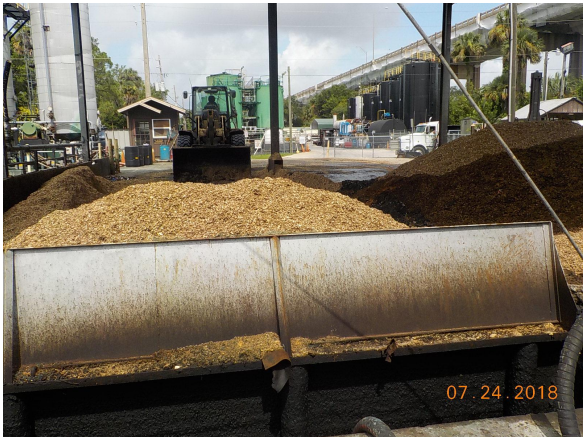
Photo 24

A large, two-pit Solid Waste Solidification Area is also located across Bryan Street (Photo 24). The pit is used to solidify other facility's waste streams containing solids, sludges and wastewater with heavy suspended solids. This activity may need a solid waste permit. A copy of this inspection report is being sent to the DEP Solid Waste Program Subject Matter Expert for a solid waste permit determination. In addition, WR process wastes, including the wastewater filter cake and truck clean-out solids, are also added to the pit. This solid waste mainly consists of tobacco, peanut shells, paper dust, ceiling tile dust and other non-hazardous solids or sludge. A small bucket loader is used to mix up the solid, non-hazardous waste before being sent off-site for disposal to a landfill in Valdosta, Georgia or Chesser Island Landfill. The facility currently analyzes the solidification pit sludge quarterly for Toxicity Characteristic Leaching Procedure (TCLP) metal, semi-volatile, and volatile constituents. Results have indicated the waste is non-hazardous.

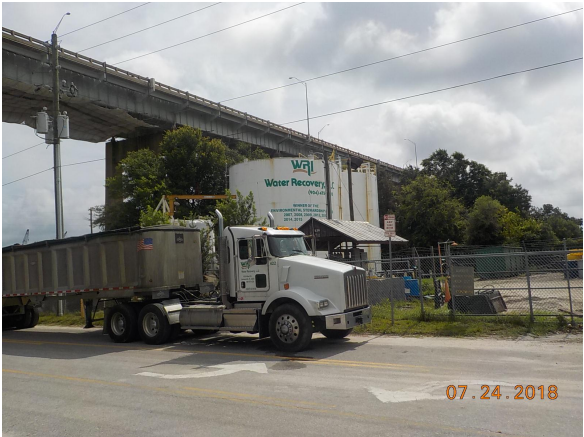
Photo 25

There were two landfill leachate wastewater tanks (Photo 25) located adjacent to the truck clean-out holding pit. The tanks receive leachate from tanker trucks. Recovered leachate wastewater is stored in tanks and then discharged, typically without treatment. If treatment is required due to nitrogen levels, aeration of the wastewater is performed until acceptable nitrogen levels are achieved.
