Re: Return to Compliance Letter
FPL – Fort Myers Lee & Thompson Service Center
Facility ID No. FLD000807370
Lee County - HW

**Florida Department of
Environmental Protection
Hazardous Waste Inspection Report**

Facility Name: FPL - Ft Myers Lee & Thompson Service Center
On-Site Inspection Start Date: 01/15/2019 **On-Site Inspection End Date:** 01/15/2019
ME ID#: 52574 **EPA ID#:** FLD000807370
Facility Street Address: 2425 Thompson St, Fort Myers, FL 33901-3045
Contact Mailing Address: 2455 Port West Blvd, Riviera Beach, FL 33407-1214
County Name: Lee **Contact Phone:** (561) 845-4973

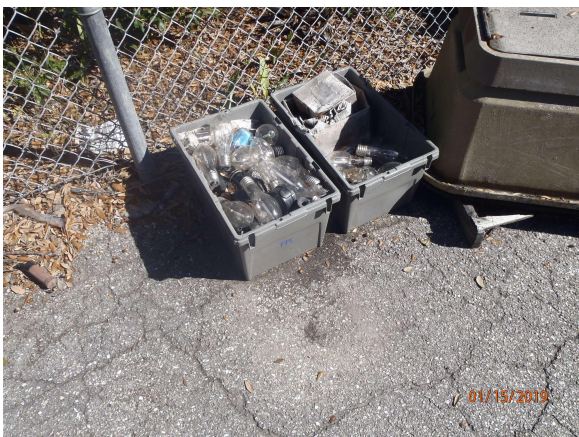
Explanation: Spent fluorescent lamps should be stored inside containers or boxes in an area and in a manner that will prevent them from breaking. Containers must be closed, structurally sound, compatible with the contents of the lamps and must lack evidence of leakage and spillage.

At the time of the inspection, two gray bins containing streetlight bulbs were observed outside the east side of the parts storage building. The bins were open and not labeled.

Corrective Action: Following the inspection, the facility provided documentation reflecting the spent lamps were being properly managed in closed/labeled/dated containers.

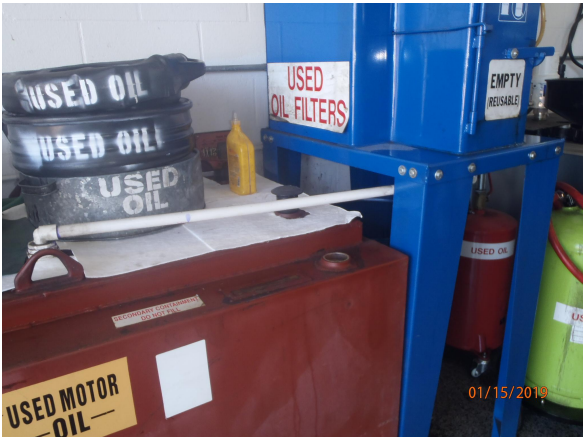
fleet maintenance area

General repair and maintenance is conducted on approximately 150 vehicles in one building situated in the southwest corner of the property. The shop area was very clean and orderly. No floor drains were noted. Used oil is collected in a 250-gallon double walled tank labeled 'used oil'. Several drain pans and wheeled

grated pans were noted and all labeled 'used oil'. Adjacent to the storage tank is a used oil filter crusher. A PVC pipe transfers used oil from crushing the filters directly into the used oil storage tank. A blue 55-gallon drum labeled 'used oil filters only' is situated beneath the crusher. Receipts also reflect Heritage Crystal Clean picks up used oil, used oil filters and oily water. Used antifreeze is collected and recirculated/reused back into vehicles without filtering. Oily rags, and absorbent pads are collected and transferred with other oily debris to Okeechobee Landfill. Scrap metal, spent fluorescent lamps and waste aerosols are transported by Ryder Logistics [FLR000088377] to the PDC. The facility manages waste aerosols as D001 hazardous waste/compressed gas. Shipping papers are maintained documenting 74 pounds of aerosol cans was shipped to the PDC on 8-1-2018; and approximately 75 pounds of spent mercury lamps are shipped monthly. A 'hazardous waste generation - monthly generation & on-site accumulation - 2018' log is maintained documenting the pounds of hazardous waste generated monthly. Spent lead acid batteries are stored indoors. Receipts reflect Wallace International picks up/exchanges battery cores. The facility has two ZEP parts washers which are equipped with two filters. The sandbag filter is changed once a year; and the filter cartridge is changed twice a year. Analytical results reflect spent filters were last sampled and tested on 2-20-2017 and determined to be non-hazardous. Solvent is replenished as needed, approximately every 2 years.

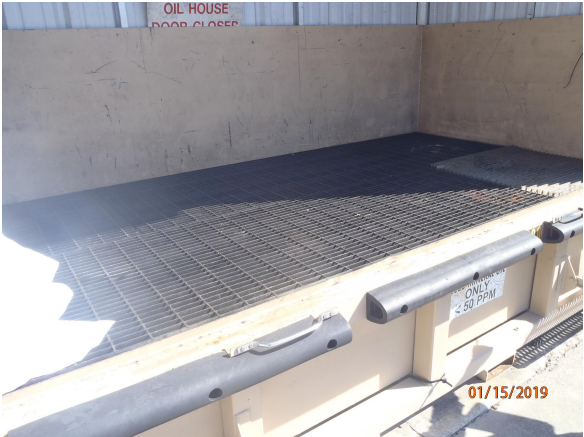
used oil shed

The oil shed is constructed of metal and the seams are welded to ensure integrity. A grated containment sump is built into the floor of the shed. According to the previous inspection report, the shed is a double-walled, self-contained unit capable of holding 150% of the volume of oil in the largest transformer that may be placed into the shed. The oil shed was empty at the time of the inspection. Equipment and debris may also be stored in an enclosed yellow plastic containment pallet. The pallet was also empty at the time of the inspection. The shed and yellow containment pallet were both faintly labeled 'caution containing PCBs' and 'mineral oil pending analysis'. It was not discussed during the inspection however it is recommended to clearly re-label the oil shed and yellow containment pallet; and routinely inspect the integrity of the structures.

It is recommended to clearly re-label the oil shed and yellow containment pallet; and routinely inspect the integrity of the structures.

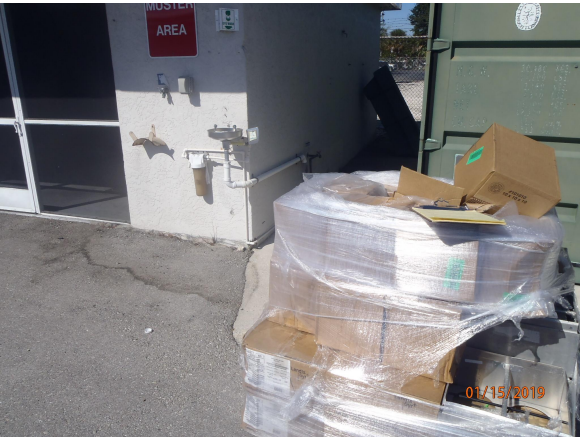
An eye wash was noted outside a storage building located towards the center of the yard. Ms. Shoosmith indicated the eye wash is routinely inspected. A pallet of boxes was situated near the eye wash. It was discussed that areas around emergency equipment (i.e. eye wash, shower, fire extinguishers, etc.) should be maintained unobstructed pursuant to OSHA regulations.

Areas around all emergency equipment (i.e. eye wash, shower, fire extinguishers, etc.) should be maintained unobstructed allowing employees a clear path in the event of an emergency.

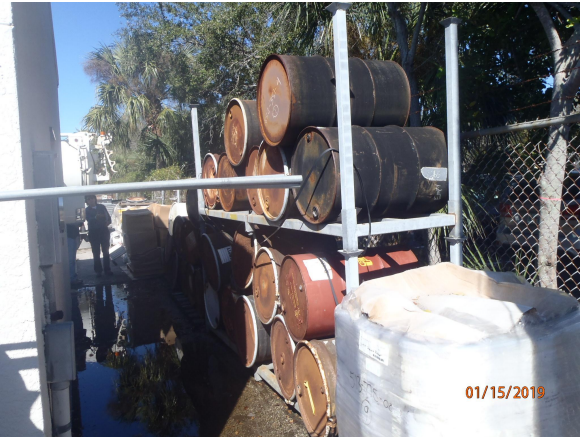
empty drum storage

Empty 55-gallon drums are stored horizontally on a rack behind a building. Ms. Shoosmith indicated the drums are used for managing waste material in the event of a spill, etc. The drums appeared rusted. Ms. Shoosmith indicated the drums will be evaluated and any unusable drums will be shipped to PDC for disposal.

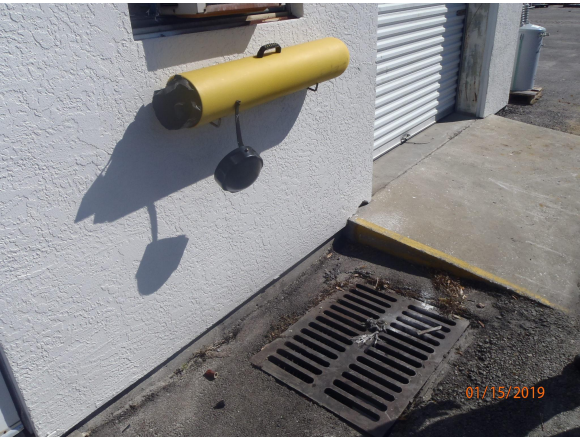
drain covers

Several buildings on the property are used for parts storage, oil spill equipment storage and offices. No wastes were noted to be stored in these buildings. Drain covers are maintained by storm drains throughout the yard in the event of release or emergency.

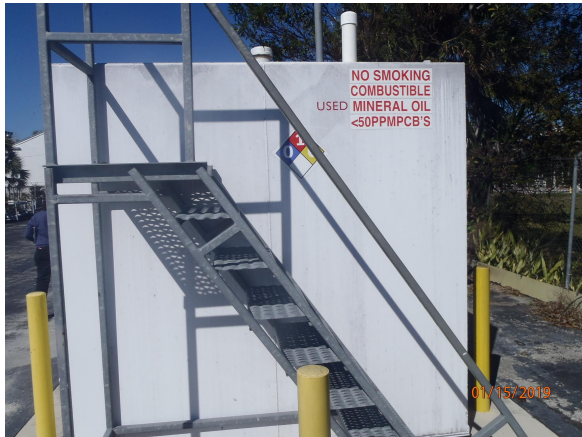
used oil storage tank

Non-PCB used mineral oil is also collected from other FPL service centers in Charlotte, Lee and Collier counties with the collection/transfer truck. The truck was not at the facility at the time of the inspection. Used oil is off loaded from the truck into a 6,000-gallon, double-walled above ground storage tank the same day the used oil is picked up. Ms. Shoosmith indicated that used oil is never stored in the truck for >24 hours. The truck is parked on visqueen when at the facility. The driver records the date of pick-up, quantity of used oil, and signature on the 'transporters used oil acceptance log daily used oil pickup log' next to the appropriate name, address and EPA ID# of the used oil pick-up. At the bottom of the log, the driver records the tank #, date transferred, gallons and signature reflecting the total volume of used oil off loaded from the truck to the tank. It was noted that some logs were either incomplete or incorrectly completed i.e. initials rather than the drivers signature, or the drivers signature box was blank. Another log is maintained documenting the start date of used oil in the storage tank to ensure the used oil is not stored longer than 35 days. Used oil disposal manifests were reviewed confirming the used oil is not stored for longer than 35 days. Orlando Industrial Contractors (EPA ID# FLR000220392) picks up used oil every month and transports it to Theta America Group (EPA ID# FLR000220202). It was noted the facility does not maintain copies of the completed manifests. Ms. Shoosmith indicated she would obtain and maintain all completed manifests.

The storage tank was clearly labeled 'no smoking, combustible, used mineral oil, <50ppm PCBs'. The tank is registered and a current placard was posted (TKS ID#8519172). Records reflect Lee County environmental staff inspected the storage tank system on 12-20-2017 and was found in compliance.

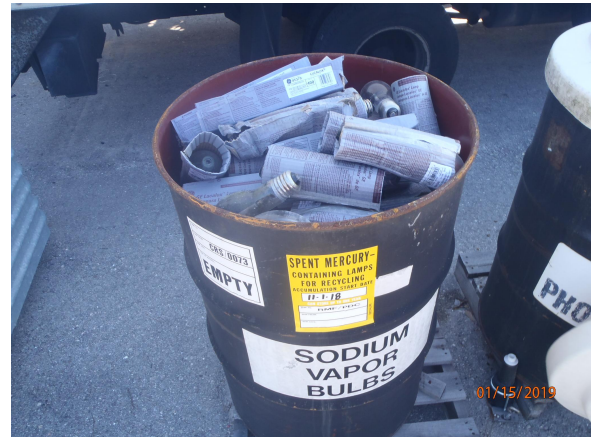
Several closed/covered and labeled 55-gallon drums, stored on pallets, outside, are used to store wastes/recyclables prior to shipping to the PDC. Drums were labeled aerosol cans, arrestors bagged & taped, lead pins, photo cells. One drum was labeled 'sodium vapor bulbs, spent mercury containing lamps for recycling, empty' and dated 11-1-18. Large open top metal containers are used to collect scrap metal, wire, cutout & disconnect switches, scrap porcelain insulators, polymer arrestors, salvaged street lights, plastic, etc. Each container is clearly labeled as to its contents. Roll-offs are used to store scrap wood, solid waste and recyclables. It was not discussed during the inspection however the drum containing aerosol cans should be labeled 'waste' or 'spent' aerosol cans.

It is recommended to label the drums containing aerosol cans 'waste' or 'spent' aerosol cans.

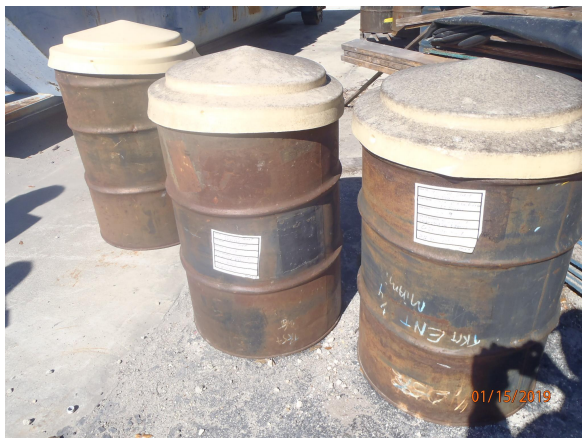
oily debris drums

Three closed/covered 55-gallon drums were noted near the used oil storage tank. The drums were dated and labeled as containing oily debris. Following the inspection, Ms. Shoosmith indicated the drums were re-located to the used oil shed.

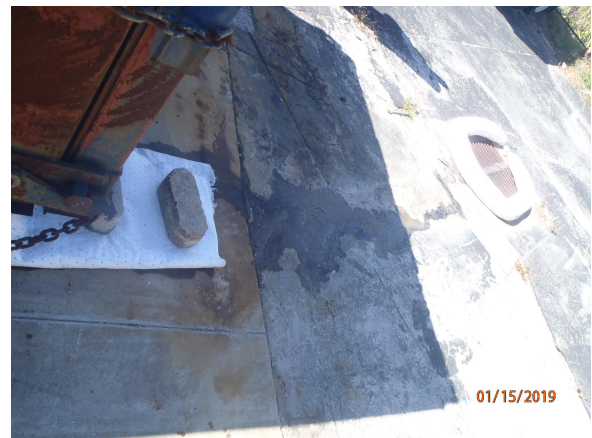
discharge from roll-off

Two metal roll-off containers were noted and labeled 'oily waste <50 ppm absorbents, used poly bags, rags, kitty litter' and 'under 50 ppm oily dirt & debris'. Ms. Shoosmith indicated that the roll-off containers are lined. The roll-offs were closed and contents not verified. One of the roll-offs was leaking what appeared to be water which led to a storm drain. No sheen or oil was detected in the water. The facility had placed down absorbent beneath the leak/dripping and placed absorbent boom around the floor drain.
