**Florida Department of
Environmental Protection
Hazardous Waste Inspection Report**

Facility Name: US Ecology Tampa Inc
On-Site Inspection Start Date: 01/14/2019 **On-Site Inspection End Date:** 01/14/2019
ME ID#: 21659 **EPA ID#:** FLD981932494
Facility Street Address: 2002 N Orient Rd, Tampa, FL 33619-3356
Contact Mailing Address: 7202 E 8th Ave, Tampa, FL 33619-3380
County Name: Hillsborough **Contact Phone:** (813) 319-3423

Routine Inspection for TSD Facility facility

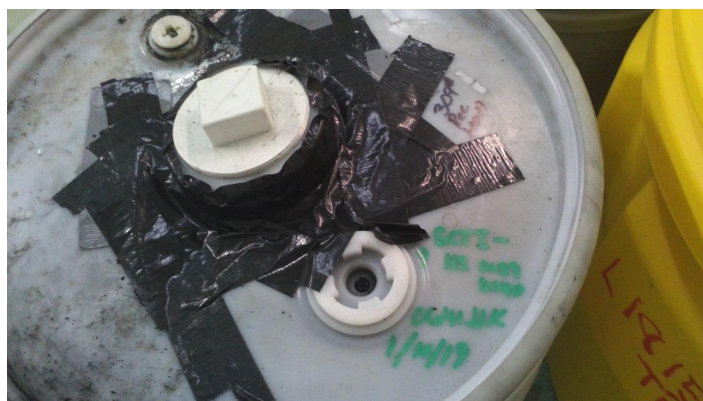
Explanation: Two 55-gallon poly drums containing hazardous waste solids (tetrachloroethane and trichloroethane) were not properly closed.

Improperly closed container

Corrective Action: Going forward, please ensure that US Ecology is not accepting nor transporting any hazardous waste that is improperly managed.

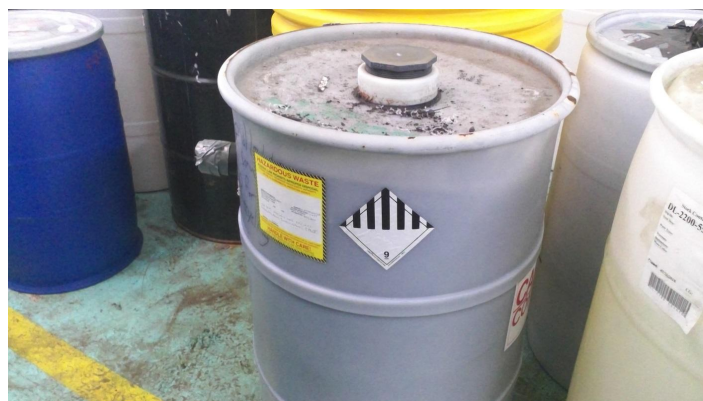
Improperly closed container
