Re: US Ecology Tampa, Inc.
EPA ID No. FLD981932494
Hillsborough County

**Florida Department of
Environmental Protection
Hazardous Waste Inspection Report**

Facility Name: US Ecology Tampa Inc
On-Site Inspection Start Date: 01/14/2019 **On-Site Inspection End Date:** 01/14/2019
ME ID#: 21659 **EPA ID#:** FLD981932494
Facility Street Address: 2002 N Orient Rd, Tampa, FL 33619-3356
Contact Mailing Address: 7202 E 8th Ave, Tampa, FL 33619-3380
County Name: Hillsborough **Contact Phone:** (813) 319-3423

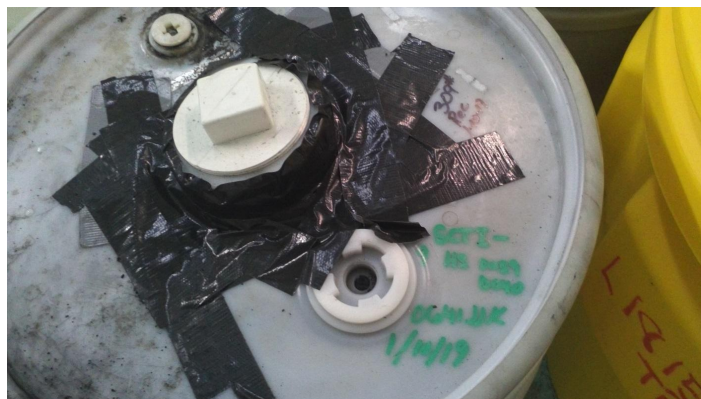
Explanation: Two 55-gallon poly drums containing hazardous waste solids (tetrachloroethane and trichloroethane) were not properly closed.

Improperly closed container

Corrective Action: Going forward, please ensure that US Ecology is not accepting nor transporting any hazardous waste that is improperly managed.

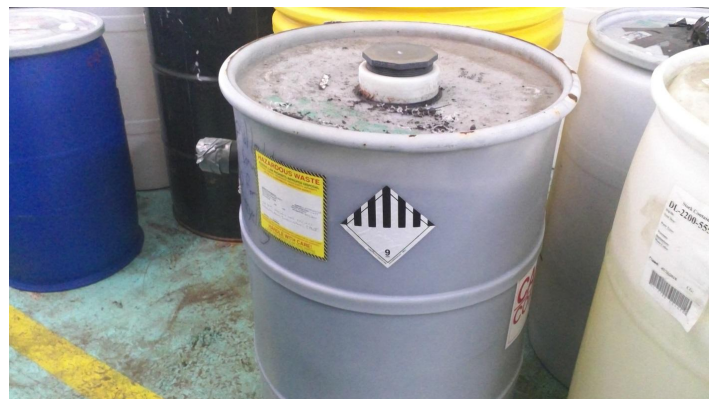
Improperly closed container
