**Florida Department of  
Environmental Protection  
Hazardous Waste Inspection Report**

**Facility Name:** Mobile Impact Services LLC  
**On-Site Inspection Start Date:** 02/13/2020      **On-Site Inspection End Date:** 02/13/2020  
**ME ID#:** 110098      **EPA ID#:** FLR000203158  
**Facility Street Address:** 407 W Lake Dr, Sarasota, Florida 34232-1948  
**Contact Mailing Address:** 407 W Lake Drive, Sarasota, Florida 34232  
**County Name:** Sarasota      **Contact Phone:** (941) 952-8945

Routine Inspection for Used Oil Transporter Facility

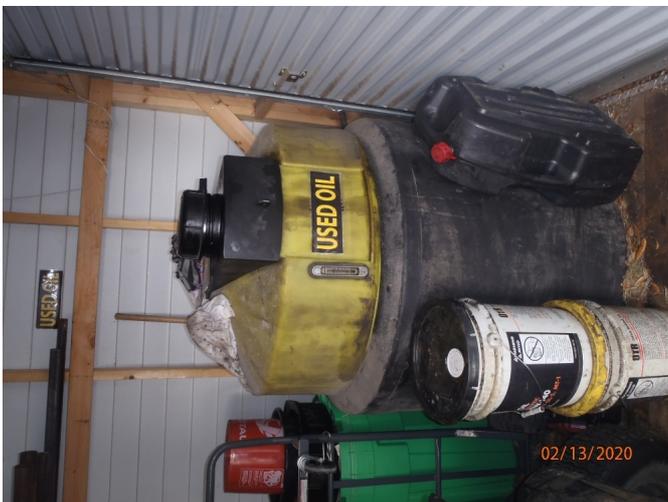
Mobile Impact Services conducts hydraulic cylinder repair/maintenance and on site hose repair. The majority of hydraulic cylinders are transported in tact (oil contained within the sealed cylinder) to the facility. Used hydraulic oil is drained and placed directly into a 150-gallon double-walled above ground storage tank maintained in the shed (see photo). The tank was properly labeled 'used oil'. A container of absorbent material and absorbent pads are maintained inside the shed to respond to spills.

Disposal records reflect Cliff Berry Inc. picked up 120-gallons of used oil on 01-16-2019 and 150-gallons on 05-03-2018. Mr. Baxter verified the storage tank currently contains 104-gallons of used oil and soon due for pick-up.

Used oil storage tank

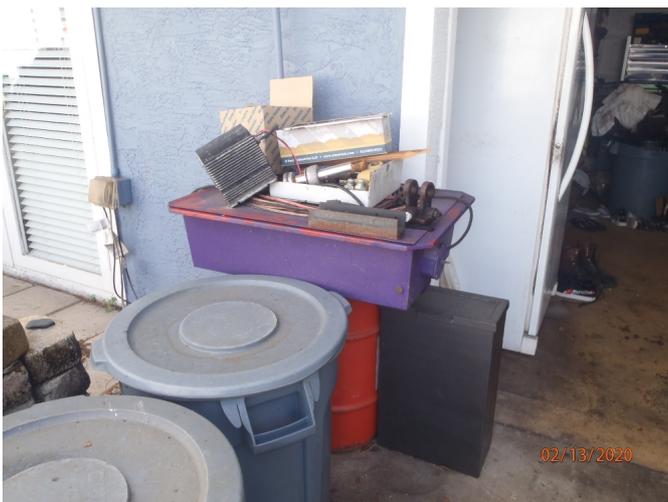
A sink top parts washer with a 16-gallon drum base was noted outside (see photo). Mr. Baxter indicated the drum contains approximately 5-gallons of mineral spirits, is rarely used and he has not disposed of any spent solvent to date. It was recommended to maintain the parts washer inside the shed, protected from weather in the event of a release. It was discussed that a small volume of spent mineral spirits may be added to the used oil for disposal as long as it does not cause the used oil to be considered ignitable and the used oil transporter is notified and approves. Spent mineral spirits may also be disposed thru the Sarasota County Project Green Sweep program. Information about the program was provided to Mr. Baxter at the time of the inspection, along with used oil labels and stencils.

parts washer

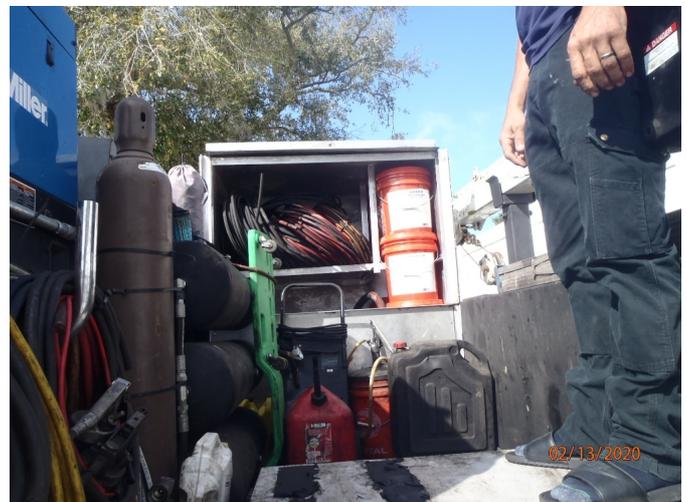
Large hydraulic lifts are serviced in the field. Used hydraulic oil is drained, collected in closed/labeled 5-gallon plastic containers and transported back to the facility. Containers holding used oil are stored inside a metal 'job box' inside the bed of the truck, capable of containing releases (see photo). A log is maintained reflecting the facility always transports <55-gallons of used oil at one time; and <500-gallons of used oil annually over public highways and is therefore not subject to the Certification Program under Rule 62-710.600 Florida Administrative Code.

Truck and job box for transporting used oil
