**Florida Department of
Environmental Protection
Hazardous Waste Inspection Report**

Facility Name: Ring Power Corp
On-Site Inspection Start Date: 12/11/2019 **On-Site Inspection End Date:** 12/11/2019
ME ID#: 36377 **EPA ID#:** FLR000119347
Facility Street Address: 500 World Commerce Pkwy, St Augustine, Florida 32092-3788
Contact Mailing Address: 500 World Commerce Pkwy, St Augustine, Florida 32092-3788
County Name: St. Johns **Contact Phone:** (904) 494-1417

Ring Power Corporation (Ring Power, the facility) was inspected December 11, 2019, as an unannounced hazardous waste compliance inspection. Ring Power was last inspected by the Department's Hazardous Waste program on December 17, 2015. The facility is registered and operating as a Used Oil Transporter, Used Oil Transfer Facility, Used Oil Filter Transporter and Used Oil Filter Transfer Facility. The facility is also operating as a used oil generator and Small Quantity Generator (SQG) of hazardous waste.

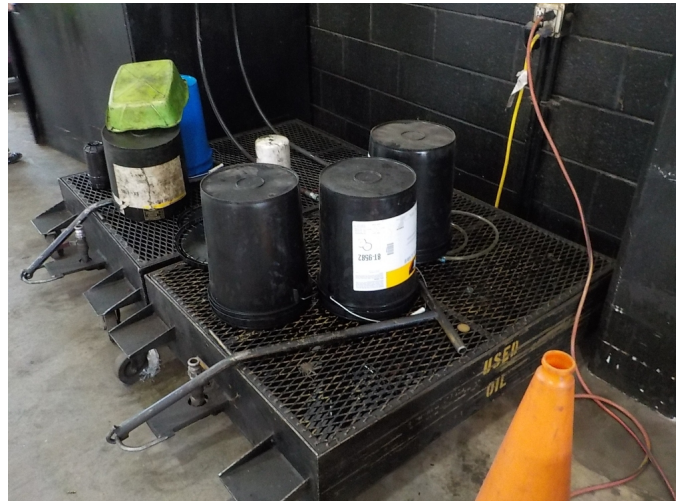
Photo 2

Used oil generated by Maintenance and Repair Shop operations is drained into portable drain containers (Photo 2) and then either transferred to 55-gallon drums or pumped directly to the used oil tank located in the Tank Farm described below by means of a suction piping system (Photo 3). In the Crane Shop, used oil is transferred to a 500-gallon double-walled tank located in the shop. The used oil tanks, drums and drain containers were in good condition, closed and properly labeled as "Used Oil."

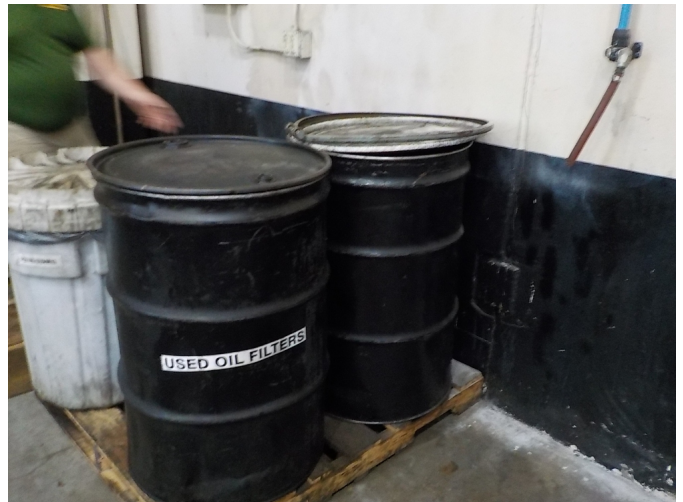
Photo 4

Used oil filters generated by Maintenance and Repair Shop operations are accumulated in 55-gallon drums located throughout the Shops (Photo 4). The containers were in good condition and properly labeled as "Used Oil Filters."

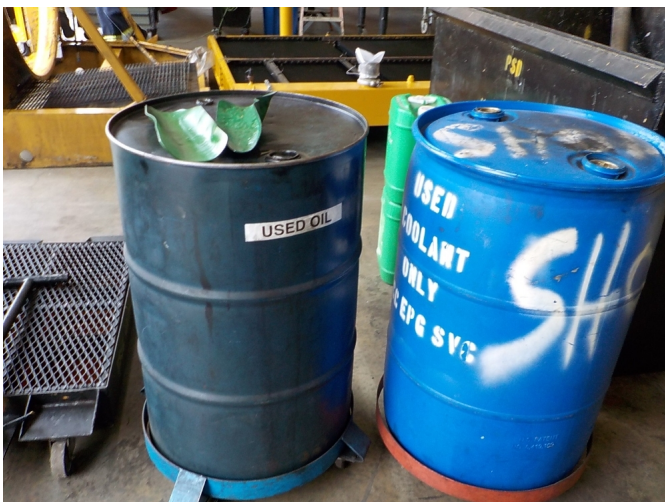
Photo 5

Used antifreeze generated by Maintenance and Repair Shop operations is either accumulated in portable drain containers, 55-gallon drums (Photo 5) or pumped directly to the used antifreeze tank located in the Tank Farm described below by means of a suction piping system. Containers were in good condition, closed and labeled as either "Used Coolant" or "Used Antifreeze."

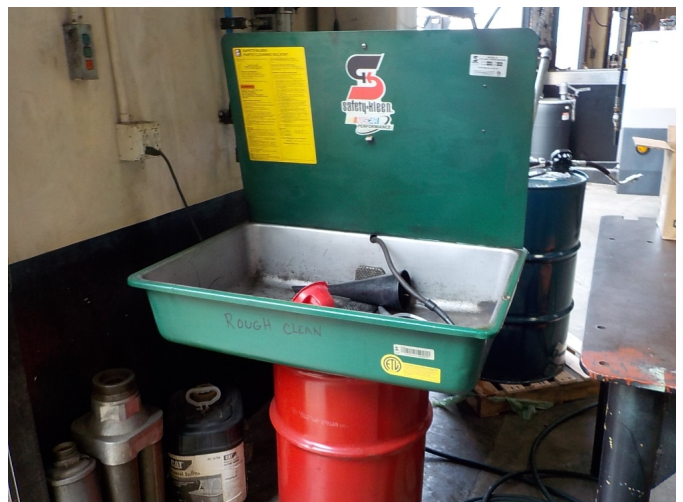
Photo 6

The Maintenance and Repair Shops operate one Model 33 30-gallon Safety-Kleen parts washer that uses Safety-Kleen Premium Solvent (hydrotreated light petroleum distillates 100%; flashpoint 148°F) (Photo 6). The unit is on an 8-week maintenance schedule with Safety-Kleen. The Maintenance and Repair Shops also operate two, 30-gallon Heritage-Crystal Clean parts washers that use Mirachem 500 Cleaner/Degreaser (proprietary surfactant blend <2% and water). Spent solvent is managed as non-hazardous waste, but the facility has not made an accurate hazardous waste determination on this waste stream to support this action [40 CFR 262.11]. The Maintenance and Repair Shops operate eleven Model 250 (System One) and one Model 260, 30-gallon Safety-Kleen parts washers that use Safety-Kleen Premium Solvent. The units distill the solvent. Therefore, the only waste generated is an oily sludge that is disposed of occasionally depending on usage. The units are on an 8-week maintenance schedule with Safety-Kleen to top-off any evaporated solvent. The sludge has not been disposed of in at least three years. The facility is reminded that a hazardous waste determination should be conducted prior to disposal of the sludge.

Corrective Action:	<p>In order to return to compliance, the facility should make an accurate hazardous waste determination for each waste stream listed below that has not already been analyzed. If the laboratory analysis is not sufficient to make an accurate waste determination, the facility should provide additional documentation to support its waste determination. The waste should be analyzed by a certified Florida laboratory as follows:</p> <p>Maintenance and Repair Shops:</p> <ol style="list-style-type: none">1. Make a hazardous waste determination on the spent parts washer solvent by analyzing it for:<ul style="list-style-type: none">-TCLP for RCRA Metals, pursuant to 40 CFR 261.24, via method 6010-TCLP for RCRA Volatiles, pursuant to 40 CFR 261.24, via method 82602. Make a hazardous waste determination on the Track Shop spent blast grit by analyzing it for:<ul style="list-style-type: none">-TCLP for RCRA Metals, pursuant to 40 CFR 261.24, via method 6010 <p>MCRC:</p> <ol style="list-style-type: none">3. Make a hazardous waste determination on the Engine Tear Down area spent blast grit by analyzing it for:<ul style="list-style-type: none">-TCLP for RCRA Metals, pursuant to 40 CFR 261.24, via method 60104. Make a hazardous waste determination on the Engine Tear Down area tanks 2-4 parts washer spent sludge by analyzing it for:<ul style="list-style-type: none">-TCLP for RCRA Metals, pursuant to 40 CFR 261.24, via method 6010- pH, pursuant to 40 CFR 261.22, via method 9040C5. Make a hazardous waste determination on the MCRC Model 33 parts washer spent solvent by analyzing it for:<ul style="list-style-type: none">-TCLP for RCRA Metals, pursuant to 40 CFR 261.24, via method 6010-TCLP for Volatiles, pursuant to 40 CFR 261.24, via method 8260 <p>Blasting and Painting Shop</p> <ol style="list-style-type: none">6. Make a hazardous waste determination on the paint booth filters by analyzing them

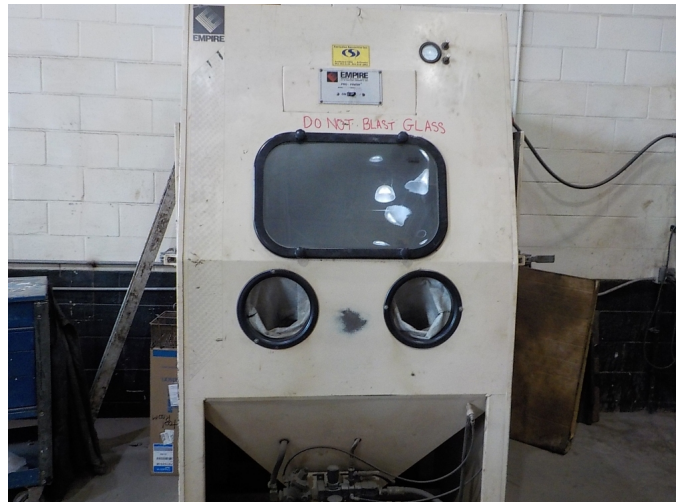
Photo 10

There is one glovebox blasting unit installed in the Track Shop (Photo 10) and one unit installed in the CAT Rental Store Shop. Both Ring Power and customer painted and unpainted parts are blasted in the units. Spent blasting media is added to the Wash Rack dirt/sludge as described below for disposal at Evergreen Landfill in Valdosta, Georgia. Analysis of the CAT Rental Store Shop spent blasting media has indicated that it does not contain TCLP metal constituents above the TCLP regulatory limits. No TCLP analysis had been performed and no hazardous waste determination records were available at the time of inspection for the spent Track Shop blasting media [40 CFR 262.11].

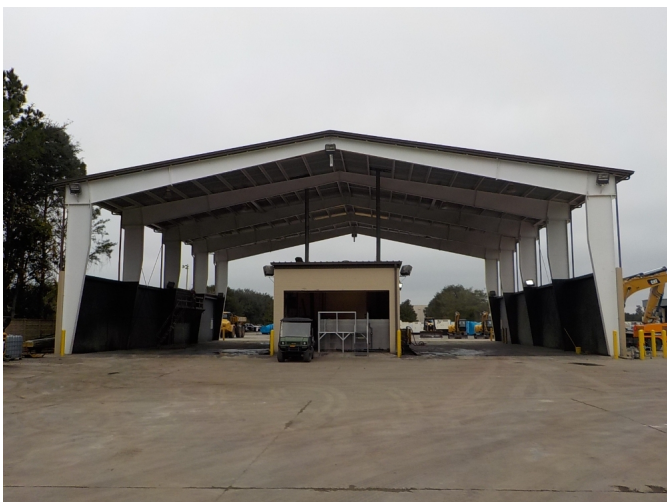
Photo 11

The Wash Rack is a covered area used to wash equipment that has been potentially contaminated with oil and dirt prior to repairs (Photo 11). The Wash Rack is equipped with a rough clean area on one side of the structure and a polishing area on the other side of the structure. The rough clean and polishing areas are separated by a change in elevation. The rough clean area is a closed-loop system where dirt/debris is washed from equipment with high pressure water. Dirt and debris are separated from water by a weir and are removed and accumulated as needed in a walled pit in the Wash Rack area. Equipment is cleaned with Mean Green 9 in the polishing area. Water drains to a trough which is pumped to a biofiltration unit that treats the water with microbes and a defoaming agent prior to discharge to the POTW. The biofiltration unit filters are pressure washed in the rough side area of the Wash Rack as needed, approximately every six months. Sludge that accumulates in the biofiltration unit is cleaned out as needed. The unit is relatively new and therefore sludge has not yet been disposed, but analysis of the sludge has indicated that it does not contain TCLP volatile, semi-volatile, metal, pesticide or herbicide constituents above the TCLP regulatory limits. Dirt and debris collected from the rough

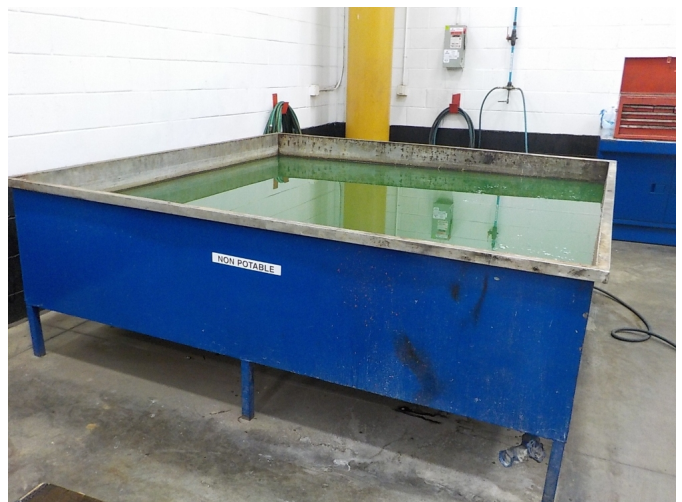
Photo 12

Radiators are pressure tested in a large tank containing water and Barbee #54/56 Tank Block/Powder (sodium carbonate 95%, pyalor fluorescene >5%) (Photo 12). Air pressure is placed on radiators placed into the tank where bubbles indicate potential leaks. When the liquid is no longer usable, it is released to the floor drain. The floor drain is piped to the Wash Rack described above. Analysis of the spent liquid has indicated that it does not contain TCLP volatile, semi-volatile, metal, pesticide or herbicide constituents above the TCLP regulatory limits.

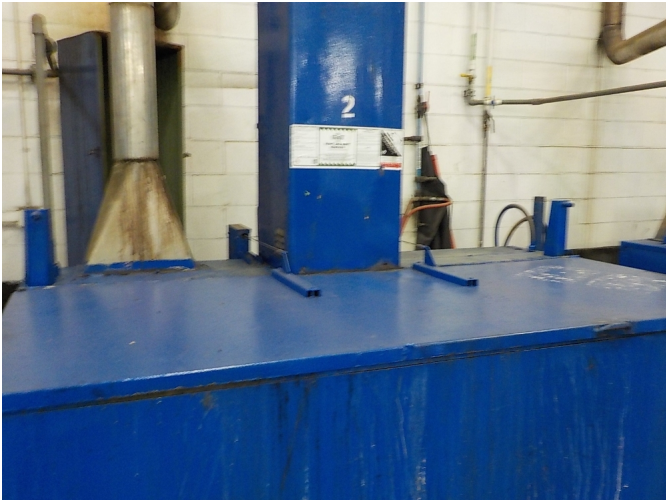
Photo 15

Tanks 2-4 use heated Foremost 1195 Paint and Rust Remover (sodium hydroxide; no flashpoint; pH 12.6-13.4) to clean cast iron and steel parts with agitation (Photo 15). Tanks 2-4 are cleaned out as needed based on particle testing. The spent liquid is placed into drums, the sludge is removed and drummed, the spent liquid is placed back into the tank for reuse and fresh product is added to top off the tank. Although the liquid is reused and not disposed of as described, analysis of the spent liquid has indicated that it is a D002/D007/D008 hazardous waste. The facility has not analyzed the sludge. As a result, the facility has not made an accurate hazardous waste determination on this waste stream [40 CFR 262.11].

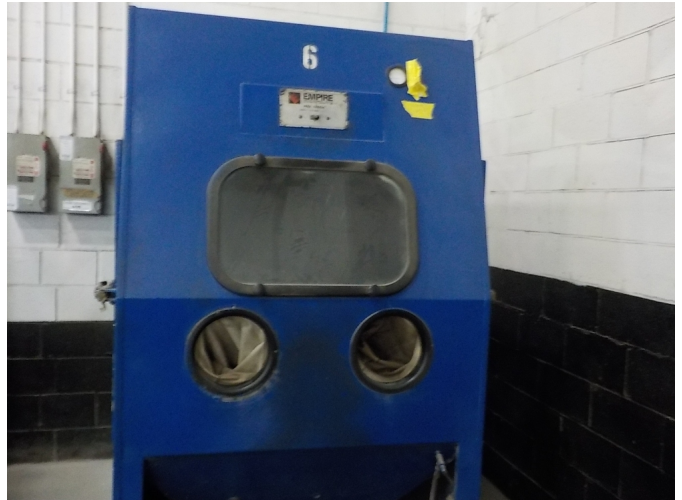
Photo 16

One glovebox blasting unit is installed in the Engine Tear Down area (Photo 16). Both Ring Power and customer painted and unpainted parts are blasted in the unit using glass beads. No TCLP analysis had been performed and no hazardous waste determination records were available at the time of inspection [40 CFR 262.11].

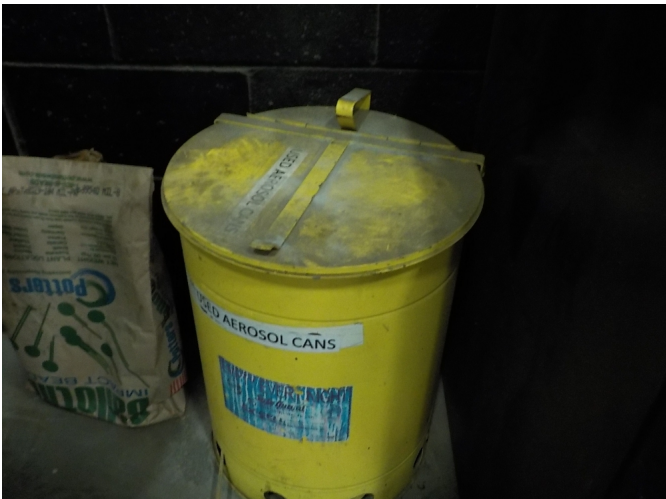
Photo 17

closed. The step can was not labeled as "Hazardous Waste" or with an indication of the hazards of the contents (Photo 17) [40 CFR 262.15(a)(5)]. The 30-gallon drum was not labeled with an indication of the hazards of the contents (Photo 18) [40 CFR 262.15(a)(5)]. The five aerosol cans were punctured and drained into the 30-gallon drum and the 30-gallon drum was properly labeled at the time of inspection.

Type:	Violation
Rule:	262.15(a)(5)
Explanation:	The 30-gallon satellite accumulation drums of aerosol can waste located in the Air Compressor Service Bays and CAT Rental Store/Heavy Equipment Shops and the step can containing non-empty aerosol cans located in the MCRC Engine Tear Down area were not labeled as "Hazardous Waste" and with an indication of the hazards of the contents. The 30-gallon satellite accumulation drum of aerosol can waste located in the MCRC Engine Tear Down area was not labeled with an indication of the hazards of the contents.
Corrective Action:	No further action is needed. The facility returned to compliance by labeling all containers properly at the time of inspection.

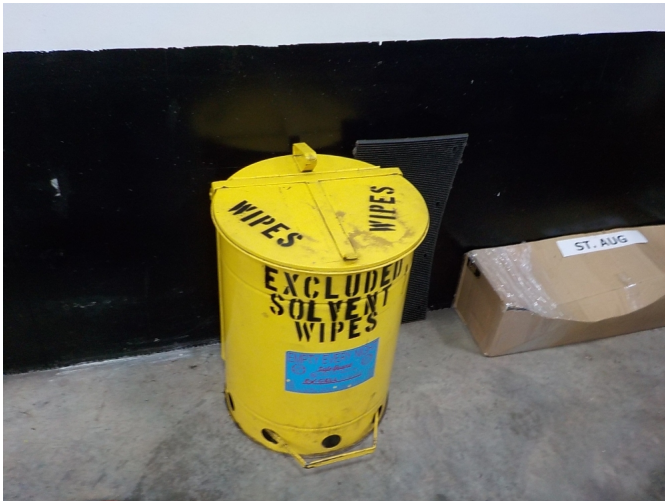
Photo 19

There is one excluded solvent contaminated wipes collection container installed in the Assembly area that is used to collect disposable rags that may be contaminated with oil, WD-40, Brakleen Brake Parts Cleaner-Non-Chlorinated or Loctite Threadlocker Blue 242 (oleic acid 20-30%, saccharin 1-5%, silica 1-5%, cumene hydroperoxide 1-5%, propane-1,2-diol 1-5%, cumene 0.1-1%, titanium dioxide 0.1-1%; flashpoint > 199.94°F). The step can was closed and properly labeled (Photo 19).

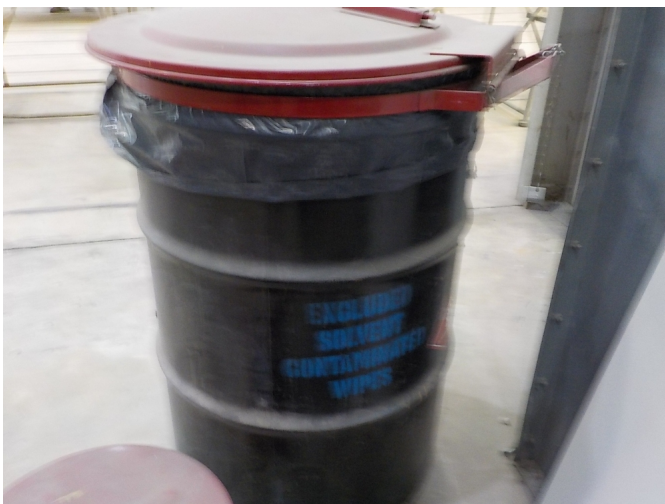
Photo 23

After blasting or sanding, Finish Pro 6000 Wax & Grease Remover (acetone 90-100%; flashpoint -4° F) may be used on a rag to remove debris, depending on the project. Spent rags contaminated with Finish Pro 6000 Wax & Grease Remover are non hazardous waste when used as described and are disposed of as excluded solvent contaminated wipes. There was one 55-gallon drum of excluded solvent contaminated wipes accumulating (Photo 23). The drum was closed, in good condition and properly labeled.

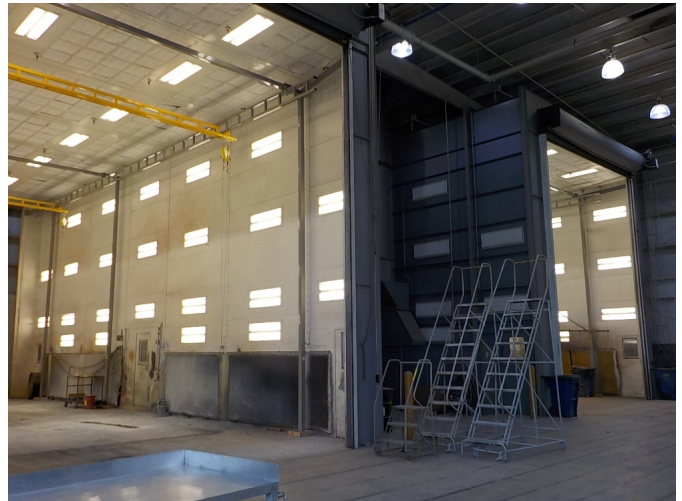
Photo 20

The facility blasts and paints both Ring Power and external customer equipment in this area (Photo 20). The facility also conducts a small amount of hand sanding when blasting is not feasible.

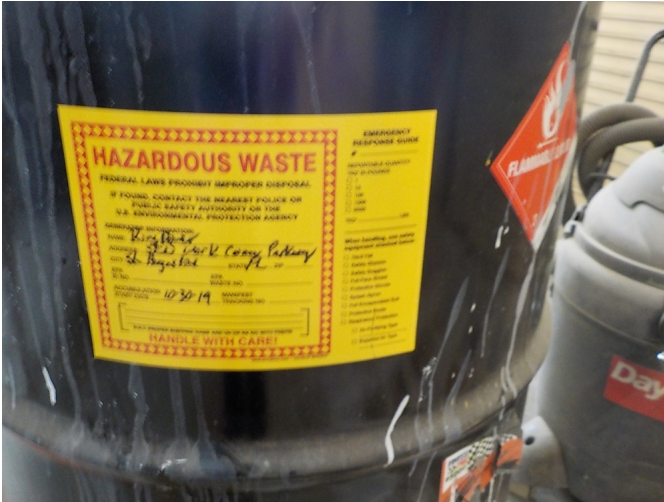
Photo 25

The 180-Day Hazardous Waste Accumulation Area (HWAA) is located in the Blasting and Paint Shop. There was one 55-gallon drum of spent paint and thinner observed at the time of inspection (Photo 25). The drum was closed, in good condition and properly labeled. There was one 30-gallon drum-top aerosol can puncturing device observed in the HWAA. The drum was closed, in good condition and properly labeled. Both drums had been accumulating waste for less than 180-days.

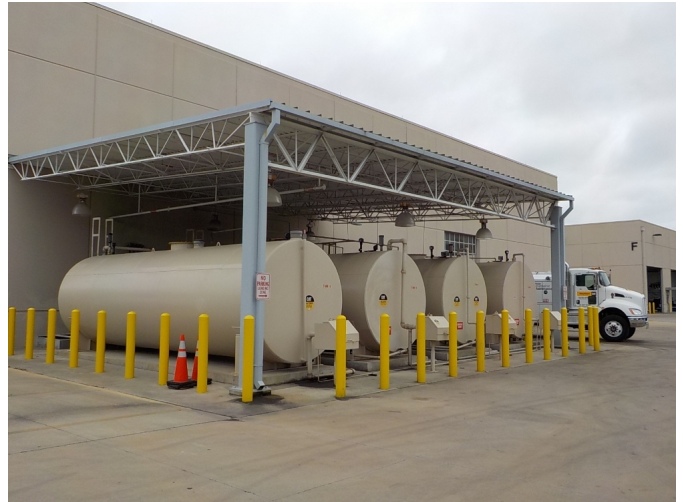
Photo 28

The Tank Farm consists of four aboveground, 10,000-gallon double-walled, steel tanks located under a roof (Photo 28). Tank 5 contains product diesel engine oil. Tank 6 is compartmentalized and contains a 2,500-gallon section for used oil and a 7,500-gallon section for product hydraulic oil. Tank 7 is compartmentalized and contains product 30-weight oil and 50-weight oil. Tank 8 is compartmentalized and contains a 5,000-gallon compartment for product antifreeze and a 5,000-gallon compartment for used antifreeze. The tanks appeared to be in good condition and were properly labeled.
