Re: Flagler Construction Equipment
Facility ID No.: FLR 000 213 694
Duval – Hazardous Waste Program

**Florida Department of
Environmental Protection
Hazardous Waste Inspection Report**

Inspection Date: 12/17/2019

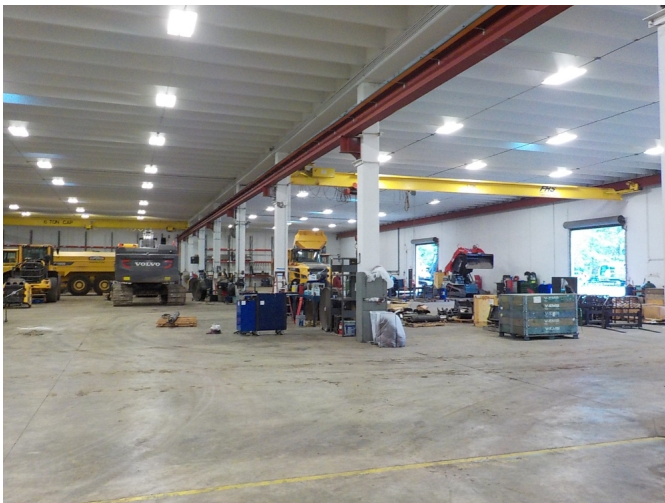
Photo 1

The warehouse side of the main building is used for materials and supply storage. Maintenance on forklifts, vehicles, and various other heavy equipment is performed on the other side of the building (Photo 1). Used oil, used oil filters, oily rags and oily absorbent are generated in this area. Used oil is drained into drip pans or mobile carts located throughout the area. Several of the used oil containers were not labeled "Used Oil" (Photos 2 and 3) [40 CFR 279.22(c)(1)]. Used oil is drained from the drip pans and mobile carts into a larger collection container and then pumped to a double-walled 200-gallon aboveground storage tank located against the wall of the maintenance area. The tank was labeled and in good condition (Photo 4). Used oil filters and oily absorbents are accumulated in 55-gallon drums located inside the maintenance area. All of the drums and containers were closed and labeled. If antifreeze has to be drained from a vehicle, the facility collects the antifreeze and re-uses it in the vehicle once maintenance is complete. If the antifreeze is not reusable, it is collected and disposed of by Safety-Kleen on an as-needed basis.

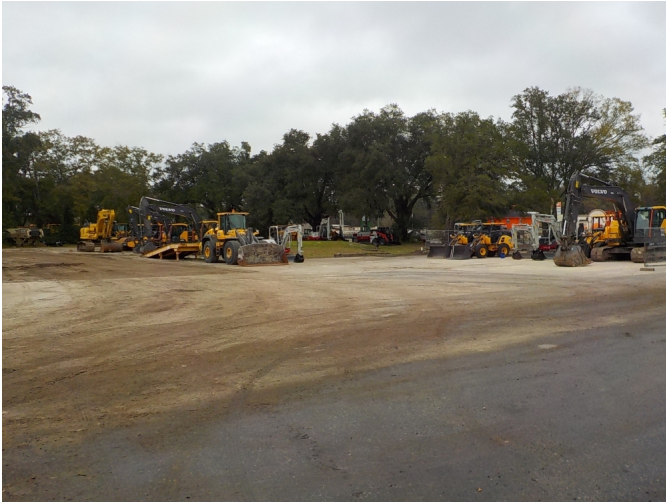
Photo 5

This yard is located north of the Warehouse and Maintenance Area and is used as a laydown area for materials and to stage equipment for sale, lease and/or maintenance (Photo 5). Dumpsters for solid waste and scrap metal are also located in this area. No maintenance is performed in the yard but two areas were observed to have stained soil/gravel that appeared to be from petroleum releases that had not been cleaned-up (Photos 6 and 7) [40 CFR 279.22(d)(3)].
