Florida Department of Environmental Protection
Twin Towers Office Bldg. 2600 Blair Stone Road, Tallahassee, Florida, 32399-2400
Division of Waste Management
Petroleum Storage Systems
Storage Tank Facility Annual Compliance Site Inspection Report

Facility ID:	9102866	County: PALM BEACH	Inspection Date: 03/07/2017
Facility Type:	C - Fuel user/Non-retail		
Facility Name:	AT&T MOBILITY	# of Inspected ASTs:	0
	11051 S MILITARY TRL, ***SEE ALSO	USTs:	1
	BOYNTON BEACH, FL 33436	Mineral Acid Tanks:	0
Latitude:	26° 30' 46.4484"		
Longitude:	80° 7' 26.0985"		
LL Method:	DPHO

Result: In Compliance

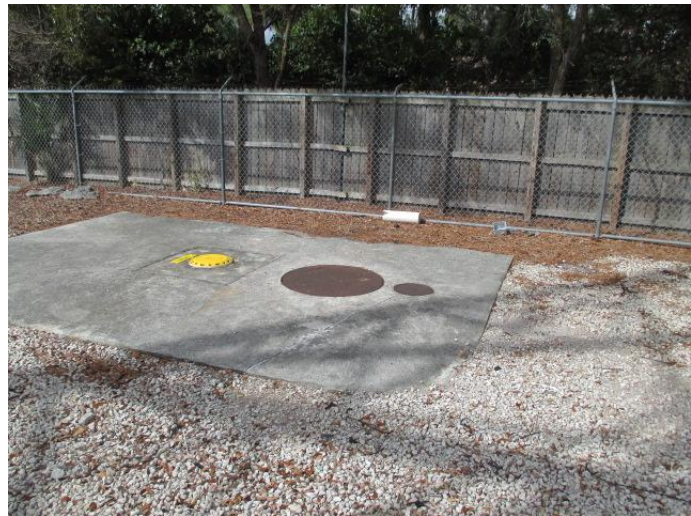
Tank Pad

EMERGENCY GENERATOR DIESEL UST: (1) Double walled UST inspected; Annular sensor was NORMAL. Anti siphon valve appeared in use.

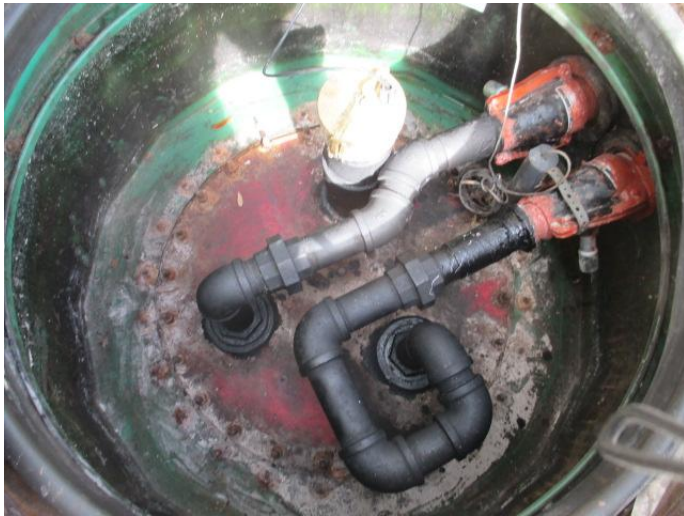
Piping Sump

PIPING SUMP: (1) inspected; appeared dry; Return and Supply lines and inventory riser appeared in intact; pipe entry fittings appeared intact; piping air test boots appeared open; sensor appeared properly positioned below piping entries.

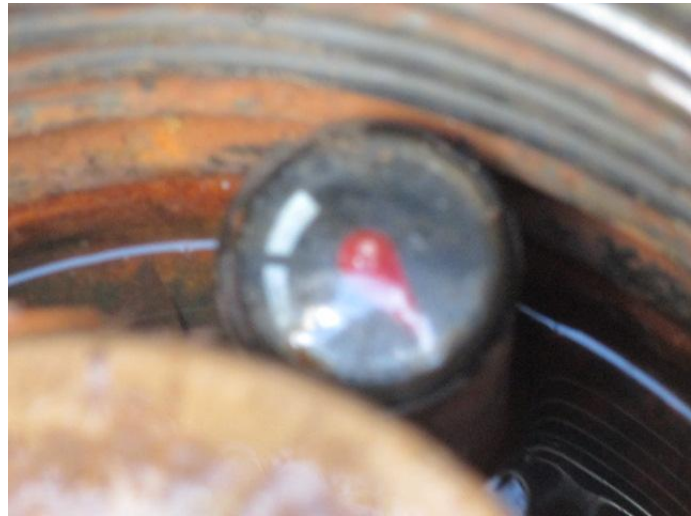
Spill bucket visigauge

SPILL BUCKET: (1) has key lock; interior appeared dry; fill cap tight and drop tube observed. API color coding observed. Visigauge did not appear to indicate the presence of liquid in the double wall.

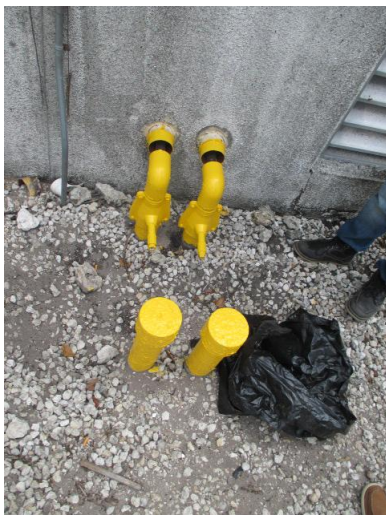
Piping transition into Generator Room

ABOVEGROUND PIPING: All piping appeared OK from underground transition to generator room.
