SUBJ: Resource Conservation and Recovery Act (RCRA) Compliance Evaluation Inspection (CEI)
Safety Kleen Systems, Inc.
EPA ID: FLD982133159

RCRA Inspection Report

Safety Kleen Systems, Inc.
4426 Entrepot Boulevard
Tallahassee, Florida 32310
Leon County

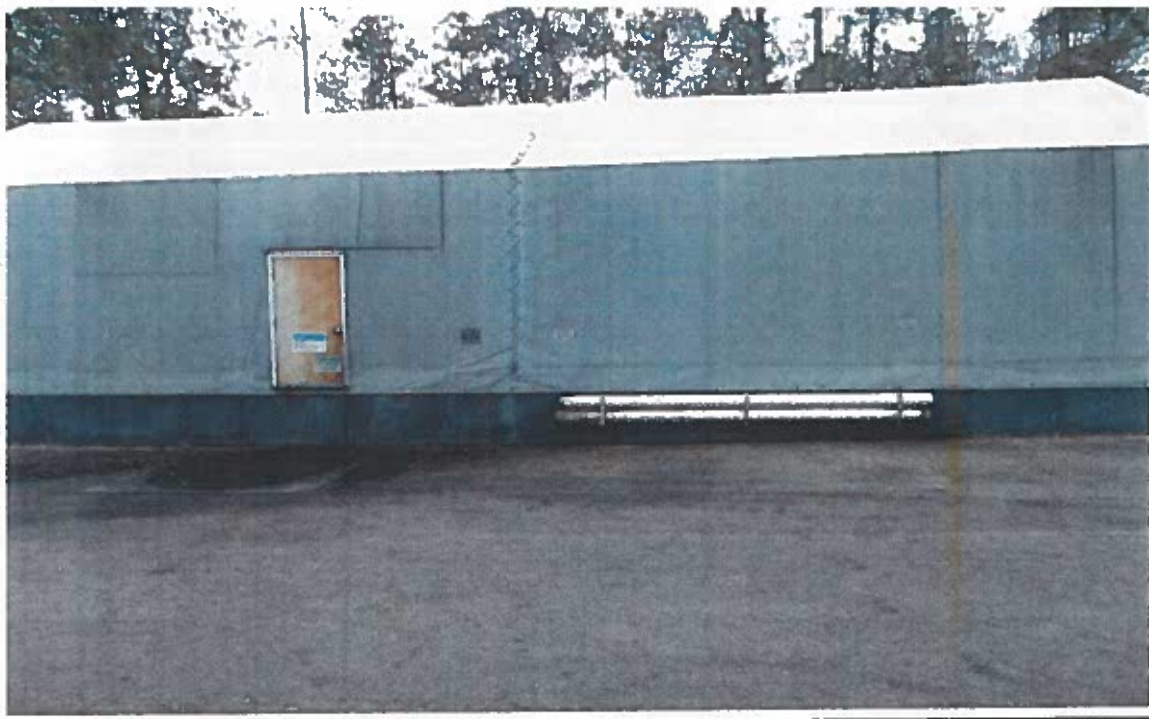
Safety Kleen Systems, Inc. – Tallahassee FL. RCRA Permitted Tank Farm. Observed two 15,000-gallon used oil tanks and one 15,000-gallon RCRA permitted tank (Tank). The tank farm is constructed with a concrete floor four to five-foot high concrete walls and covered by a rigid canvas material. Photograph 1 taken at 12:22 p.m. WK.

The Tank Farm is an outdoor complex constructed with a concrete slab, a three to four-foot high concrete wall for secondary containment and enclosed by a rigid canvas liner supported by an internal metal structure. The Tank Farm consists of one 15,000-gallon horizontal hazardous waste tank (Tank) and two 15,000-gallon horizontal used oil tanks. The facility maintains one

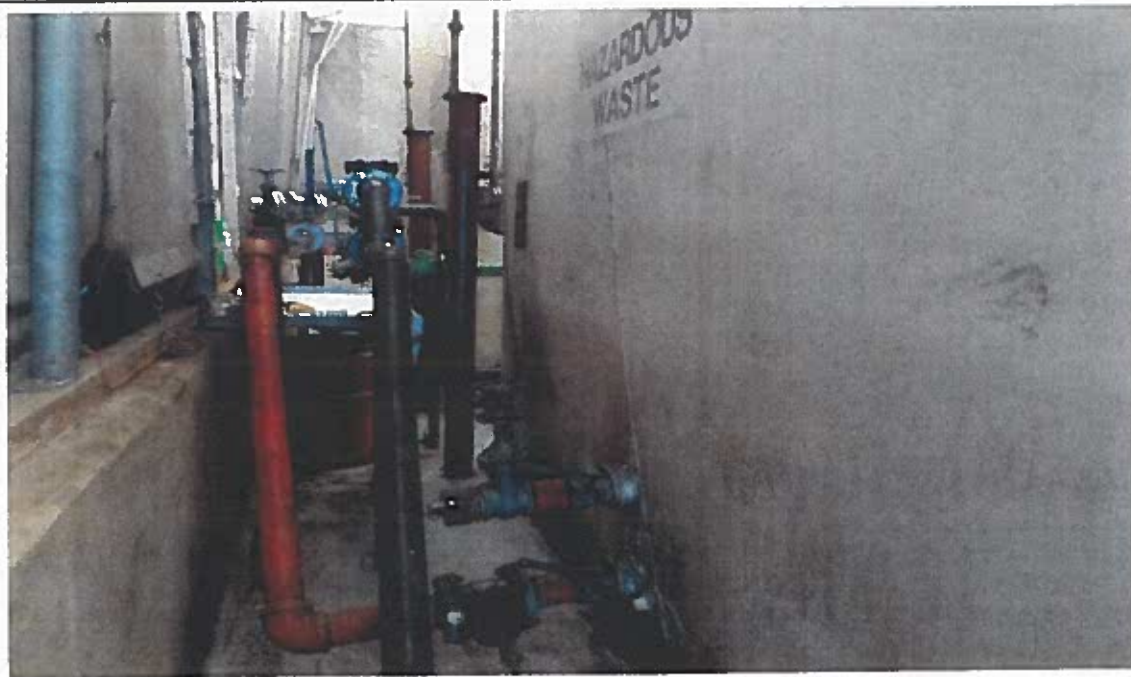
Safety Kleen Systems, Inc. – Tallahassee FL. RCRA Permitted Tank Farm. Inspectors observed one 15,000-gallon Tank marked with the words hazardous waste. Inspectors observed metal numbered tags on each valve, flange, and pipe connection. Photograph 2 taken at 12:22 p.m. WK.

Inspectors accessed the Tank Farm and observed one 15,000-gallon Tank. Inspectors observed the piping ran vertical to the top of the tank and connected to the Tank pump and valve system. Inspectors observed the Tank ancillary equipment (couplings, flanges, valves, and pump connections) were identified with numbered tags for Subpart BB requirements. The piping system leaving the Tank was observed inside secondary containment. The Tank is equipped with a top mounted emergency vent and pressure/vacuum vent. Inspectors observed no visible cracks, holes, gaps, or other open spaces with the Tank joints or between the roof edges and the Tank walls. Inspectors observed the Tank was labeled with the words hazardous waste and labeled with an indication of the hazards of the contents (photographs 1, 2, 3, and 4). Inspectors observed the floor surface appeared in good condition and cracks or gaps to the floor surface was not observed. Inspectors observed a sign on the Tank with the words "Dirty Solvent Tank, Max Safe Fill Level 14,250 Gallons".

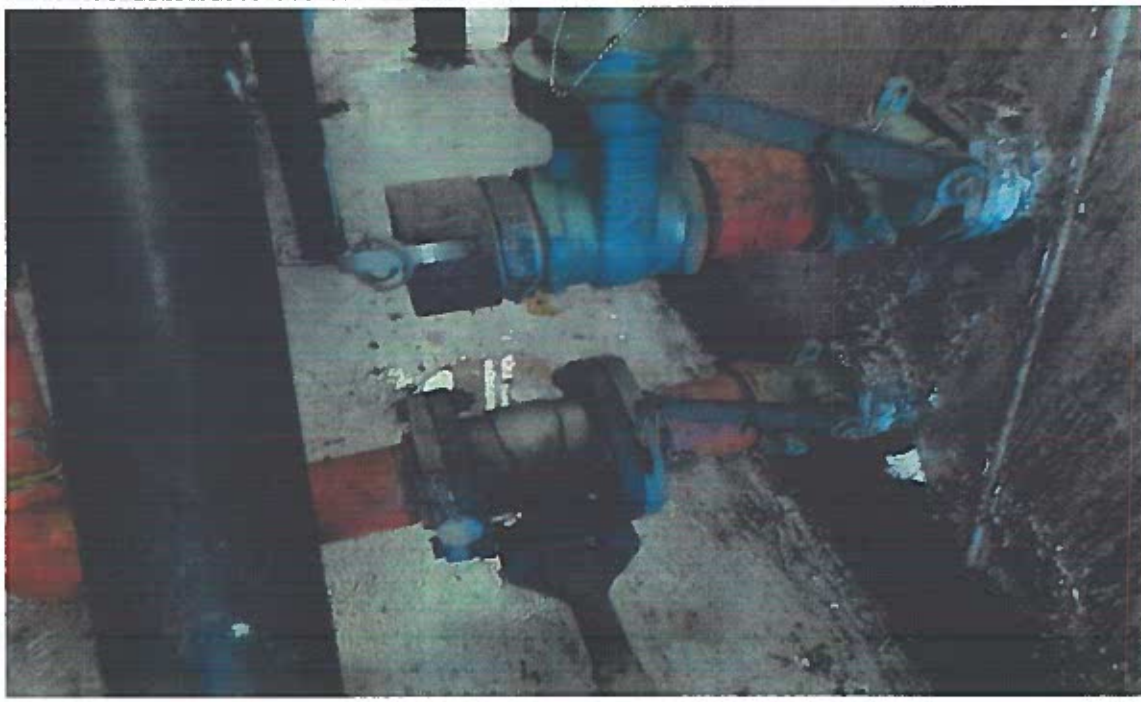
Safety Kleen Systems, Inc. – Tallahassee FL. RCRA Permitted Tank Farm. Inspectors observed one 15,000-gallon Tank marked with the words hazardous waste. Inspectors observed metal numbered tags on each valve, flange, and pipe connection. Photograph 3 taken at 12:22 p.m. WK.

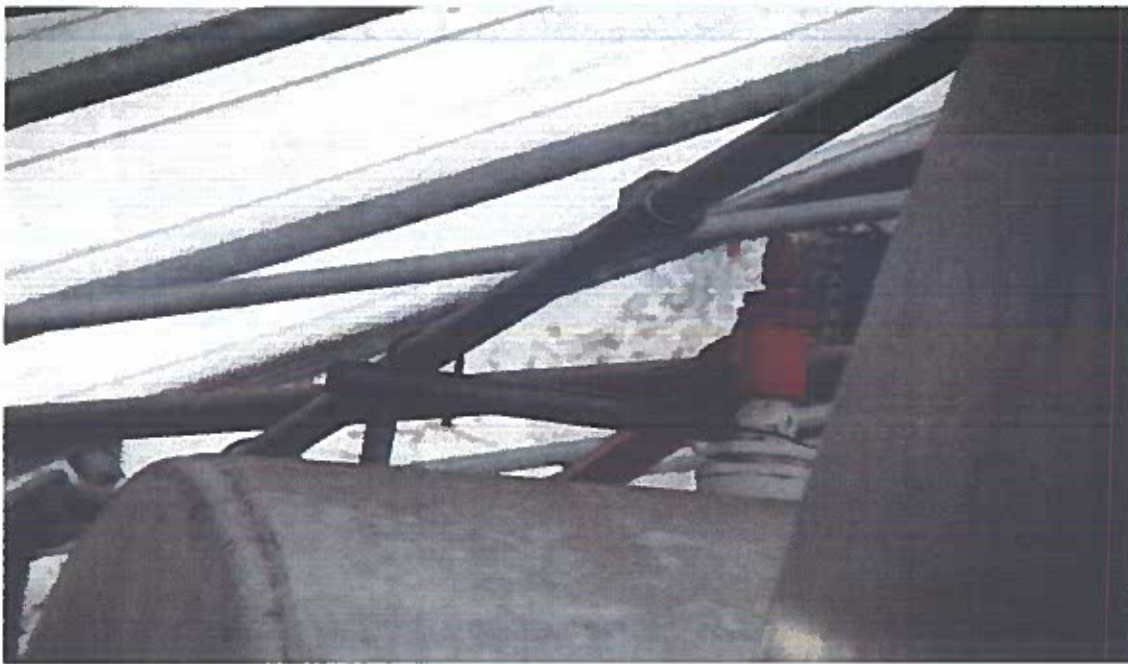
Safety Kleen Systems, Inc. – Tallahassee FL. RCRA Permitted Tank Farm. Inspectors observed one top mounted emergency vent and pressure/vacuum vent on the 15,000-gallon Tank. Photograph 4 taken at 12:22 p.m. WK.
