# FLORIDA DEPARTMENT OF Environmental Protection

Re: Compliance Assistance Offer  
Ring Power (Perry)  
EPA/DEP ID: FLD 981 480 205  
Taylor County – Hazardous Waste

**Florida Department of  
Environmental Protection  
Hazardous Waste Inspection Report**

**Facility Name:** Ring Power Corp  
**On-Site Inspection Start Date:** 07/15/2020 **On-Site Inspection End Date:** 07/15/2020  
**ME ID#:** 39549 **EPA ID#:** FLD981480205  
**Facility Street Address:** 2920 S Byron Butler Pkwy, Perry, Florida 32348-6314  
**Contact Mailing Address:** 500 World Commerce Pkwy, St Augustine, Florida 32092-3788  
**County Name:** Taylor **Contact Phone:** (904) 494-1417

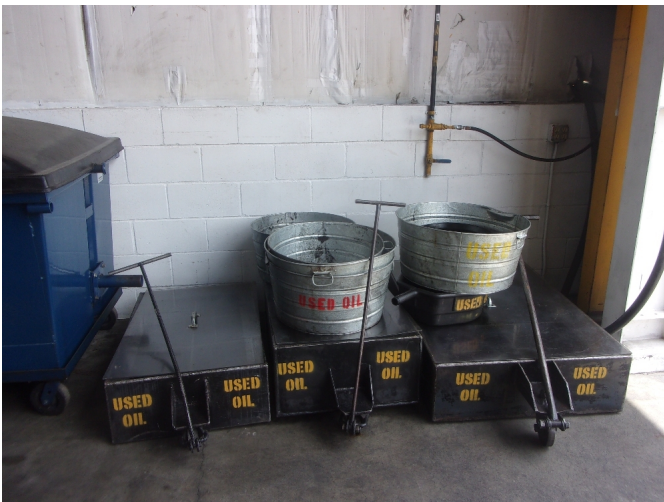
Photo 1

Used oil generated by Maintenance and Repair Shop operations is drained into portable drain containers (Photo 1) and then pumped by means of a suction piping system directly to the used oil tank described below. The containers were in good condition and properly labeled as "Used Oil."

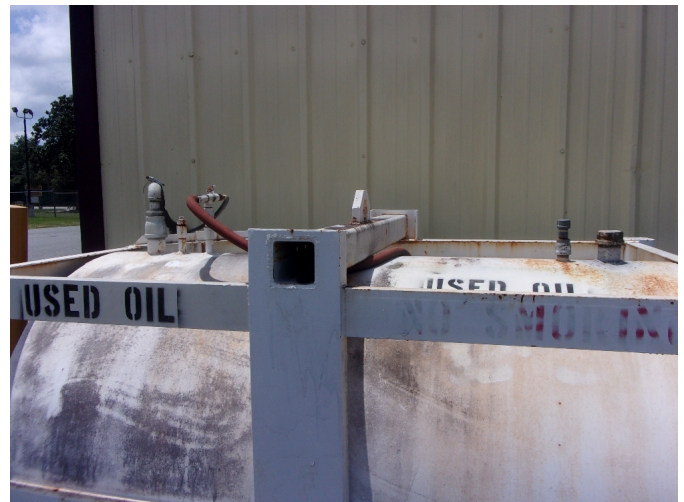
Photo 2

There is one 500-gallon, double-walled used oil tank located just outside the Maintenance and Repair Shop adjacent to the building (Photo 2). The tank appeared to be in good condition, was closed and properly labeled as "Used Oil." Mr. Vaughn stated that there have been no residues cleaned out from the used oil tank since at least the last inspection.

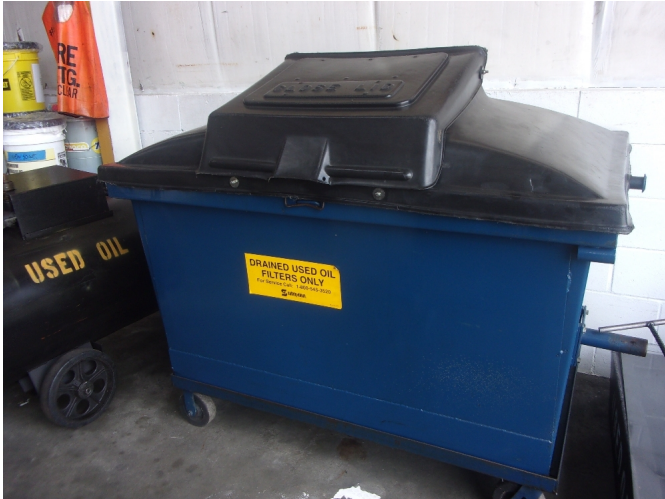
Photo 3

Used oil filters generated by Maintenance and Repair Shop operations are drained into used oil containers and then accumulated in a 330-gallon steel container. There was one 330-gallon container accumulating used oil filters (Photo 3). The container was stored on an impervious surface, in good condition, closed and properly labeled as "Used Oil Filters."

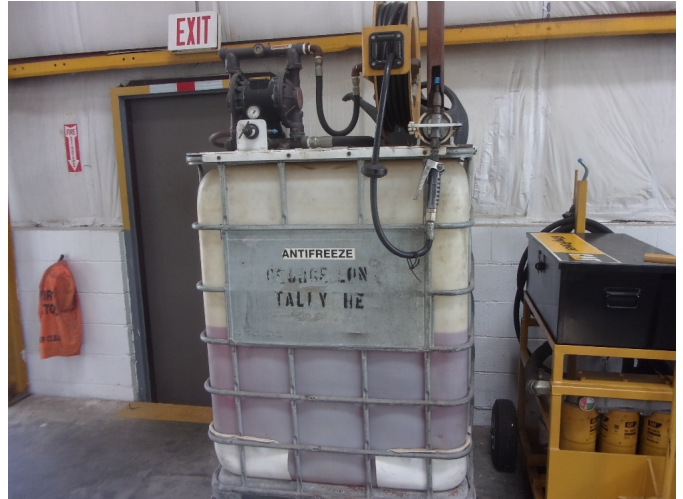
Photo 4

Used antifreeze generated by Maintenance and Repair Shop operations is accumulated in portable drain containers that are emptied into an approximately 250-gallon tote for re-use (Photo 4). The facility representative stated that used antifreeze contained in the tote is recycled onsite and has not been disposed of in at least the past 15 years. The tote was closed, in good condition and labeled as "Antifreeze Coolant." The facility is reminded that the tote should be labeled "Used Antifreeze" to comply with the Department's "Best Management Practices for Managing Used Antifreeze at Vehicle Repair Facilities." There is an empty 55-gallon drum available for spent antifreeze that cannot be re-used.

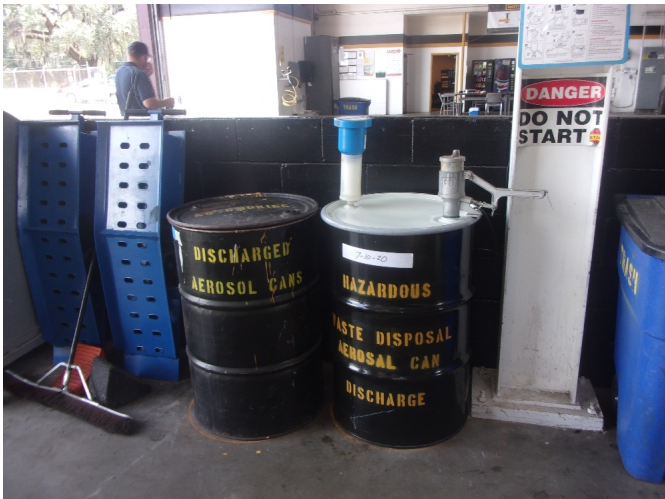
Photo 5

Aerosol cans of Brakleen Brake Parts Cleaner-Non-Chlorinated (methanol 40-50%, toluene 10-20%, acetone 5-15%, 3-methylhexane 5-10%, carbon dioxide 5-10%, n-heptane 5-10%, methylcyclohexane 3-5%, hydrotreated light naphtha (petroleum) 3-5%, cyclohexane 1-3%, ethylbenzene <0.2%; flashpoint 0°F), CAT Battery Cleaner (isobutane 5-10%; flashpoint -119°F), CAT Standard Performance Topcoat-CAT Yellow (flashpoint -20.2°F), CAT Yellow Primer Paint (flashpoint 71°F), CAT Black Paint High Gloss (flashpoint 88°F), CAT Black Muffler Paint (flashpoint -99°F) and CRC Insect Repellent (isopropyl alcohol 30-40%, liquified petroleum gas 20-30%, N,N-diethyl-m-toluamide (DEET) 25%, N-octyl bicycloheptene 5%, di-n-propyl isocinchomeronate 2.5%, acetone 1-3%, propylene glycol 1-3%; flashpoint 75°F) are generated by Maintenance and Repair Shop operations. One drum-top aerosol can puncturing device is installed in the Maintenance and Repair Shop. Aerosol cans are punctured and the liquid is drained into a 55-gallon drum. Empty cans are disposed of as scrap metal. The drum was in good condition, closed and labeled as "Hazardous Waste Disposal Aerosol Can Discharge" with an

accumulation start date of July 10, 2020 (Photo 5). Liquid generated from puncturing and draining non-empty aerosols of these products will generate a D001 hazardous waste.

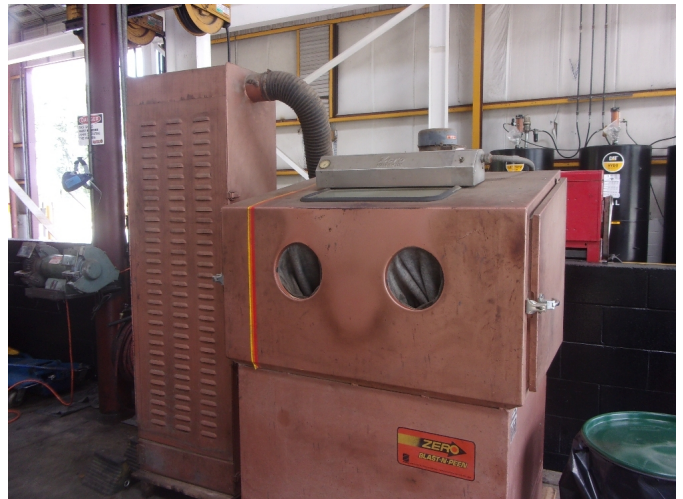
Photo 6

There is one glovebox blasting unit installed in the Maintenance and Repair Shop (Photo 6). The unit is used occasionally to blast both painted and unpainted parts. The spent media has not been disposed of yet. The facility is reminded to perform TCLP analysis for RCRA metals on the spent blasting media and manage the waste appropriately.

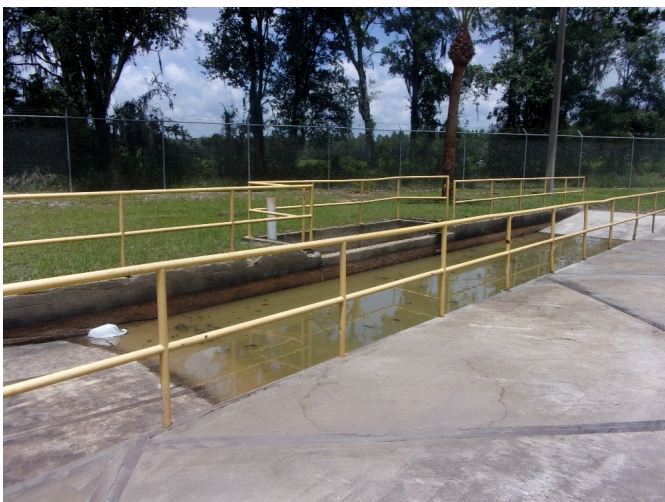
Photo 7

-----  
The Wash Rack is a closed-loop system used to wash equipment or vehicles that have been potentially contaminated with oil and dirt prior to repairs (Photo 7). Mean Green 9 and heated water are used to pressure wash the equipment on a concrete pad. Wash water drains to a collection pit. When the water reaches a certain level in the collection pit, it overflows into a series of weirs that filter particulate matter from the wash water. The first weir allows water to underflow and contains any free oil. According to the standard operating procedures, if free oil is observed in the weir, an oil absorbent pad would be used to absorb the oil and the pad would be disposed of in the absorbent pad drum. The accumulated dirt and debris is cleaned out of the collection pits as needed, approximately every 8-9 months. The dirt and debris is dried in a covered accumulation area adjacent to the Wash Rack (Photo 8) and disposed of as non-hazardous waste at Evergreen Landfill in Valdosta, Georgia. Analysis of the dirt and debris indicates that it does not contain TCLP volatile, semi-volatile, metal, or pesticide constituents above the regulatory limits. The dirt and debris were analyzed for TCLP herbicides as well, however, the method detection limit for Silvex was above the regulatory limit, so a complete hazardous waste determination was not conducted [40 CFR 262.11]. Analysis indicated that the dirt and debris did not contain the herbicide dichlorophenoxyacetic acid above the regulatory limits. The solids were last transported by Pritchett Trucking on June 3, 2019.
