Re: Howco Environmental Services  
2650 Edison Ave., Fort Myers, FL  
Facility ID No. FL0001000611  
Lee County - HW

**Florida Department of  
Environmental Protection  
Hazardous Waste Inspection Report**

Inspection Date: 08/31/2021

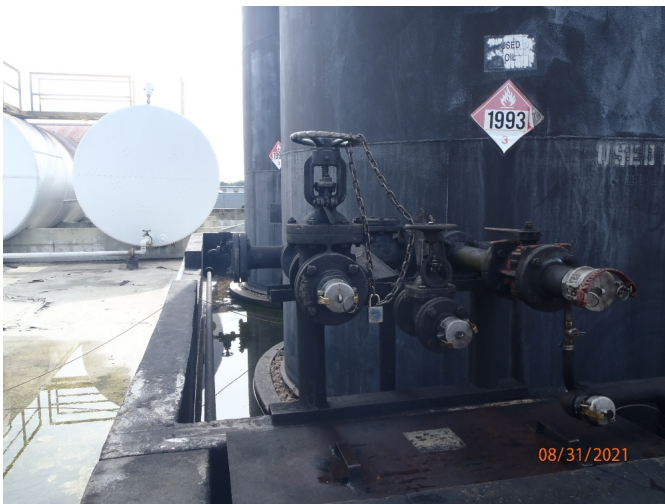
valve header

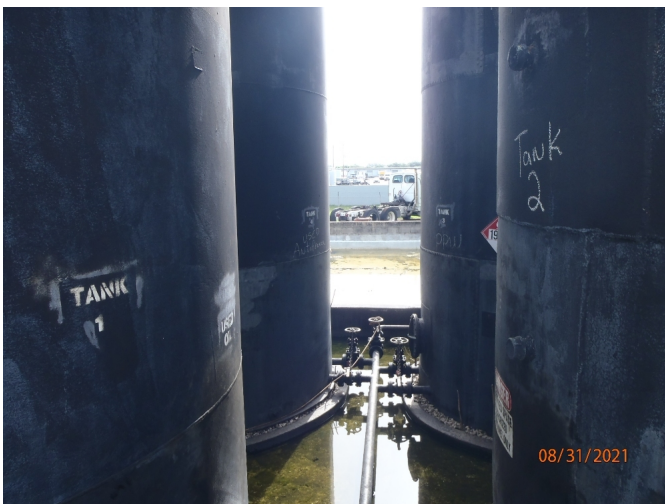
The four storage tanks are situated within a concrete secondary containment structure. The containment structure is part of a larger containment structure that includes fuel tanks owned/operated by Ryan Petroleum. At the time of the inspection, the containment structure contained approximately 1-2 inches of rainwater, algae and organic matter (see photos). The interior walls of the containment structure appeared in good condition and coated with a sealant/coating; however it was not possible to evaluate the base of the structure. A file review reflects the facility applied an impervious sealant inside the secondary containment structure in 2017. Following the inspection, Ms. Mull was provided photos of the containment structure. \*Immediately following the inspection, documentation was provided reflecting the containment structure was cleaned, evaluated and verified in good condition. A follow-up inspection was conducted by FDEP hazardous waste staff on 09-29-2021 and confirmed the containment structure and sealant were in good condition.

containment structure

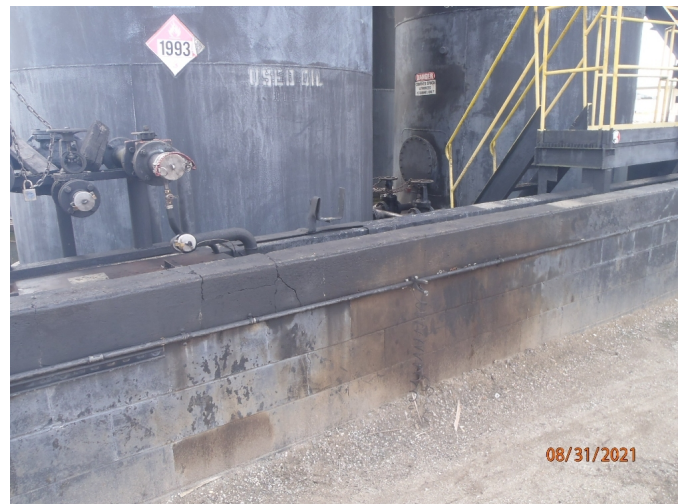
At the time of the inspection, the truck and driver were not at the facility. According to Ms. Mull, the truck is off-loaded every day and pumped into the designated storage tanks. Before off-loading waste fluids, the driver measures the before (and end) volume of the storage tanks. The driver then connects a hose to a valve header which is situated within the containment structure (see photo). Beneath the valve header is a metal box to collect drips, etc. from the hoses. Drivers open the lid when loading/off-loading fluids. At the time of the inspection, the lid was on the box which prevents rainwater from collecting, and was not inspected. Fluids that collect in the box are removed and properly managed. What appeared to be weathered staining was noted on the outside of the containment wall, adjacent to the valve header (see photo). Ms. Mull was provided a photo. \*Immediately following the inspection, documentation was provided reflecting the wall had been repainted.

staining on exterior wall

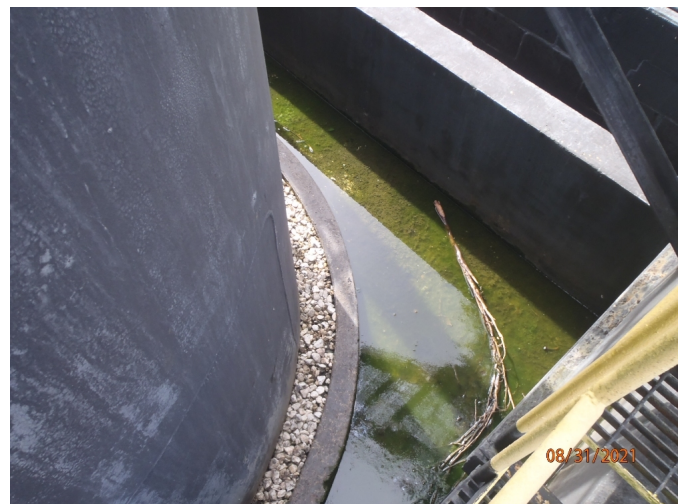
containment structure

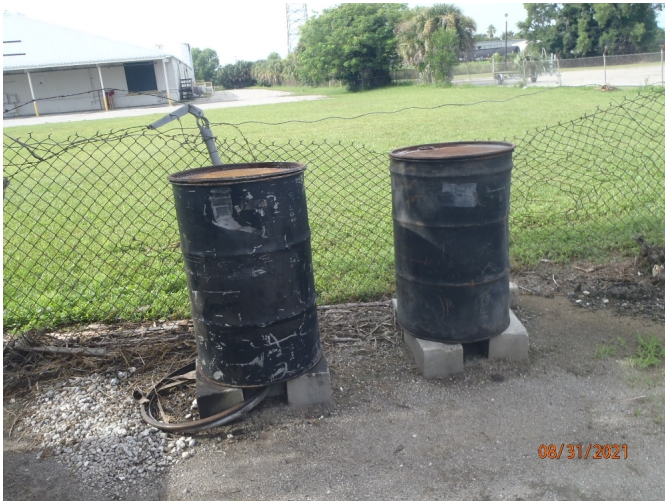
Two closed 55-gallon steel drums were observed adjacent to the containment structure (see photo). One drum was approximately half full of spent/oily absorbent material and the second drum was approximately half full of trash. Neither drum was labeled. According to Ms. Mull, drums of spent absorbent are placed in the used oil filter trailer and transported to the Howco St. Petersburg facility for disposal. Ms. Mull was provided photos of the drums. \*Immediately following the inspection, documentation was provided reflecting both drums were labeled.

spent absorbent and trash drums

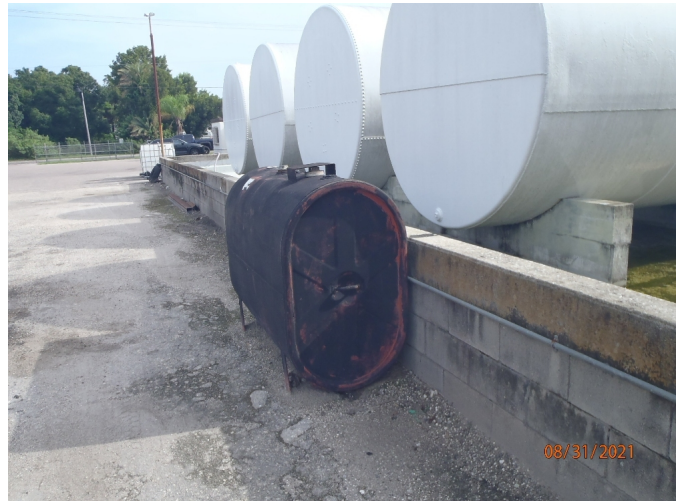
Also noted outside adjacent to the containment structure was an approximate 200-gallon steel aboveground storage tank (see photo). The tank was closed, not labeled and appeared empty. Ms. Mull was provided a photo of the tank. \*Immediately following the inspection, documentation was provided reflecting the tank is empty and belongs to Ryan Petroleum.

200-gallon AST

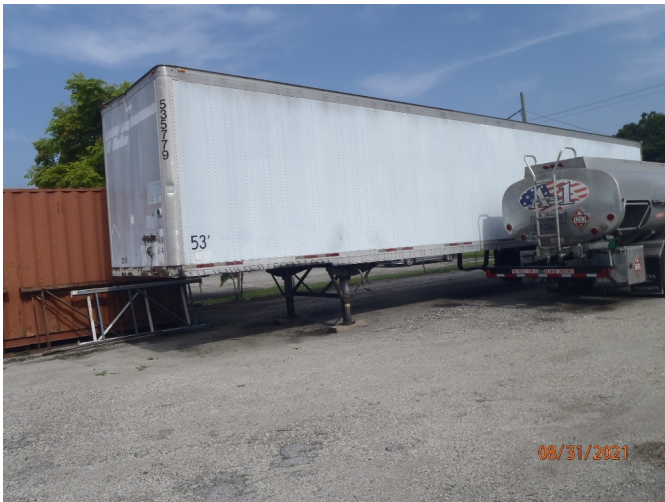
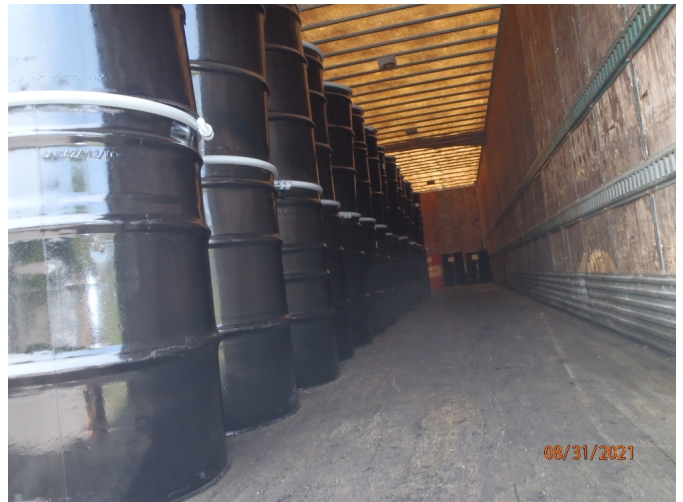
55-gallon drums of used oil filters are stored inside a 53-foot trailer parked over a concrete surface (see photos). The trailer is swapped out when full and transported to the Howco Environmental St. Petersburg facility. The trailer was not inspected however the drums appeared labeled, closed and in good condition. According to the previous inspection report, the drums are on a wood surface situated on top of the metal base of the trailer. It was noted that the wood surface is starting to wear. No petroleum discharges were noted inside or beneath the trailer. Ms. Mull indicated they are aware of the wood surface wearing and looking into replacing it.

used oil filter trailer
