**Florida Department of  
Environmental Protection  
Hazardous Waste Inspection Report**

**Facility Name:** Cliff Berry Inc - Miami Terminal  
**On-Site Inspection Start Date:** 03/01/2022 **On-Site Inspection End Date:** 03/01/2022  
**ME ID#:** 51668 **EPA ID#:** FLD058560699  
**Facility Street Address:** 3033 NW North River Dr , Miami, Florida 33142-6304  
**Contact Mailing Address:** PO Box 13079, Fort Lauderdale, Florida 33316-0100  
**County Name:** Miami-Dade **Contact Phone:** (954) 763-3390

## Cliff Berry Inc - Miami Terminal Inspection Report

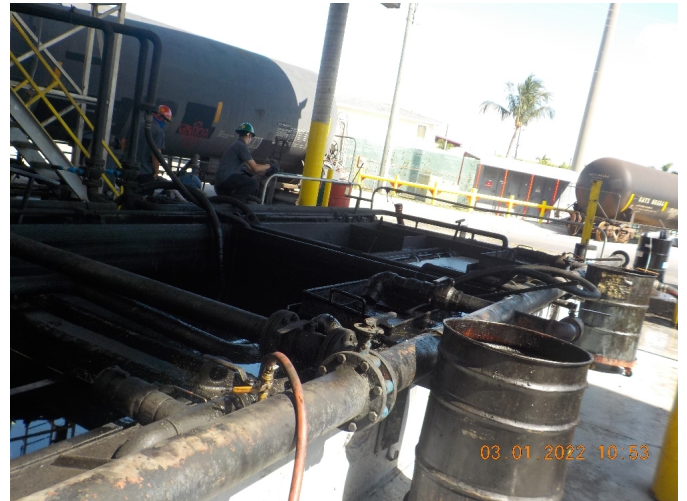
## The Pit Area

Tanker trucks of oil and wastewater with solids are vacuumed into dark pits for the settling stage. These open pits are separated into three sections. Oil and water are added to the pits and the water is pumped into the outer two sections while oil consolidates in the middle. This area is open but under a covered roof within secondary containment. The water is then drained off and the oil is pumped into an oil tank for used oil processing. Tanker trucks with only liquid waste that do not contain solids are taken directly to used oil tanks for processing. Bunker tank waste from ships are not used oil and are therefore not managed as used oil. These wastes are managed as oily wastes because they contain 40-60% water.

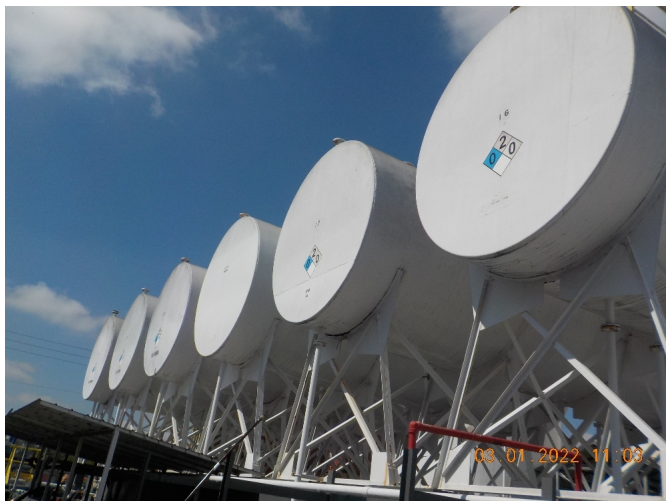
## The Wall

Beyond the pit area is the area know as The Wall. Four tank trucks were lined up in this area parallel to six horizontal steel tanks with approximately 17,500-gallon capacities each, numbered 16-21. These tanks hold used oil, diesel fuel, and oily water and are loaded from the tank trucks after the lab receives sampling results. Tank 18 is currently out of service. CBI has two pumps for unloading used oil and two for oily water. Oil related waste is brought via CBI trucks and other third-party transporters. Facilities are required to notify CBI in advance if waste is brought from other sources. A fire extinguisher and "No Smoking" sign were observed in this area. The Wall and Pit Area were surrounded by secondary containment.

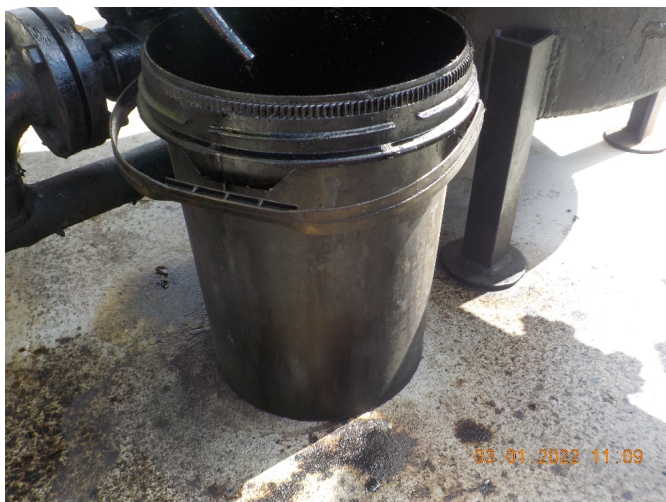
A tank car for off-site railway transportation was also observed near this area. Mr. Arce informed inspectors that the facility began shipping via railroad last year, but it is not done often. Separate black pumps are used for removing waste from bunker tanks. 5-gallon buckets sat next to each pump for priming the used oil and oily water pumps to remove air before unloading. When the pump is opened, air is removed from the pump, displacing the air in the tank. Air is displaced until liquid emerges from the pump to the 5-gallon bucket. The pump is then shut off and the rest of the liquid is loaded into the appropriate tank. Buckets are filtered about once a week to once every other week depending on the amount of wastes deposited. If the bucket is full, liquid can be collected back by the pump.

## Buckets used for pump priming

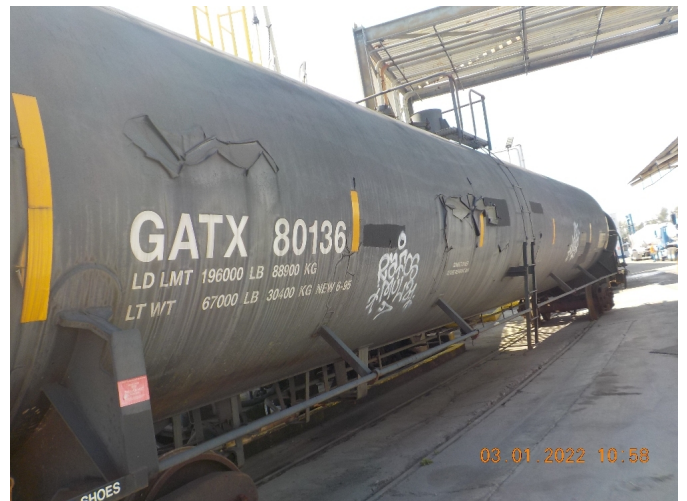
## CBI Rail Car

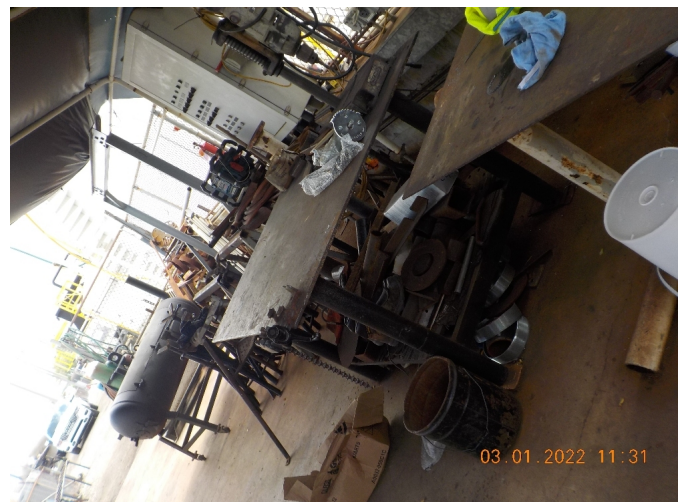
## Welding Area

The Welding Area of the facility is where welding operations are performed to construct materials to be used in the used oil processing. CBI currently employs 2-3 welders and all equipment is built on site, including black strainers used to remove solids remaining in the oil. No waste was observed in this area.

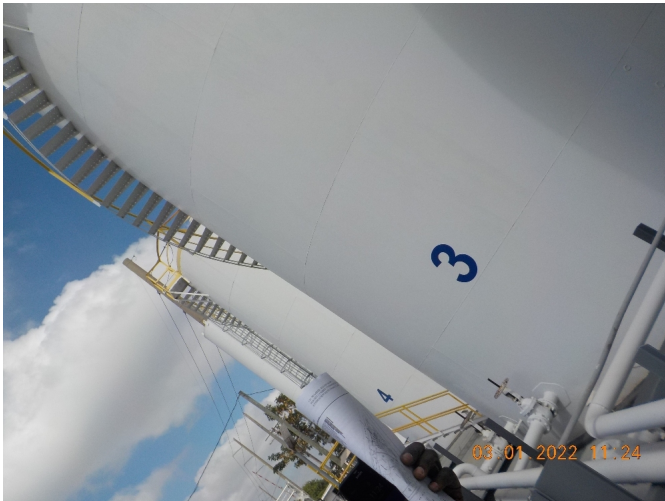
Tanks 1, 3, and 4 are used for oily water processing. A demulsifier is used to segregate the oil and water, and different tanks are used depending on the required length of processing. Tank 1 is used for oily water with the lowest water content and Tank 4 is used for oily water with the highest water content that will take longer to process. The length of time required to process depends on the laboratory determination of the composition of the oily water, as well as knowledge of where the water is coming from and the processes it was used for. The Laboratory tests this water to estimate the length of time to process and predict which speed of demulsification is required. All tanks have a tank gage and flays that indicate when the tank is full. Tank 2 holds finished oil that has been run through the Advanced Oil Processing System. Fuel oil stored here is continually monitored and adjusted as necessary. This area was surrounded by secondary containment walls.

Oily Water Processing Tanks 1, 3, and 4

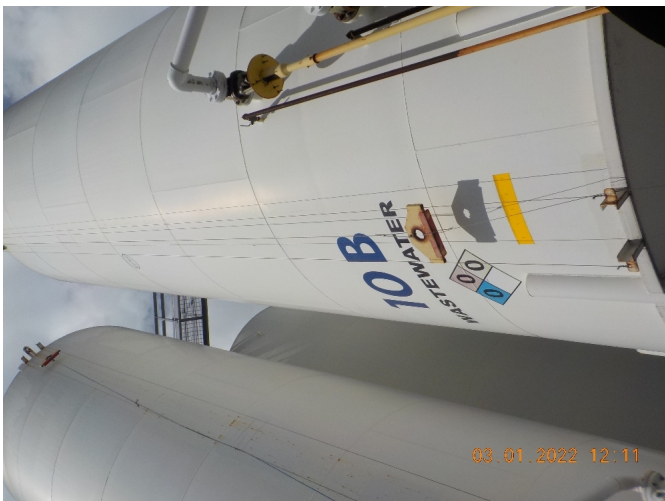
Tanks 10A and 10B hold wastewater after it has been processed in the wastewater treatment system. Each tank has a capacity of 44,000 gallons. Water is discharged from here to the Miami-Dade Publicly Owned Water Treatment Works (POTW), which the facility holds a permit for.

Process Water Tanks

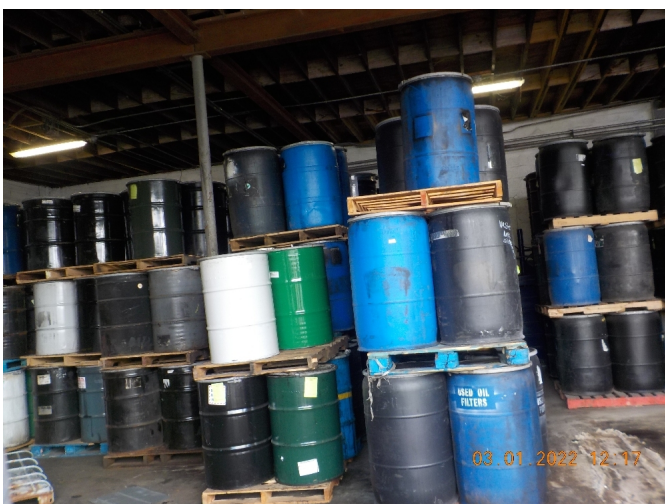
Used oil filters are stored in a large garage area outside of the facility's tank farm. Mr. Arce informed inspectors that the facility is authorized to process used oil filters, but the machine used to crush filters was currently broken and would not be returning to operation. The facility was then sending used oil filters to US Foundry, which later shut down about 6-8 months prior to the inspection. CBI is in the process of acquiring a new used oil filter processing system, but there is currently a 5-6 month backlog on the delivery. The facility is currently sending used oil filters to the Cliff Berry facility located at 5218 Saint Paul St Tampa, FL 33619, as well as other competitors.

At the time of the inspection, the facility had approximately 280 55-gallon drums of used oil filters stored in the Used Oil Filters Storage Area. The facility is registered as a used oil transfer facility and is therefore authorized to store used oil filters for more than 10 days in accordance with 62-710.201(9) F.A.C. Drums were stacked and stored on pallets and labeled "Non-Hazardous Waste, Used Oil Filters". The labels were marked with the name and address of the shipper and Cliff Berry facility, an accumulation date, and manifest number.

Used Oil Filters Storage Area

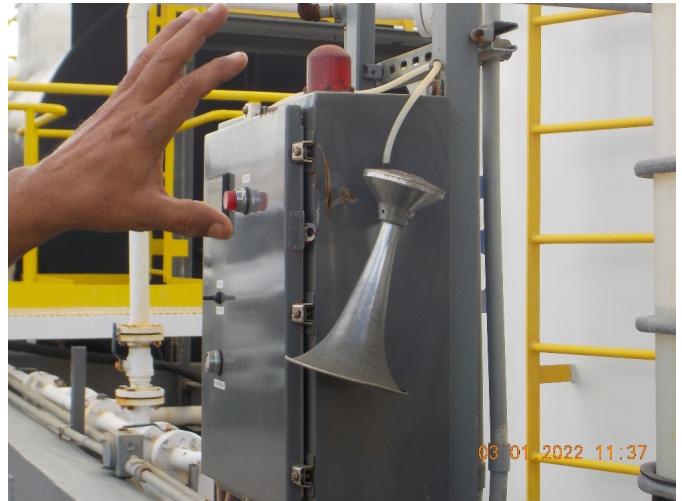
Inspectors observed a box with a light and alarm in this area. Mr. Arce informed inspectors this was a closed alarm system that turns off the shaker if a leak is detected. Leaks are collected in a closed secondary containment part of the tank. If the box fills, a leak is detected and the alarm rings. Mr. Arce also informed inspectors that most tanks are painted white to easily spot any oil residue outside of the tanks. Some pumps and pipes are painted black to maximize their heat and aid in the process.

Cooker Tank leak detection alarm

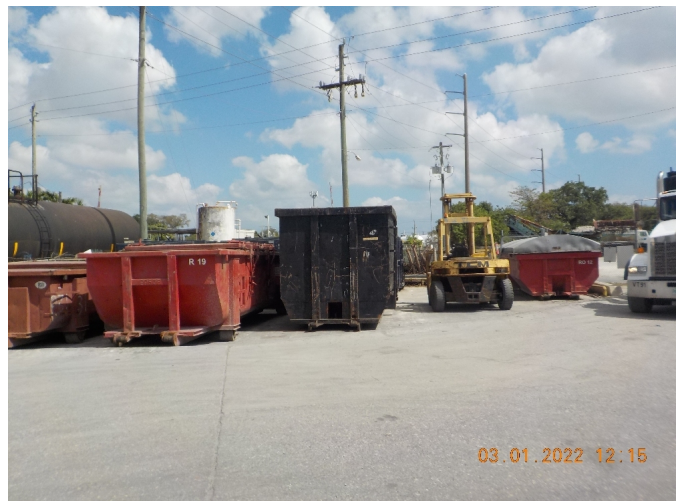
Five dumpsters serving as sludge containers were located in this area as well. All were empty except one container marked "RO12". Mr. Arce informed inspectors that solids are collected here from the wastewater treatment plant and goes to a landfill when the container is full.

RO12 sludge container

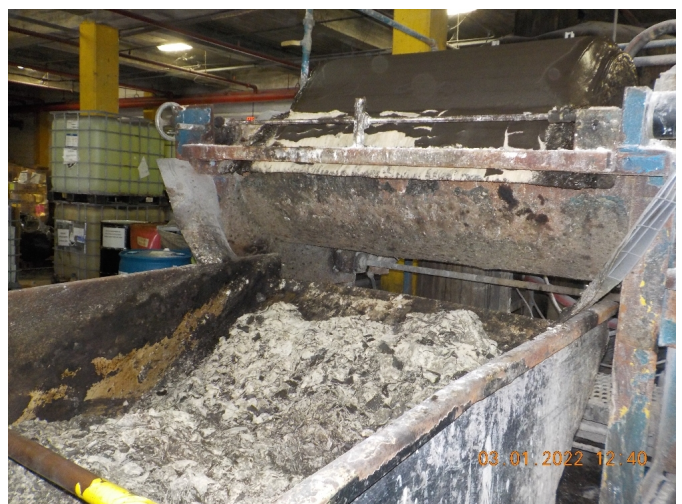
The building with the facility's wastewater treatment plant is adjacent to the Used Oil Filters Storage Area. The Wastewater Treatment Area serves as the head of the plant. The wastewater treatment plant separates oil and water using a water separator machine to catch free oil within the wastewater. This free oil is then brought to a pit. The remaining water is then transferred through a narrow pipe to a separate pit that serves as a mixing chamber. The pH of the water is adjusted by adding a coagulant and metal precipitant. This gives solids and water within the wastewater a positive charge. The pH of the water is then raised, and metals are removed. Finally, a polymer is added to remove solids, which are then dried using a drying drum and disposed of in the dumpster for nonhazardous sludge. The wastewater treatment plant operator controls the speed of the drying drum depending on the quantity of solids to ensure solids are completely dry before being moved to the dumpster. Water dispersed into a tank after oil and solids are removed should pour clear if properly separated. Air is forced into the wastewater during the entire process to aid in separation. Totes of coagulant and precipitant were observed in this area, as well as tanks of alkaline liquid to raise the pH of the wastewater. These containers held product and not waste.

Drying Drum in wastewater treatment plant

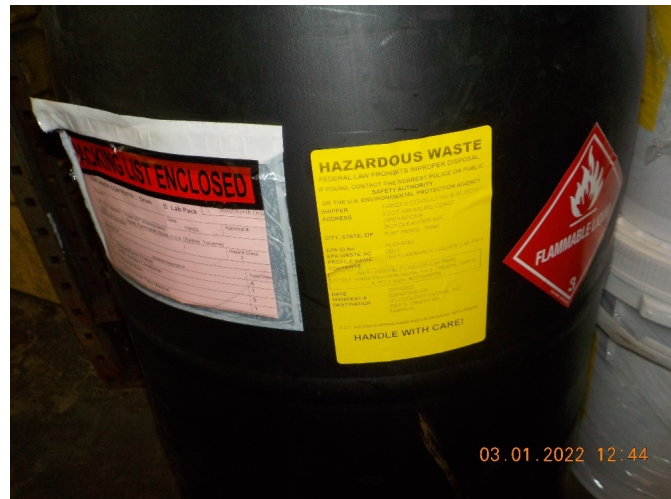
All drums in this area were marked with the Shipper's name, address, and EPAID number, the shipment's manifest tracking number, the designated facility, DOT shipping name, and applicable EPA waste codes and DOT regulated hazardous waste placard. Inspectors also observed a weekly hazardous waste storage log documenting the amount of used xylene generated by the facility stored in this area. Facility representatives informed inspectors that hazardous waste was shipped from this area every Thursday.

## Labeling in Hazardous Waste Storage Area
