**Florida Department of  
Environmental Protection  
Hazardous Waste Inspection Report**

**Facility Name:** Safety-Kleen Systems Inc  
**On-Site Inspection Start Date:** 05/25/2022 **On-Site Inspection End Date:** 05/25/2022  
**ME ID#:** 11672 **EPA ID#:** FLD984171694  
**Facility Street Address:** 8755 NW 95th St, Medley, Florida 33178-1462  
**Contact Mailing Address:** 5610 Alpha Dr, Boynton Beach, Florida 33426-1462  
**County Name:** Miami-Dade **Contact Phone:** (561) 523-4719

## Safety-Kleen Systems Inc Inspection Report

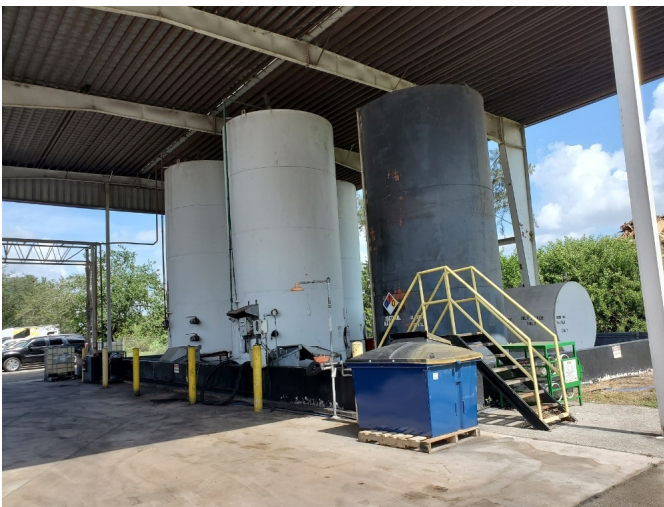
Picture#1

### Tank Storage (Picture#1):

The storage tanks are housed under a covered concrete bunker equipped with a sump and high-level alarm. SK utilizes one 20,000-gallon storage tank for the management of waste solvent under their permit as well as one 15,000-gallon tank and one 20,000-gallon tank for used oil. Oily water is stored in the 10,000-gallon tank in this area and one 20,000-gallon tank holds bulk solvent product. All tanks were observed to be closed, in good condition, and properly labeled. The tank area was equipped with secondary containment, fire extinguishers, and a sprinkler system. Additionally, seven containers holding used oil filters were observed, all seven containers were observed to be closed and properly labeled. Outside the south side of the tank storage building is the tanker truck spill containment area. This is where tanker trucks are loaded/unloaded, or tanker-to-tanker transfer occurs. This area is also equipped with a sump. Facility representatives indicated that each tanker is equipped with a TIF and ChlorDetect dextsil kits, and each load is screened for halogens at the pick-up location.

The facility commingles its used oil and spent antifreeze onsite which is later sent to SK in East Chicago, Illinois, for processing. The facility shall ensure a proper waste determination is conducted on all future spent antifreeze loads before its commingled with used oil to ensure potential hazardous waste is not mixed with used oil.

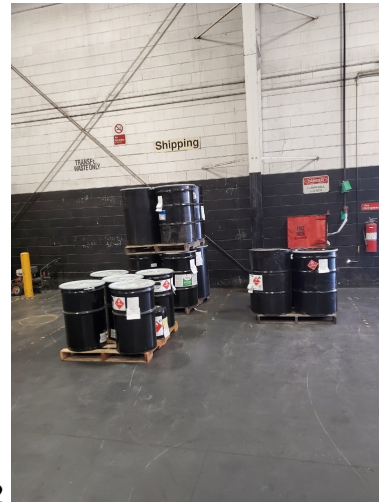
Picture#2

The Department inspector observed the following containers in its 10-day area(Picture#2):

- > Six 55-gallon drums holding spent gasoline and diesel.
- > Four 55-gallon drums holding spent flammable liquids.
- > One 5-gallon drum holding waste paint.
- > Six 55-gallon drums holding absorbent contaminated with oil.

All drums were observed to be closed, properly labeled, placed over the secondary containment, and in-compliance with the 10-day storage limit.
