**Florida Department of  
Environmental Protection  
Hazardous Waste Inspection Report**

**Facility Name:** CEMEX Miami Cement Plant & SCL Quarry  
**On-Site Inspection Start Date:** 06/21/2022 **On-Site Inspection End Date:** 06/21/2022  
**ME ID#:** 27064 **EPA ID#:** FLD981758485  
**Facility Street Address:** 1200 NW 137th Ave, Miami, Florida 33182-1803  
**Contact Mailing Address:** 1200 NW 137th Ave, Miami, Florida 33182-1803  
**County Name:** Miami-Dade **Contact Phone:** (305) 229-2949

Routine Inspection for Used Oil Processor Facility  
Routine Inspection for VSQG (<100 kg/month) Facility

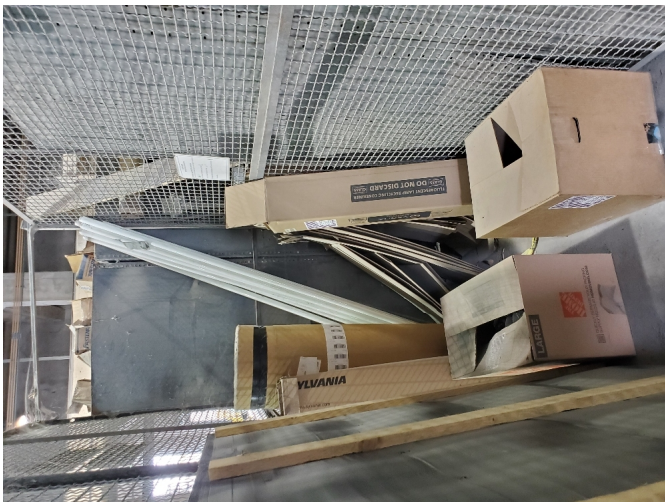
- A pallet of universal waste batteries and electric waste stored in cardboard boxes
- One closed 2 by 3 ft cardboard box of bulbs labeled "Universal waste, Mercury-containing lamps/ bulbs, 03/22"
- One open 4' cardboard box labeled "Universal Waste, 4' fluorescent bulbs, 03/22"
- Thirteen (13) 8' bulbs not in a container.

Type:	Violation
Rule:	273.13(c)(1)
Explanation:	At the time of the inspection, the facility had one 4' box of universal waste lamps that was not closed and thirteen 8' lamps not in a container.
Corrective Action:	Submit photo documentation of all universal waste lamps in closed containers with proper labeling.

Universal Waste Lamps open/ not containerized

Per 40 CFR 273.13(c)(1), a small quantity handler of universal waste must place universal waste mercury-containing equipment in a closed, structurally sound container. Inspectors requested on-site and in the exit interview photo documentation of all universal waste lamps in closed containers with proper universal waste labels.

\*\*Violation Resolved\*\* via submittal of photo documentation on 07/25/2022.

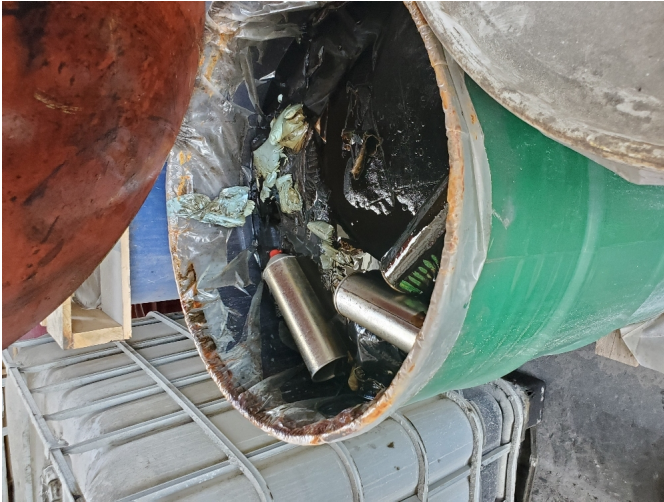
Inspectors observed approximately 60 waste drums on pallets in the middle of the drum building. Wastes stored here included used oil and sand, oily wastes, waste coolants, and waste lubricants. All drums were labeled with their contents, but none contained hazardous waste. At the time of the inspection, the facility had two 55-gallon drums of oily wastes in the drum building missing a label. Inspectors asked facility representatives to open the drums during the inspection, one of which contained used oil, PPE, rags, and two aerosol cans, and the other contained used oil and absorbent rags. Both drums clearly contained free liquid used oil comingled with the other waste materials. Mr. Hogg removed the aerosol cans from the container and disposed of the waste properly using the puncture device. Inspectors requested on-site and in the exit interview that the facility drain the free liquid in the container and ensure all free liquid has been removed from waste shipped as oily waste in

Type:	Violation
Rule:	279.10(c)(1)
Explanation:	At the time of the inspection, inspectors observed a 55-gallon drum of oily wastes that clearly contained free liquid oil material.
Corrective Action:	Remove free liquid from all solid waste contaminated with used oil prior to storage and shipment as oily waste. Submit photo documentation of the liquid and solid waste observed during the inspection separated.

Free liquid and solid waste in drum marked as oily waste

**\*\*Violation Resolved\*\*** via submittal of photo documentation on 07/25/2022.

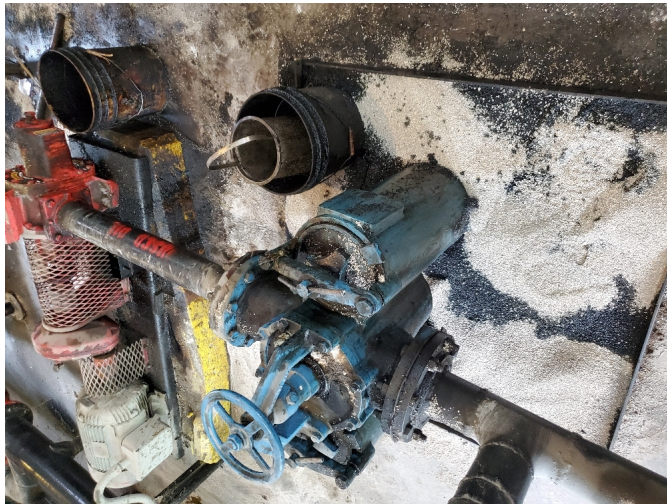
Type:	Violation
Rule:	279.54(d)(2) , 62-710.401(6)
Explanation:	The inspectors observed that the secondary containment of the used oil day tank was covered with dust from cement clinker and cat litter used as an absorbent. The floor pump transfer station in the receiving area was also covered in used oil-contaminated absorbents. It was observed that ¼ of the secondary containment was full of dust or material which could compromise the 110% capacity of the secondary containment. In addition, the facility is required under permit number 56307-006-HO to remove waste and absorbents from secondary containment within 24 hours of detection.
Corrective Action:	Submit photo documentation of the secondary containment in the day tank and receiving area cleaned and free of debris or used oil.

Secondary containment in receiving area covered in absorbents

**\*\*Violation resolved\*\*** via submittal of photo documentation on 07/25/2022.

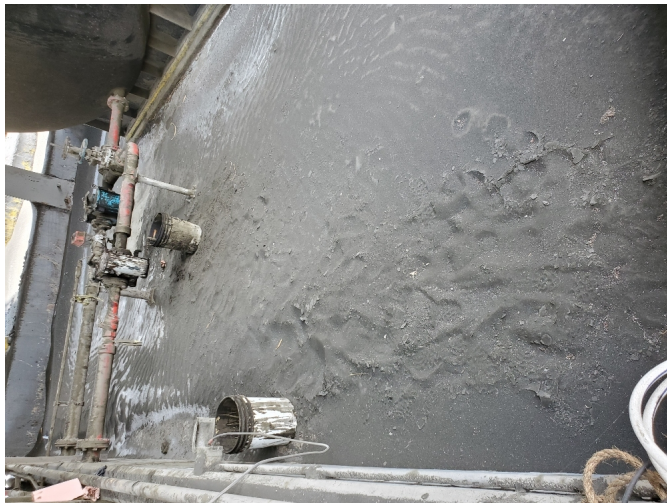
At the time of the inspection, the ground of the secondary containment of the Day Tank was covered in cat litter used as absorbent and dust blown in from the clinker. Mr. Hogg informed inspectors that this area is cleaned out and maintained regularly to manage dust accumulated in this area, and the day tank secondary containment was connected to a closed loop sump for additional containment. Mr. Hogg also informed inspectors that some absorbent is in this area to clean minor spills due to cracked phalanges.

Secondary containment in day tank area covered in clinker dust

Inspectors requested on site and in the exit interview that all dust and absorbent be removed from this area to ensure the secondary containment was at all times able to prevent any used oil released into the containment

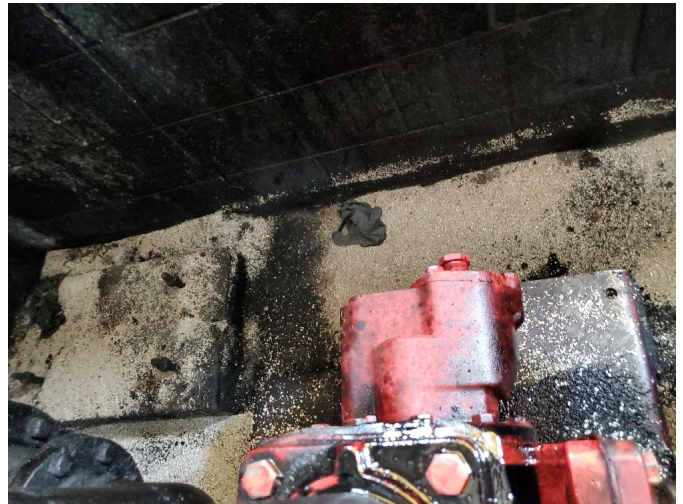
Pump Transfer Station floor covered in absorbents and oil

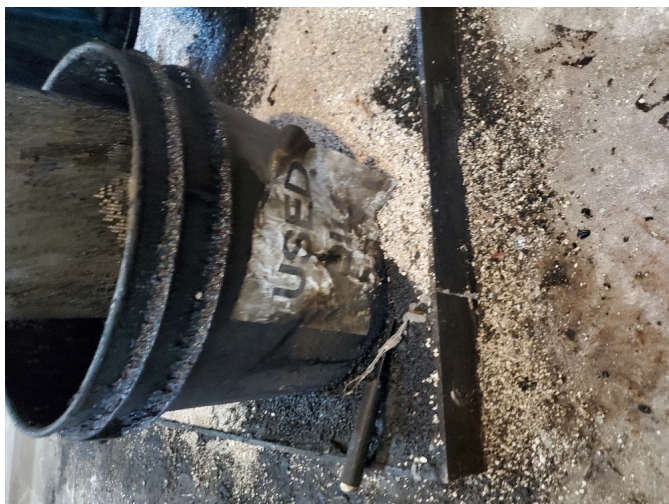
Pumps within the transfer station were spray painted with the words "Used Oil," and some 5-gallon containers were marked with a printed "Used Oil" label and some were not labeled. The printed labels on these drums were covered in oil, ripped, and nearly illegible. The facility was asked on-site and in the exit interview to clearly mark all containers, aboveground tanks, and fill pipes used to transfer used oil with the words "used oil," per 40 CFR 279.54(f)(1) – (2). Inspectors also requested clear labeling on the 5-gallon drums used for leak collection, as these meet the definition of container specified in 40 CFR 279.1. Inspectors also requested during the inspection that all containers of used oil outside should be closed, covered, or otherwise protected from the weather, per 62-710.401(6) F.A.C.

Type:	Violation
Rule:	279.54(f)
Explanation:	At the time of the inspection, some containers and pipes used to store and transfer used oil were not labeled "used oil," and some labels were deteriorated and not clearly marked.
Corrective Action:	Submit photo documentation of all used oil containers, including containers used to collect leaks from the receiving area equipment, properly labeled "used oil."
<b>Comments:</b>	
**Violation Resolved** Via submittal of photo documentation on 07/25/2022.

Deteriorated used oil label in receiving area

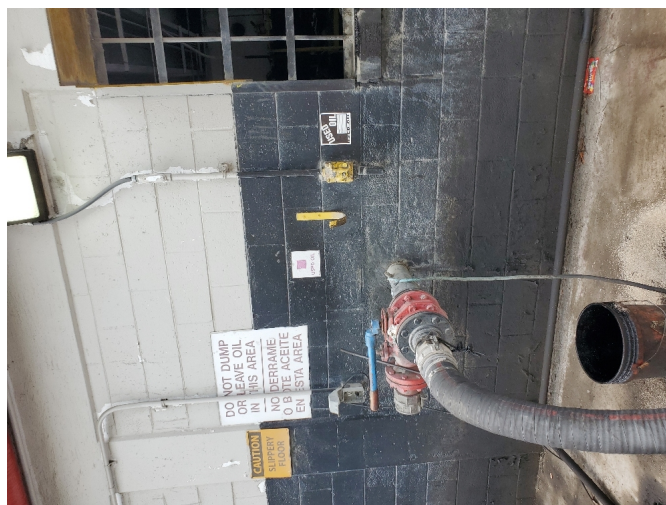
Receiving area container for leaks of used oil not labeled

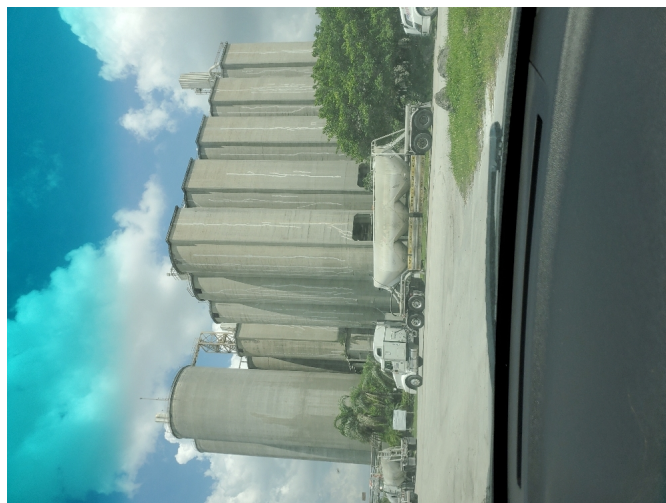
Finished cement is pumped into 22 tall gray cylinders northwest of the pump transfer station. Cement is then dispensed into fill trucks for bulk transportation or moved to the packing facility adjacent to the silos for packaging into cement bags to be sold in stores. Operators control the loading area inside the silos. Different silos hold different grades of cement. This area has three active bays, numbered 3, 4, and 5, while the other bays are not in use.

Cement Silos

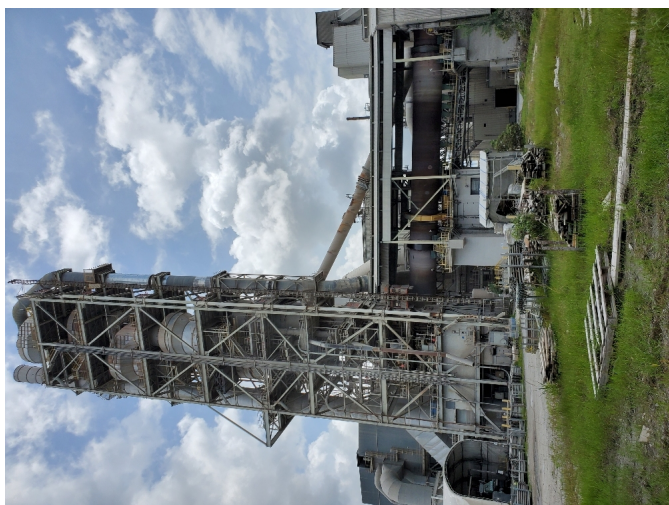
Residence time in the entire kiln process takes about seven hours from start to finish. The facility is authorized to process 4,500 tons of clinker per day, but typically uses around 3,000 tons per day. The cement is gradually produced in five stages of varying temperatures and reactions. The calcination process takes place within the kiln itself in a gray cylinder at the bottom of the kiln tower. There is a fuel injection area on each side and the cement product spins, rolls downhill, and is crushed again. Material is quickly cooled to 300° F after kiln. Inspectors observed a 55-gallon drum used for grease collection in this area. An open pipe from the kiln was actively dripping grease used as lubrication in the kiln process into this drum. This grease is managed as used oil.

Kiln tower

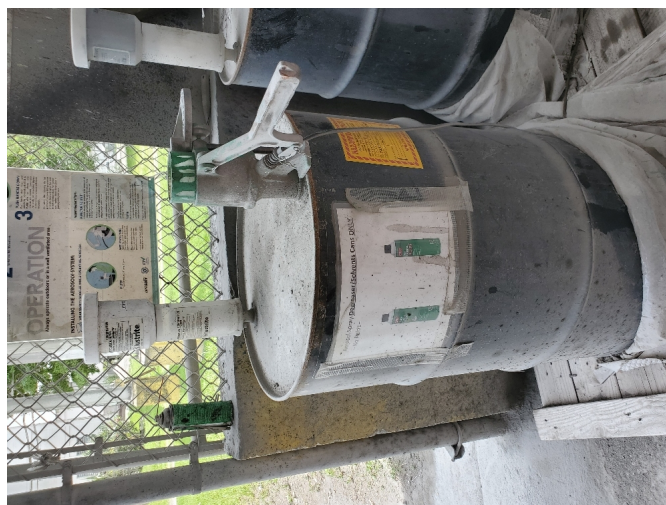
Aerosol puncture device

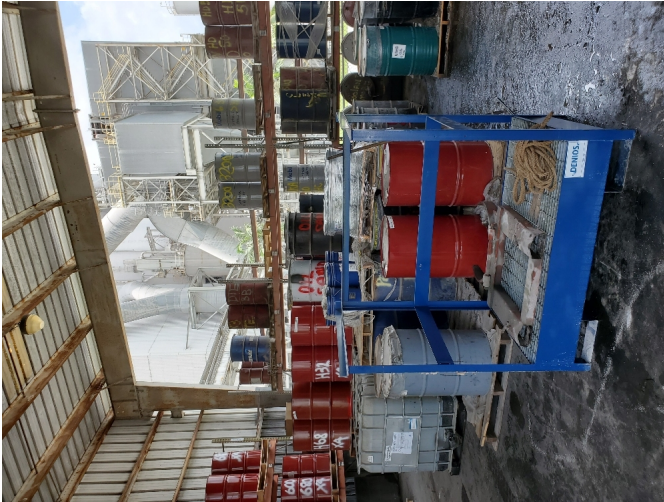
The drum building of the facility is used for the storage of hazardous waste and used oil. Inspectors observed 22 pallets holding four 55-gallon drums each on shelves three rows high along the left wall of the drum building. These drums contained new oil for facility use. The puncture devices for aerosol can waste generated at the facility were also stored in this area attached to two 55-gallon drums marked with hazardous waste labels. Aerosol cans are punctured, the liquid drained into the drums, and the metal cans are placed in a plastic bag near the drums to be recycled. Inspectors observed facility representatives properly puncture and dispose of waste from aerosol cans found in the day tank area during the inspection.

Drum Building

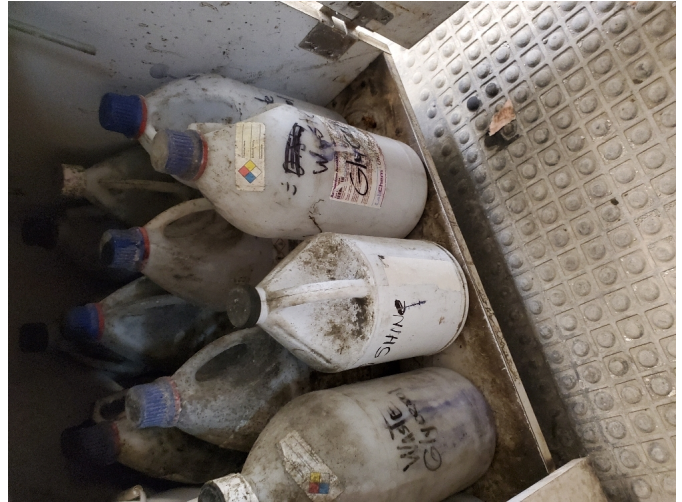
The quality control (QC) laboratory conducts quality control testing for cement products produced at CEMEX. Operations conducted in the QC laboratory include free line testing on cement and clinker using ammonium acetate to titrate using glycerol solution. Hazardous waste generated in this area is exclusively waste glycerol from free line testing. CEMEX operates as a Very Small Quantity Generator based on the quantity of waste generated in the QC laboratory and the hazardous waste generated from puncturing waste aerosol cans. Waste is accumulated in 1-gallon satellite containers labeled "waste glycerol." All containers observed in the lab were compliant with Federal and state regulations for VSQGs. Following the inspection, inspectors requested the waste profile for QC laboratory glycerol waste from Safety-Kleen. Based on the amount of waste observed on-site, the facility operates as a Very Small Quantity Generator of Hazardous Waste.

Waste in QC laboratory
