Re: Compliance Assistance Offer
Ring Power Corporation (Gainesville)
EPA/DEP ID: FLD982150237
Alachua County – Hazardous Waste

**Florida Department of
Environmental Protection
Hazardous Waste Inspection Report**

Facility Name: Ring Power Corporation
On-Site Inspection Start Date: 05/31/2022 **On-Site Inspection End Date:** 05/31/2022
ME ID#: 15436 **EPA ID#:** FLD982150237
Facility Street Address: 4900 N Main St , Gainesville, Florida 32609-1407
Contact Mailing Address: 500 World Commerce Parkway, St Augustine, Florida 32092
County Name: Alachua **Contact Phone:** (904) 494-7445

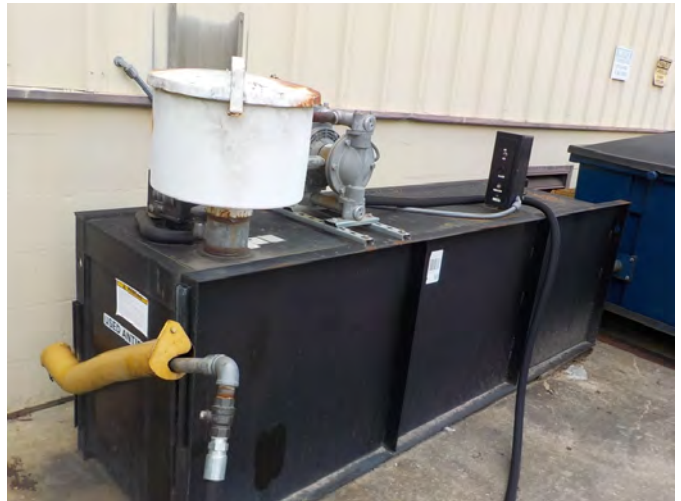
Photo 4

General maintenance is performed on a variety of vehicles in the 7-bay Service Shop. Used oil, used oil filters and used antifreeze are generated by the facility's operations and sent off-site for recycling. Used oil is drained into portable drain containers and then pumped into a 1,000-gallon double-walled tank located outside of the Service Shop (Photo 1). There was one 5-gallon drain container that contained used oil that was not properly labeled as "Used Oil" (Photo 2) [40 CFR 279.22(c)(1)]. The container was properly labeled at the time of inspection. The used oil tank was properly labeled, in good condition and closed. Used oil filters are drained into portable drain containers before being accumulated in a 330-gallon steel container located outside of the Service Shop. The container was in good condition, closed and properly labeled, but was not located on an oil impermeable surface (Photo 3) [62-710.850(5)(a)]. Used antifreeze is drained into portable drain containers and then transferred into a 250-gallon double-walled tank located outside the Service Shop (Photo 4). The tank was closed and properly labeled.

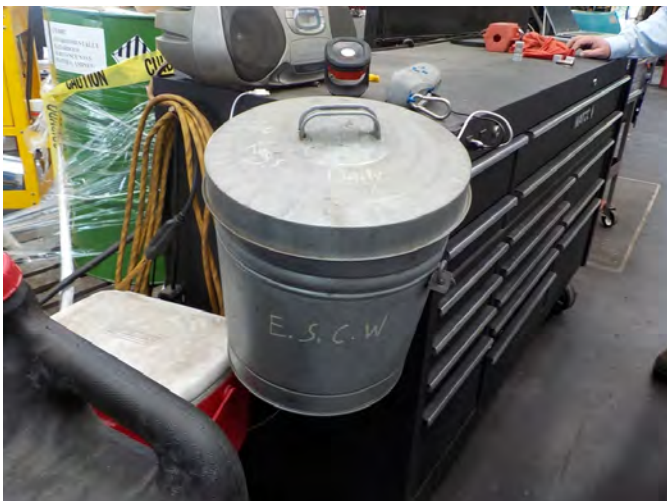
Photo 5

Rags are generated by maintenance activities and may be contaminated with oil, grease, Brakleen Brake Parts Cleaner – Non-Chlorinated (Brakleen) (methanol 40-50%, toluene 10-20%, acetone 5-15%, ethylbenzene <0.2%), PB Penetrating Catalyst (PB) or WD-40. Rags are managed as Excluded Solvent Contaminated Wipes and laundered by Cintas weekly. There was one container of wipes that was not properly labeled as "Excluded Solvent Contaminated Wipes" (Photo 5) [40 CFR 261.4(a)(26)(i)]. The container was properly labeled at the time of inspection.

Type:	Violation
Rule:	261.4(a)(26)(i)
Explanation:	Service Shop: There was one container of excluded solvent contaminated wipes that was not properly labeled as "Excluded Solvent Contaminated Wipes."
Corrective Action:	No further action is required. The facility returned to compliance by properly labeling the container at the time of inspection.
Type:	Violation
Rule:	279.22(c)(1)
Explanation:	Service Shop: There was one container of used oil that was not properly labeled as "Used Oil."
Corrective Action:	No further action is required. The facility returned to compliance by properly labeling the container at the time of inspection.
Type:	Violation
Rule:	279.22(d)(3)
Explanation:	Yard: There were two areas of soil/gravel that were stained with what appeared to be hydraulic oil that had not been properly cleaned up.
Corrective Action:	In order to return to compliance, the facility should properly clean up the stained areas and properly dispose of the impacted soil/gravel and any clean-up materials.

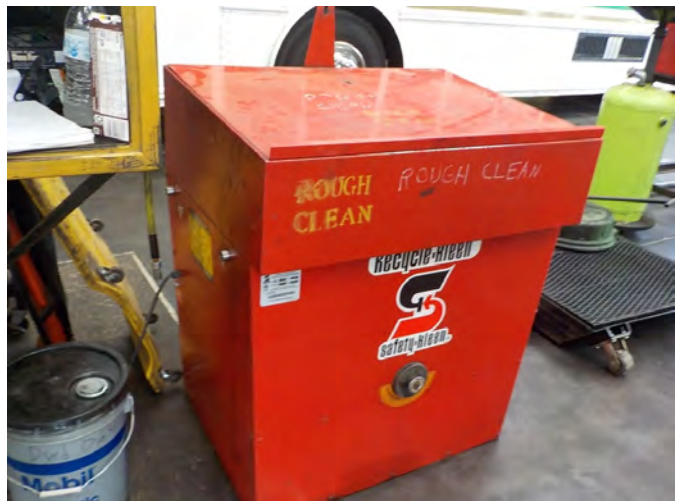
Photo 6

The facility operates three Safety-Kleen System One parts washers that use Safety-Kleen Premium Solvent (flashpoint 148° F) (Photo 6). The units distill the spent solvent within the unit and pump clean solvent into the basin. The units are on a 16-week service with Safety-Kleen to add clean solvent as needed. The sludge is collected and disposed of as D006/D007/D008 hazardous waste as needed. The last shipment was in 2012. The facility is reminded that additional waste codes may apply.

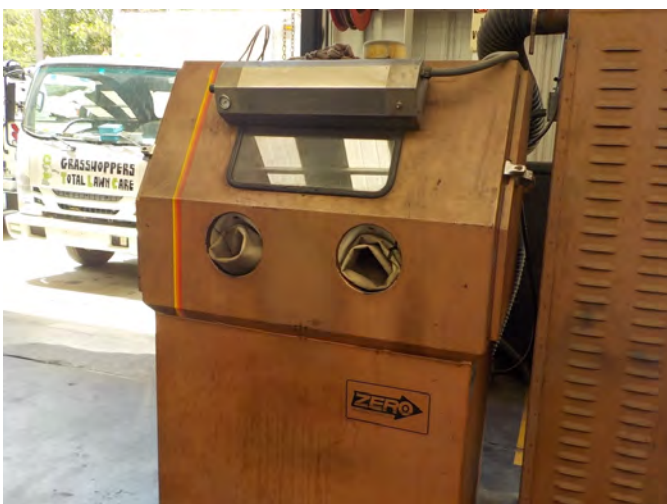
Photo 7

The facility operates one glove box bead blasting machine with a dust collector which is used to blast bare engine parts (Photo 7). Painted parts are sent to another Ring Power facility for blasting. Caterpillar Glass Beads 9U-5271 are used as the media. Mr. Morris stated that the spent blasting media has not been disposed of in at least 10 years, as the machine is rarely used. The dust collector does not appear to generate a spent media waste stream. TCLP analysis conducted in 2018 indicated the blast media was not hazardous at that time. The facility is reminded that if the process or materials used in the process changes, additional analysis may be required. The facility is also reminded to conduct a hazardous waste determination on the dust collector

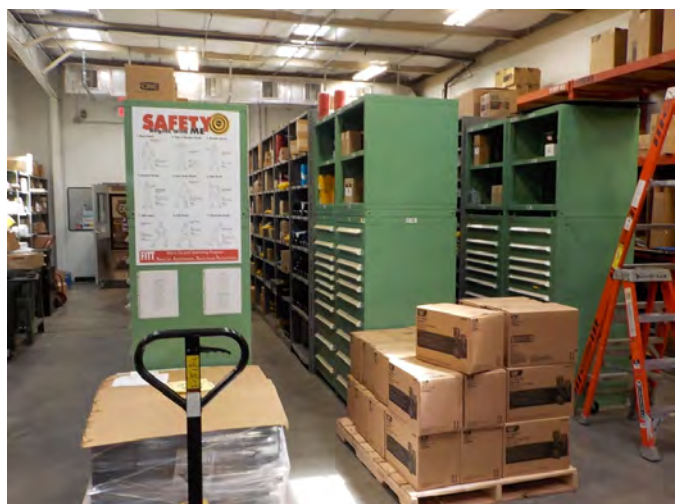
Photo 8

There is a Parts Warehouse located adjacent to the Service Shop (Photo 8). Parts Warehouse operations generate Excluded Solvent Contaminated Wipes. There was one closed, properly labeled container for the accumulation of wipes observed. Spent lead acid batteries generated by maintenance activities are stored on a secondary containment pallet outside of the Parts Warehouse. Batteries are sent back to Caterpillar for recycling by East Penn Manufacturing. Fluorescent bulbs are changed out and disposed of by the St. Augustine Ring Power facility.

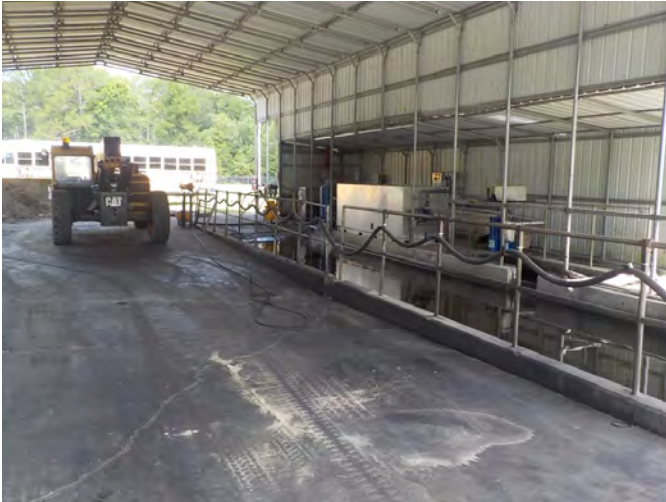
Photo 9

The Wash Rack is a covered, closed-loop system used to wash equipment potentially contaminated with oil prior to service with heated and/or pressurized water (Photo 9). Approximately one machine is washed per week. Wash water drains to a collection pit. The oil skimmer referenced in the previous inspection report is no longer utilized. Wash water is pumped from the pit to a biological filtration system that was installed approximately two years ago. TA-10X Defoamer and 55FSHCLF Bio-Treat are used in conjunction with filters in the filtration system. The facility has yet to dispose of the filters, but is reminded to conduct a hazardous waste determination on the filters prior to disposal. Filtered water is discharged back to the pit. Dirt that does not drain to the pit is accumulated with sludge/dirt cleaned out of the pit approximately every 2-3 years on a portion of the concrete pad of the Wash Rack that is enclosed by an "L" shaped concrete wall. TCLP metal and volatile analysis has indicated that the sludge/dirt is non-hazardous and is transported to a solid waste landfill as needed.
