Re: Compliance Assistance Offer
Water Recovery, LLC.
EPA/DEP ID: FLR 000 069 062
Duval County – Hazardous Waste

**Florida Department of
Environmental Protection
Hazardous Waste Inspection Report**

Facility Name: Water Recovery LLC
On-Site Inspection Start Date: 09/06/2022 **On-Site Inspection End Date:** 09/06/2022
ME ID#: 36081 **EPA ID#:** FLR000069062
Facility Street Address: 1819 Albert St , Jacksonville, Florida 32202-1103
Contact Mailing Address: 1819 Albert St, Jacksonville, Florida 32202
County Name: Duval **Contact Phone:** (904) 475-9320

Water Recovery LLC Inspection Report

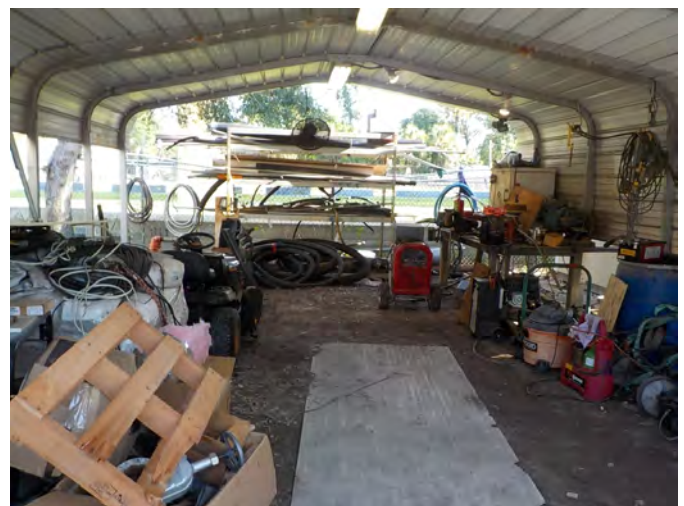
Photo 2

The Dry Storage Area is a roofed structure where equipment is stored and light maintenance work is performed (Photo 2). Aerosol cans of WD-40 are routinely used by maintenance staff directly on equipment. Electra Coat (xylenes 15-40%, hexane 15-40%, petroleum gases 15-40%, styrene butadiene polymer 10-30%; flashpoint - 136°F), CRC Lectra Clean (tetrachloroethylene 90-100%) and CRC Disc Brake Quiet were observed during the inspection and may be occasionally sprayed directly on equipment. Products are not used with wipes. Aerosol cans are punctured and the liquid is drained into a 55-gallon drum (Photo 3). Empty cans are disposed of as scrap metal. The drum was less than 25% full. Aerosol can liquid waste has yet to be disposed of. Liquid generated from puncturing and draining non-empty aerosol cans of Electra Coat generates a D001 hazardous waste and liquid generated from puncturing and draining non-empty aerosol cans of Electra Coat generates a U210 hazardous waste. Aerosol cans of WD-40 and Disc Brake Quiet generate non-hazardous liquid wastes when punctured and drained. The facility is reminded to perform a hazardous waste determination on any additional non-empty aerosol cans that may be used on a non-routine basis, as well as on any rag used with solvents or aerosol products.

Type:	Violation
Rule:	273.15(a)
Explanation:	Dry Storage Area: There were 12 spent lamps that had been accumulating for more than one year.
Corrective Action:	No further action is required. The facility returned to compliance via a September 22, 2022 email.
<hr/>	
Type:	Violation
Rule:	62-710.510(1)(b)
Explanation:	The facility did not document the generator EPA ID number on one used oil transportation shipping paper.
Corrective Action:	In order to return to compliance, the facility should re-train employees in the proper

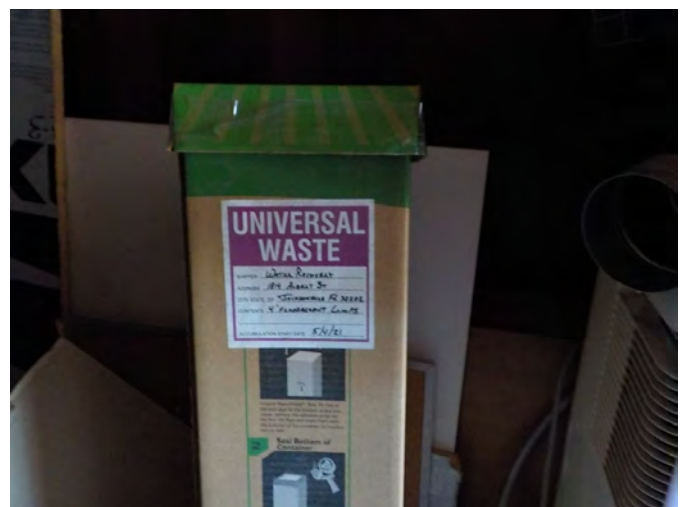
Photo 4

Adjacent to the Dry Storage Area are two shipping containers used for storage. Spent fluorescent lamps generated by maintenance staff replacing facility lamps are stored in one of the shipping containers. There were 12 spent lamps that had been accumulating since May 4, 2021 [40 CFR 273.15(a)] (Photo 4). Spent lamps are transported to WR's parent company, Moran Environmental Recovery, for management as universal waste. The facility is reminded that a person only collecting spent lamps from generators of 10 or less spent lamps per month and who does not accumulate more than 100 kg of lamps at one time, is not required to register with the Department, as specified in 62-737.400, FAC. Those not meeting these requirements may be required to register. In addition, trucks used for transport of spent lamps should comply with Department of Transportation requirements, be totally enclosed and in good condition and have emergency cleanup and containment procedures in the vehicle. Emergency procedures should also be maintained at the handler or transporter facility.

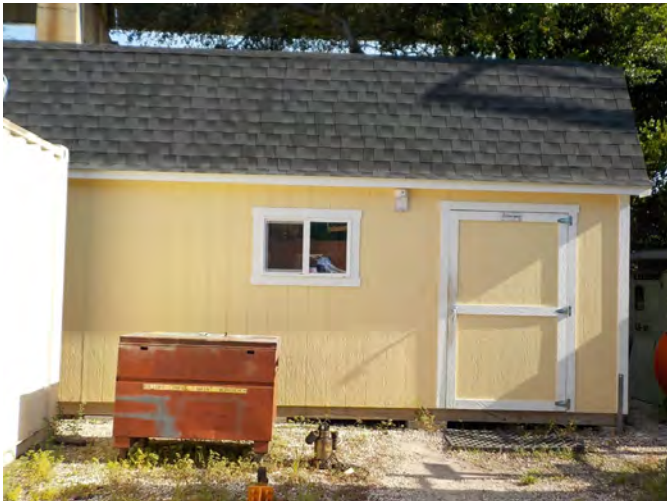
Photo 5

The Maintenance Shed, located west of the Used Oil Processing Area, is a small shed where tools and miscellaneous equipment are stored (Photo 5). The previous trailer was replaced with a wooden shed. This area does not accumulate or generate any hazardous waste. There is no longer a sink inside the Maintenance Shed.

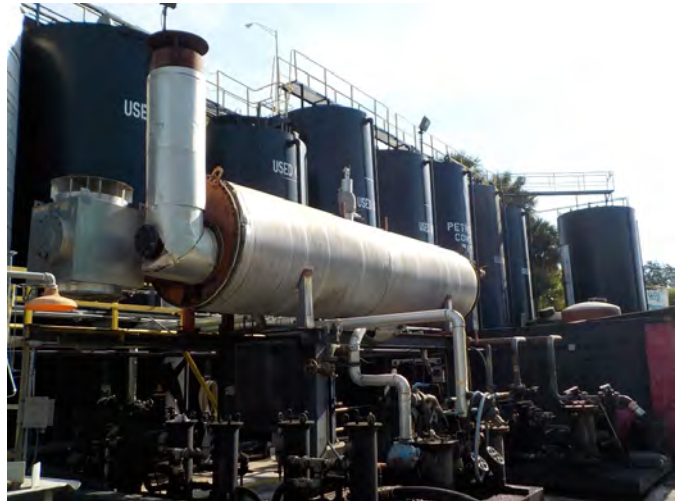
Photo 6

The facility receives shipments of used oil and PCW in drums, totes or tanker trucks. The Used Oil Processing Area includes Tanks 1P-3P (23,232-gallons each, used oil), Tank 4P (21,445-gallons, used oil), Tank 5P (20,778-gallons, used oil), Tank 6P (25,806-gallons, used oil), Tank 7P (21,446-gallons, Petroleum Contact Water (PCW)), Tank 8P (21,446-gallons, industrial wastewater/petroleum products), Tank 9P (20,833-gallons, industrial wastewater/petroleum products), Tank 10P (10,000-gallons, PCW), Tank 11P (500-gallons, used oil), Tank 1SW (30,000-gallons, stormwater) and a heater. Tanks 1P -10P and SW1 are located on the north side of the facility and are primarily painted black (Photo 6). Tank 11P is located on the south side of the facility and is associated with an oil-water separator.

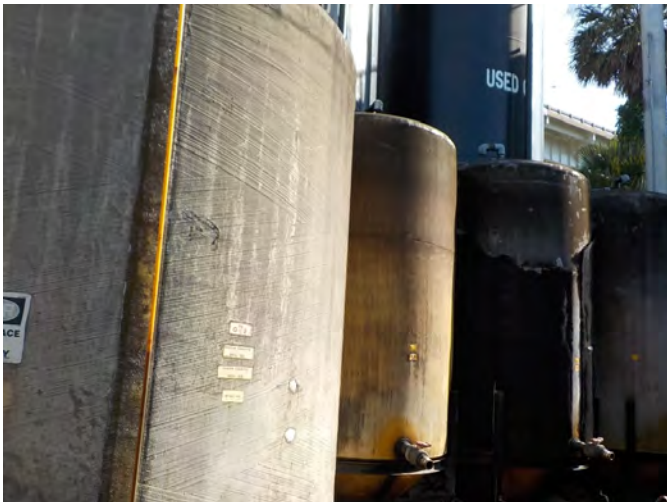
Photo 7

In addition to the permitted tanks described above, there are three 1,200-gallon portable tanks labeled B1, B2 and B3 and a 4,000-gallon portable tank labeled G2 (Photo 7). B1, B2 and B3 are used to offload small containers of industrial wastewater, such as totes, since the larger tanks are not designed for such small loads. G2 is used to offload industrial wastewater when batch tanks are full. The portable tanks were located south of the black side tanks and north of the tote storage area. It was determined by Department permitting staff that these tanks did not need to be incorporated into the permit. The small tank adjacent to the tote storage area contains product fuel for plant use.

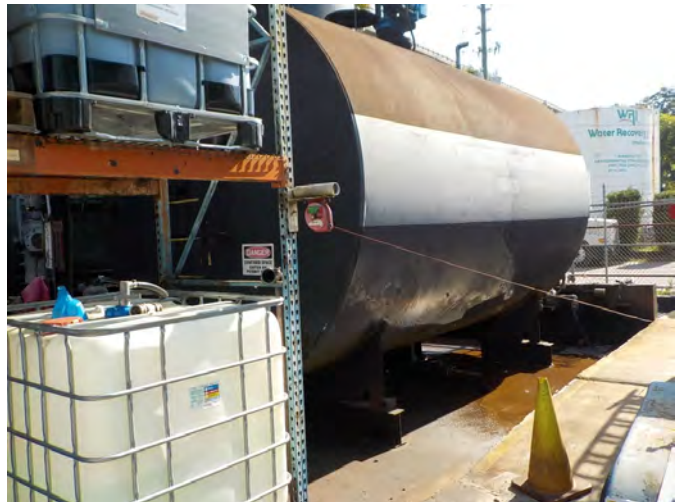
Photo 8

PCW is recovered by stationary separation and accumulated in Tank 7P and now 10P (Photo 8). Decanted wastewater and debris are piped to the green side wastewater treatment tanks for further treatment. The facility analyzes the PCW solids for metal, volatile and semi-volatile Toxicity Characteristic Leaching Procedure (TCLP) constituents each time solids are removed from the tanks. Previous results have indicated the waste is non-hazardous, however, results obtained April 30, 2019, indicated the waste was a D018 hazardous waste and was managed as an episodic event. The facility is reminded that notification must be provided within 72-hours of unplanned episodic events or no later than 30 days prior to planned episodic events. In addition, a tank cleanout is typically an event that would be anticipated and should be considered a planned episodic event. Solids have not been removed from the tanks since 2019.

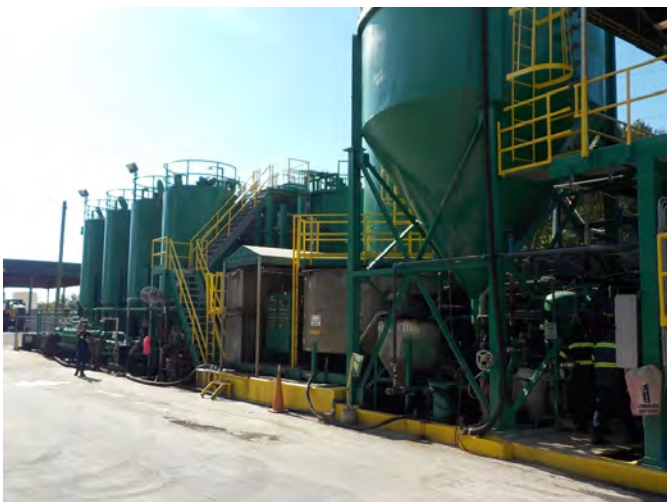
Photo 9

The Wastewater Processing Area is a tank farm of eleven green-painted cone-bottom batch tanks and a plate-and-frame filter press (Photo 9). The main green tank farm is numbered 1-W to 9-W, and is aligned in consecutive order tank pairs, 1-W/2-W, 3-W/4-W, 5-W/6-W, 7-W/8-W, with 9-W closest to the main office. The discharge and equalization tanks are adjacent to the plate-and-frame filter press. The estimated capacities for the tanks are as follows: 1-W to 9-W, 7,000 gallons each; discharge and equalization (EQ) tanks, 50,000 gallons each. The green tank system is a unilaterally interconnected loop.

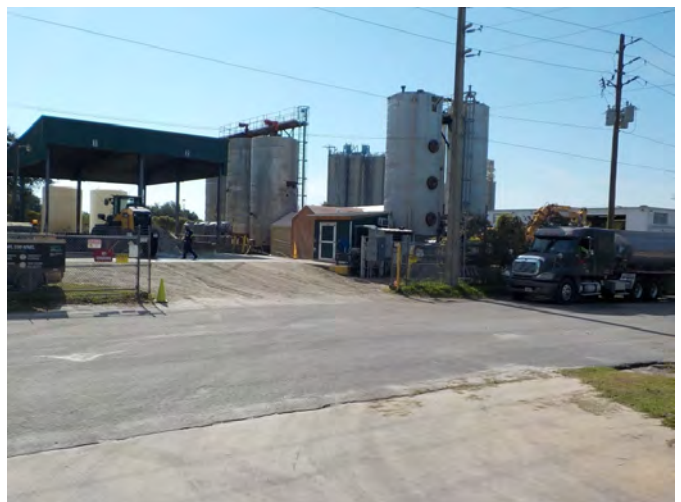
Photo 10

A large, two-pit Solid Waste Solidification Area is also located across Bryan Street (Photo 10). The pits are used

to solidify other facility's non-hazardous waste streams. Trucks which contained non-hazardous waste may be washed out directly into the pits. In addition, WR process wastes, including the wastewater filter cake, oily rags/absorbents and stormwater from the East Bryan Street side secondary containment are also added to the pits. TCLP analysis for each solidification media has indicated that the media are non-hazardous. A small bucket loader is used to mix up the solid, non-hazardous waste before being sent off-site for disposal to Chesser Island Landfill. Approximately 20 tons of waste is transported approximately daily.

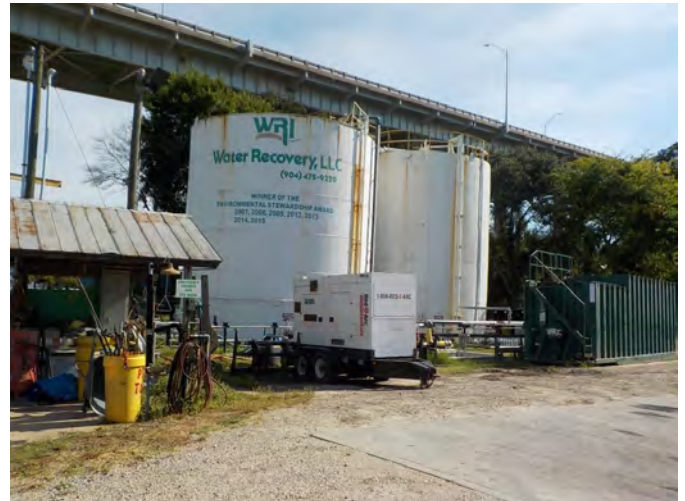
Photo 12

There are two landfill leachate wastewater tanks located north of the Solid Waste Solidification Area (Photo 12) in addition to two 5,000-gallon tanks and one 12,000-gallon tank located south of the Solid Waste Solidification Area. The tanks receive tanker trucks of leachate from Nassau County Landfill, Otis Road Landfill or Lake County Landfill. Recovered leachate wastewater is stored in tanks and then discharged under the facility's JEA Industrial User Discharge Permit, typically without treatment. If treatment is required due to nitrogen levels, aeration of the wastewater is performed until acceptable nitrogen levels are achieved. The facility, however, is in the process of installing a new treatment system for the leachate.
