**SUBJECT: Department of Environmental Protection v. New Millennium Building Systems, LLC**  
**OGC File No.: 21-0974**  
**EPA/DEP ID: FLR000121624**

**RE: Warning Letter No. WL21-200 (Significant Non-Complier)  
New Millennium Building Systems  
EPA/DEP ID: FLR 000 121 624  
Columbia County – Hazardous Waste**

**Florida Department of  
Environmental Protection  
Hazardous Waste Inspection Report**

# New Millennium Building Systems Inspection Report

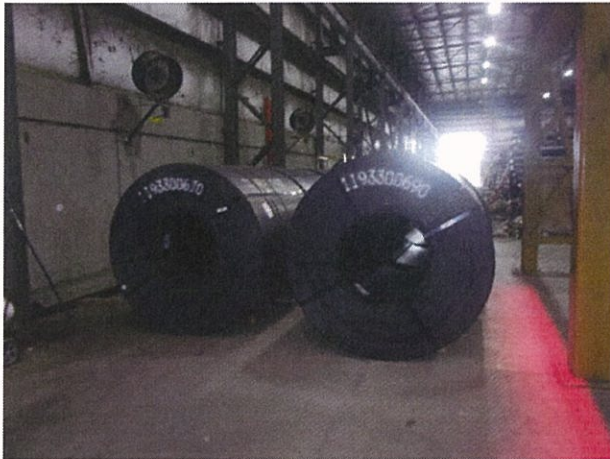
Photo 1

-----  
The Deck Plant manufactures steel corrugated deck paneling. Coils (Photo 1), or rolls of flat, steel sheets, are delivered to the facility via truck or rail from steel mills throughout the country. These rolls may be treated with a rust inhibitor that may contain chromium prior to transport. Prior to use, the steel coils go through a washing

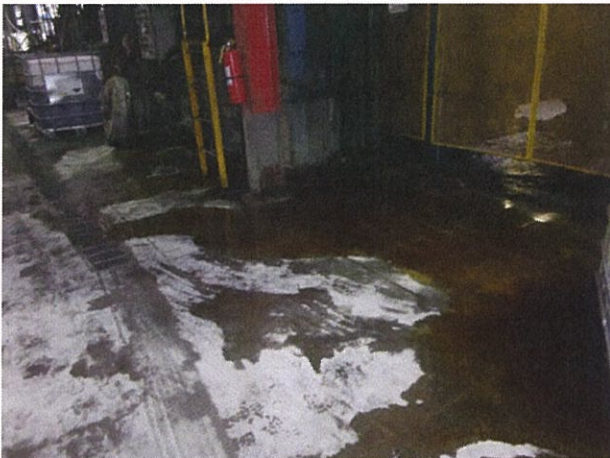
Photo 3

At the time of inspection there was a significant quantity of washwater and sludge on the floor around the pre-wash tank (Photos 3 and 4) [40 CFR 262.251]. The facility representative stated that the pre-wash tank was leaking in an area of the tank where a catch pan could not be used to contain the leak. The washwater that leaks from the tank drains to a trench drain which drains to a sump that is pumped into the 6,000-gallon accumulation tank, described below. Staff squeegeed the wastewater into the trench at the time of inspection, but because the tank was leaking, it was expected to accumulate again.

Following the inspection, the facility analyzed a sample of liquid from the pre-wash tank and sludge from the floor in the area around the pre-wash tank. Based on the results, it appears that the leaked washwater and sludge around the pre-wash tank were non-hazardous wastes. However, the facility is reminded that the characterization of these wastestreams may change with continued use of the pre-wash tank. The facility representative stated that the tank was expected to be replaced by the end of September 2021.

Explanation: Deck Plant: There was wastewater and sludge on the floor in the area around the pre-treatment tanks caused by a leak in the pre-treatment tank. Although analysis indicated the waste was non-hazardous at the time of inspection, the pre-treatment tank has the potential to generate a hazardous wastewater.

Corrective Action: In order to return to compliance, the facility should repair the leak to ensure hazardous waste is properly containerized at all times.

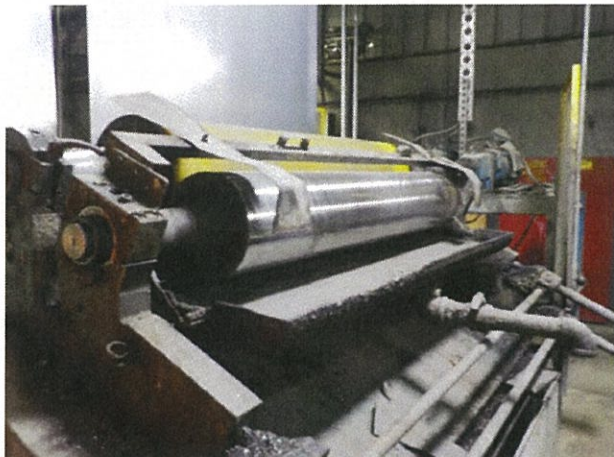
Photo 7

Following washing, the steel continues automatic feeding into the "Chem Coater" (Photo 7). The Chem Coater applies Bulk Bond NP250 (chromium chromate 6.8-15%, chromic acid 1.28-2.1%; pH 2.4), a rust inhibitor, to the steel. The NP250 is poured into trays and applied by an automatic roller system. Excess product left in the tray at the end of the day is pumped to a drum for reuse. The coating build-up must be removed from the Chem Coater as needed. The facility representative stated the coating would be scraped off and placed into the 55-gallon satellite accumulation drum, described below, for management as D007 hazardous waste. The Chem Coater feeds the steel to an oven for drying.

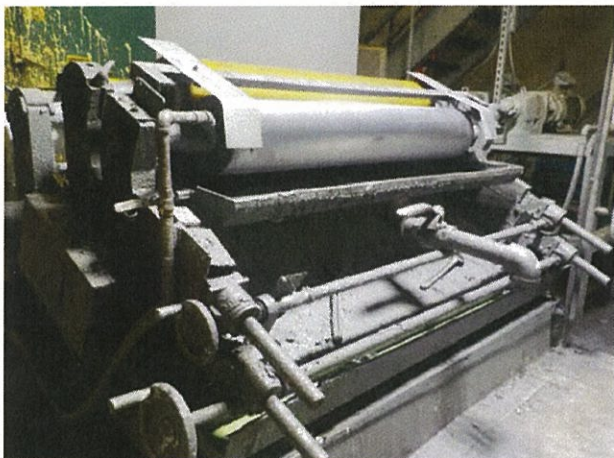
Photo 9

The steel also receives a final coat of Armorhide WC White Deck or Armorhide WC Gray Deck in the "Finish Coater" (Photo 9). The paint is applied via a similar tray/roller system as described above. Galvanized steel is coated with Bulk RP-9100 (ammonium dichromate 2.1-5.8%) in lieu of paint in this machine. Excess product left in the tray at the end of the day is pumped to a drum for reuse. Paint is scraped off the Finish Coater as needed and placed into the 55-gallon satellite accumulation drum, described below, for management as D007 hazardous waste. The Finish Coater feeds the steel to another oven for drying and then to a quench tank for cooling. Water from this quench tank is also pumped to the 9,000-gallon water tank, described above, for reuse.

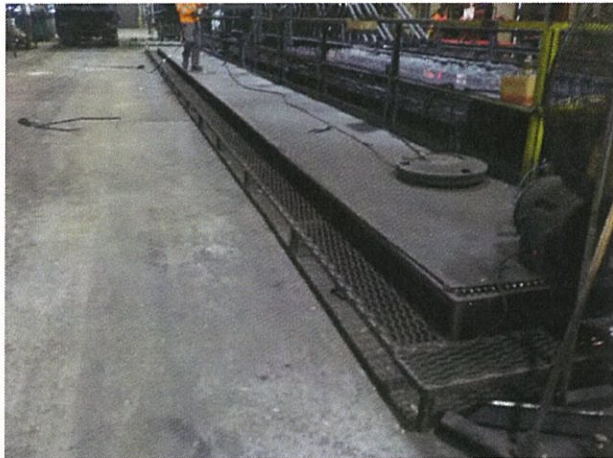
Photo 15

tank (Photo 15). The primer is used continuously and 15-C-198B Reducer (flashpoint 201.2°F) and the associated additive, Armorhide 50/50 Ammonia Additive may be added to thin the primer. Rope is placed between the steel sections to allow the paint to seep in. Excess primer is allowed to drip off the joists back into the dip tank. Most additional drips are captured by disposable mats which are placed into the "Special Waste" roll-off dumpster, described below. Moran Environmental Recovery is contracted to drain the dip tank and chisel the solid paint waste from the tank approximately annually. The solid paint material is placed into the "Special Waste" roll-off dumpster, described below. There is also a smaller dip tank used for smaller parts that attach to the joists (Photo 16). The same materials and process described above are used.

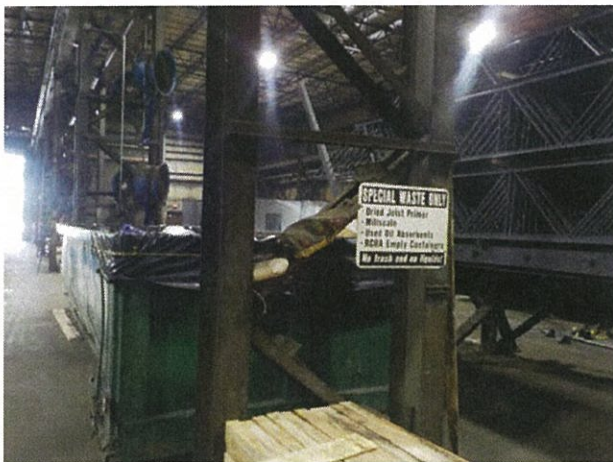
Photo 17

There is a "Special Waste" roll-off dumpster located at the rear of the Joist Plant (Photo 17). The dumpster is used for the accumulation of dried joist coatings, mill scale sludge, used oil absorbents and RCRA-empty containers and is disposed of at Winfield Landfill, located in Lake City, Florida, which is a Class I and Class III solid waste landfill.

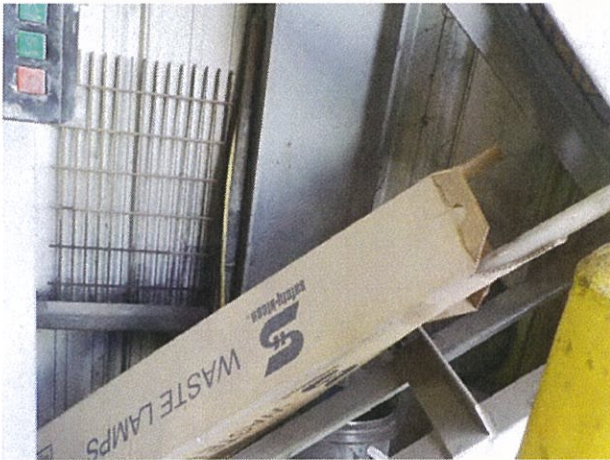
Photo 21

Bulbs may be changed throughout the facility by maintenance personnel. There was one box containing four spent bulbs accumulating at the time of inspection (Photo 21). The box was not closed [40 CFR 273.13(d)(1)].
