**RE: Warning Letter No. WL22-131 (Significant Non-Complier)**  
**Ring Power Corporation**  
**EPA/DEP ID: FLR 000 119 347**  
**St. Johns County – Hazardous Waste**

**Florida Department of  
Environmental Protection  
Hazardous Waste Inspection Report**

## Ring Power Corp Inspection Report

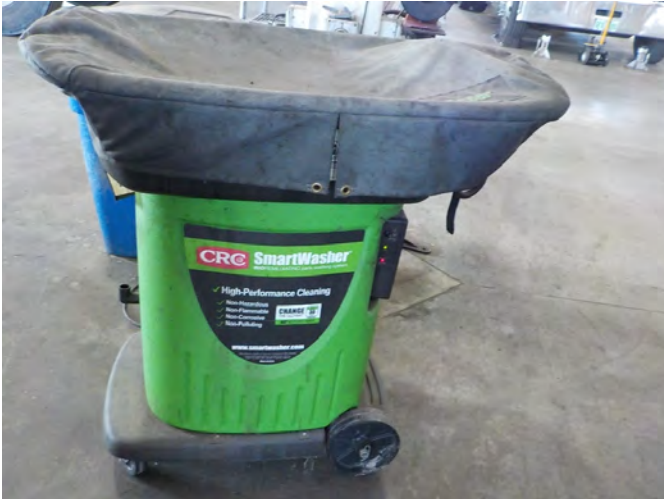
Photo 3

Since the previous inspection, the facility installed a CRC SmartWasher in the Truck Shop (Photo 3). The parts washer uses Ozzy Juice (flashpoint 148°F). Ozzy Juice is designed to be a self-cleaning solution and is therefore not typically disposed of. The facility is reminded that a hazardous waste determination should be conducted prior to disposal of the spent solvent, if ever required. Ozzy Juice parts washers are also equipped with an Ozzy Mat. The Ozzy Mat traps large particles of grease and oil cleaned off dirty parts, as well as any particulate matter. The facility representative stated that the Ozzy Mats are disposed of as non-hazardous waste approximately once per month, but the facility had not conducted an adequate hazardous waste determination to support this action at the time of inspection [40 CFR 262.11]. Subsequent to the inspection, the facility provided analytical data for an Ozzy Mat sample collected on March 14, 2022, which indicated that spent Ozzy Mats are a D008 hazardous waste [40 CFR 262.20(a)(1)].

| Corrective Action: | <ol style="list-style-type: none"><li>1. Truck Shop - Smartwasher spent Ozzy Mats<br/>No further action is required. The facility returned to compliance via an email dated May 6, 2022.</li><li>2. MCRC Engine Tear Down Area - Tank 1 sludge<br/>In order to return to compliance, the facility should perform and fully document a hazardous waste determination prior to disposal by having a representative sample of the sludge analyzed by a Florida certified laboratory for the following:<br/>TCLP for:<br/>RCRA metals, pursuant to 40 CFR 261.24, via method 6010.</li><li>3. MCRC Engine Tear Down Area - Torrent 500 parts washer spent solvent<br/>The facility provided analytical data on May 6, 2022, indicating that the spent solvent was not ignitable and did not contain RCRA metal or volatile constituents above the TCLP regulatory limits. However, the chain-of custody did not indicate that the volatile sample had been properly preserved at 4-6 degrees F. In order to return to compliance, the facility should either provide documentation from the lab that the sample was held at the proper temperature or conduct a TCLP for RCRA volatiles, pursuant to 40 CFR 261.24, via method 8260 ensuring the proper holding temperature are maintained and documented.</li><li>4. MCRC Engine Tear Down Area - Torrent 500 parts washer spent filters<br/>In order to return to compliance, the facility should perform and fully document a hazardous waste determination prior to disposal by having a representative sample of the filters analyzed by a Florida certified laboratory for the following:<br/>TCLP for:<br/>RCRA metals, pursuant to 40 CFR 261.24, via method 6010.</li><li>5. Blasting and Painting Shop - Tape contaminated with Hempel Acrylithane 2.8<br/>No further action is required. The facility returned to compliance via an email dated May 6, 2022.</li><li>6. Blasting and Painting Shop - Paint booth filters contaminated with Hempel Acrylithane 2.8<br/>No further action is required. The facility returned to compliance via an email dated May 6, 2022.</li><li>7. Blasting and Painting Shop -Distillation bottoms generated by solvent recovery process</li></ol> |

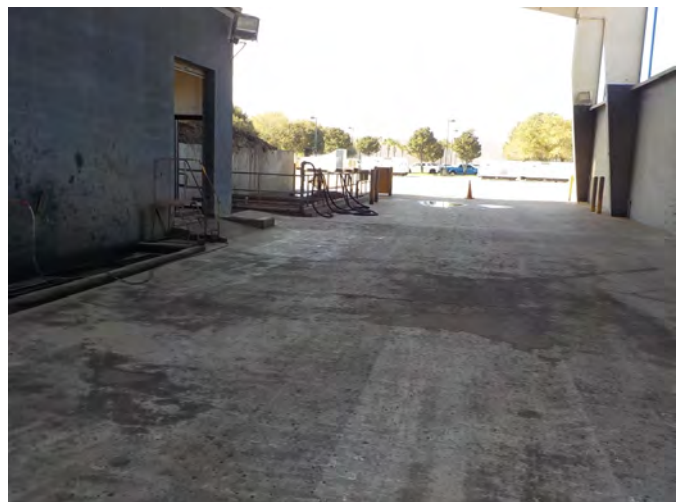
Photo 14

-----  
The Wash Rack is a covered area used to wash equipment that has been potentially contaminated with oil and dirt prior to repairs (Photo 14). The Wash Rack is equipped with a rough clean area on one side of the structure and a polishing area on the other side of the structure. The rough clean and polishing areas are separated by a change in elevation. The rough clean area is a closed-loop system where dirt/debris is washed from equipment with high pressure water. Dirt and debris are separated from water by a weir and are removed and accumulated as needed in a walled pit in the Wash Rack area. Equipment is cleaned with Mean Green 9 in the polishing area. Water drains to a trough which is pumped to a biofiltration unit that treats the water with microbes and a defoaming agent prior to discharge to the POTW. The biofiltration unit filters are pressure washed in the rough side area of the Wash Rack as needed, approximately every six months. Sludge that accumulates in the biofiltration unit is cleaned out as needed. Analysis of the sludge has indicated that it does not contain TCLP volatile, semi-volatile, metal, pesticide or herbicide constituents above the TCLP regulatory limits. Dirt and debris collected from the rough clean area is disposed of as non-hazardous waste at Evergreen Landfill in Valdosta, Georgia. Analysis of the dirt and debris has indicated that they do not contain TCLP volatile, semi-volatile, metal, pesticide or herbicide constituents above the TCLP regulatory limits.

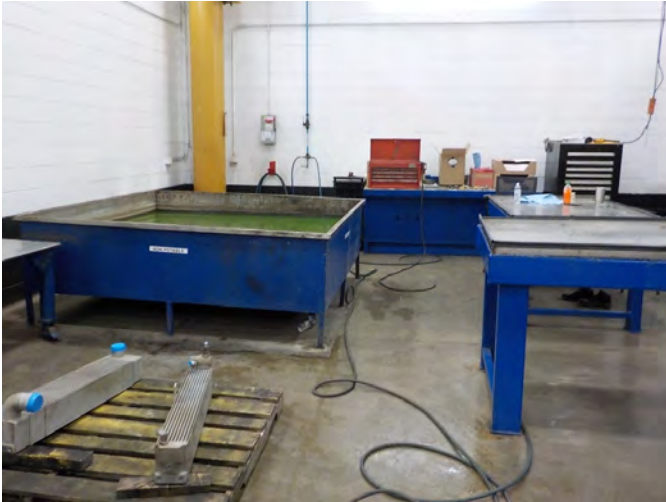
Photo 15

Radiators are pressure tested in a large tank containing Barbee #54/56 Tank Block/Powder (sodium carbonate 95%, pyalor fluorescene >5%) and water (Photo 15). Air pressure is placed on radiators placed into the tank where bubbles indicate potential leaks. When the liquid is no longer usable, it is released to the floor drain. The floor drain is piped to the Wash Rack, described above. Analysis of the spent liquid has indicated that it does not contain TCLP volatile, semi-volatile, metal, pesticide or herbicide constituents above the TCLP regulatory limits.

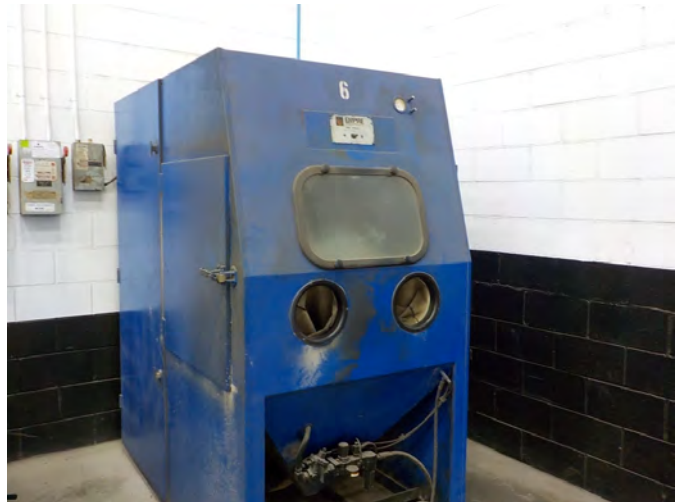
Photo 18

One glovebox blasting unit is installed in the Engine Tear Down Area (Photo 18). Both Ring Power and customer painted and unpainted parts are blasted in the unit using glass beads. Analysis of the spent blast media has indicated that it does not contain TCLP metal constituents above the TCLP regulatory limits.

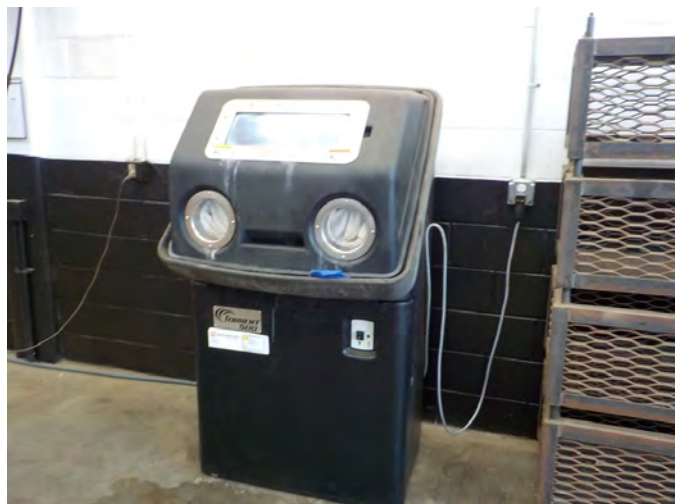
Photo 20

Since the previous inspection, the facility installed a Torrent 500 parts washer that uses Torrent 1101 Solution in the Engine Tear Down Area (Photo 20). Solvent is stored in an approximately 35-gallon drum and is filtered through an internal filter for reuse. The technician, who was present during the inspection, stated that approximately once per month, he washes the filter in the unit and disposes of the filter in the trash. He drains the spent solvent to the Wash Rack, described above. The facility has not conducted a complete waste determination to support management of the spent solvent and filters as non-hazardous waste [40 CFR 262.11]. Subsequent to the inspection, the facility provided analytical data for a spent solvent sample collected on March 14, 2022, which indicated the spent solvent was not ignitable and did not contain RCRA metal constituents above the regulatory levels. There was no documentation, however, that the RCRA volatile sample had been held at the proper temperature of 4-6° F. Therefore, the hazardous waste determination on the spent solvent remains incomplete at report issuance.

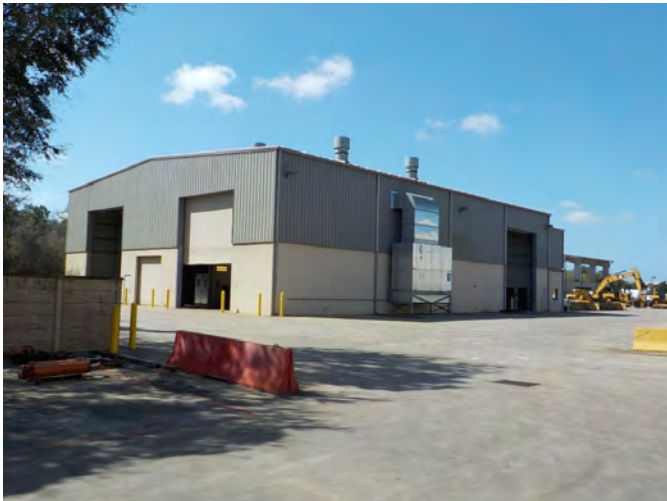
Photo 21

The facility blasts and paints both Ring Power and external customer equipment in this area (Photo 21). The facility also conducts a small amount of hand sanding when blasting is not feasible.

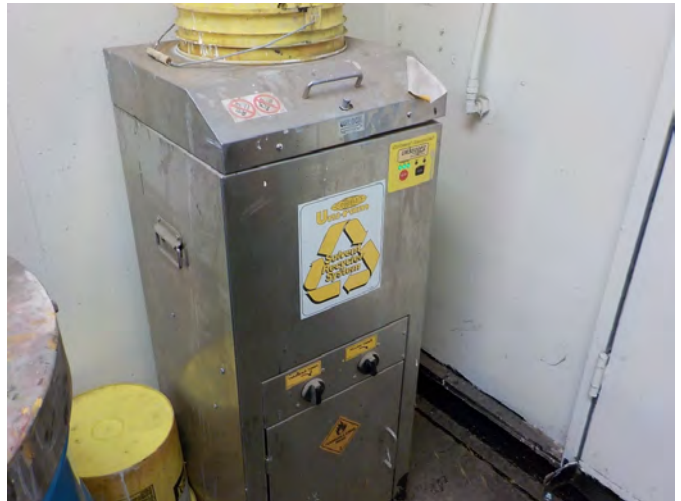
Photo 22

The facility operates one Uni-ram Solvent Recycler System (Photo 22). Approximately three gallons of liquid from the paint/thinner drum, described above, is recycled in the unit approximately 1-2 times per month for use on rags. The facility is reminded that the liquid recycled in the unit must be counted toward the facility's generator status because it is accumulated before being recycled. The recycling process generates solvent distillation bottoms that appear to be managed as D006/D007/D008 hazardous waste. Distillation bottoms, however, generate an F005 and possibly a D005 hazardous waste. Therefore, the facility has not conducted an adequate hazardous waste determination on the distillation bottoms [40 CFR 262.11]. Subsequent to the inspection, the facility provided analytical data for a sample of the distillation bottoms collected on March 14, 2022, indicating the distillation bottoms did not contain RCRA metal constituents above the regulatory levels, however the F005 code still applies.

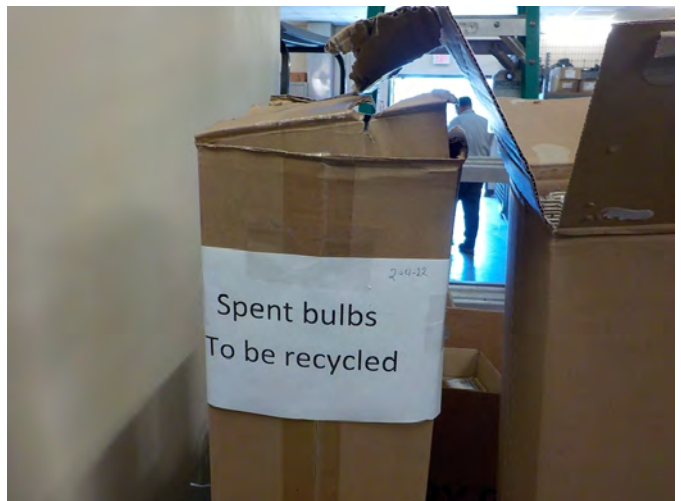
Photo 24

labeled (Photos 24 and 25) [40 CFR 273.13(d)(1) and 40 CFR 273.14(e)]. The box was closed and properly labeled during the inspection. Other wastes generated by facility maintenance activities are managed with the shop waste streams in each location.
