**Florida Department of
Environmental Protection
Hazardous Waste Inspection Report**

Facility Name: Tampa Transflo Terminal

On-Site Inspection Start Date: 06/23/2023

Routine Inspection for Used Oil Transfer Facility Facility

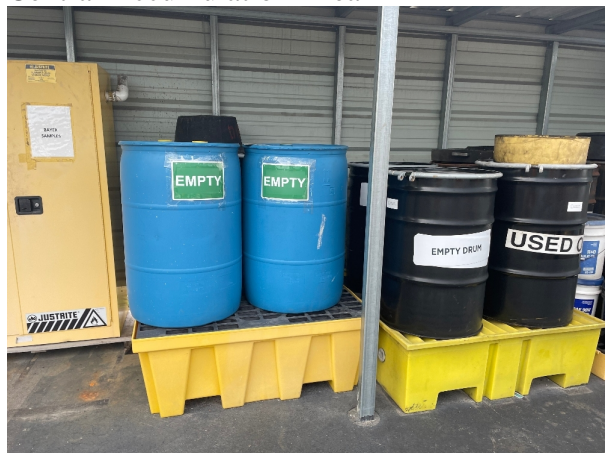
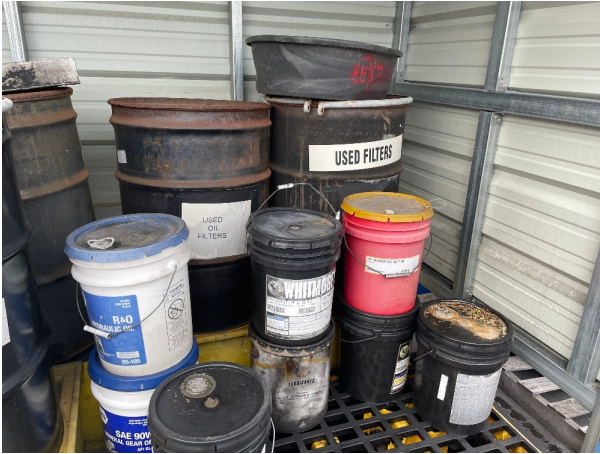
Central Accumulation Area

The CAA is located adjacent to the storage shed on the southeast end of the property. Tampa Transflo generates small quantities of hazardous waste and used oil from loading and maintenance activities onsite.

- One 55-gallon drum of used oil.
- One 55-gallon drum of used oil filters.
- One 55-gallon drum of aerosols.
- Eight 5-gallon plastic buckets of hydraulic fuel.

All containers and drums were observed to be properly closed and labeled in accordance with applicable rules and regulations.

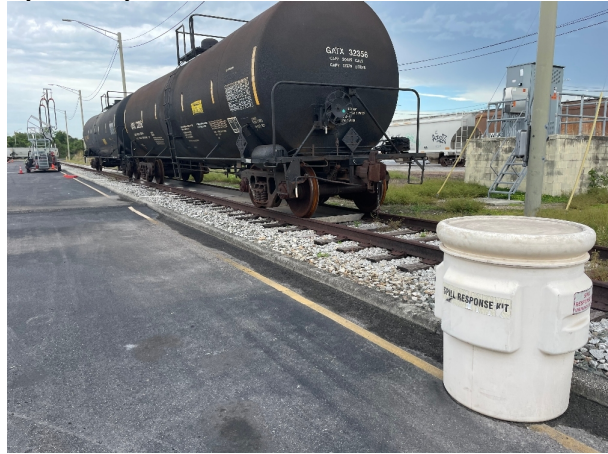
Spill Response Kit Near Each Track

The rail yard is comprised of 11 separate tracks that are numbered from 2 to 12, with each track containing several railcars dedicated to a set of products. Third-party truck drivers arrive to the scale house to weigh in and are then assigned a track and a railcar to begin loading product. All product is loaded directly into the railcars from the trucks by the truck drivers. As part of a contract, any damage sustained to the railcar in this process is the sole responsibility of the third-party contractor that loaded the product. Arriving railcars are inspected within 24 hours of arriving and again prior to leaving the rail yard. Track pans are in place and any spills which are not contained by the pan will drain to a trench which drains through a junction box to the facility's central storm water collection sump. In the event of a spill, knife valves can isolate the trenches and a secondary valve is present if needed to prevent discharge of the facility's storm water system. Emergency equipment, including spill kits, decontamination showers, and fire extinguishers are in place next to the tracks.

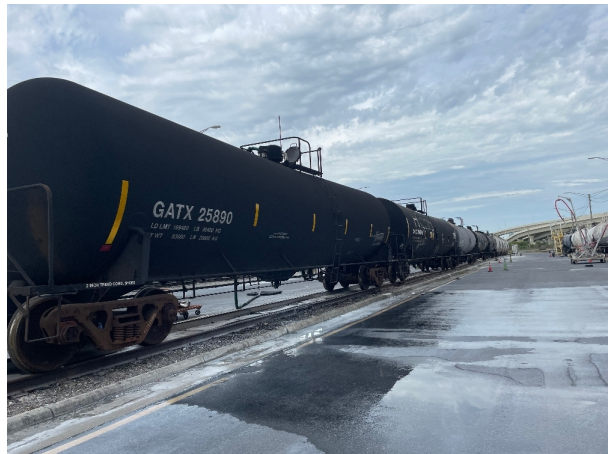
Used Oil Railcars

At the time of inspection, Department personnel observed railcars to be properly labeled with indications of the contents and DOT identification numbers. All railcars appeared to be in good working condition, during the inspection.
