**Florida Department of  
Environmental Protection  
Hazardous Waste Inspection Report**

**Facility Name:** Liquid Environmental Solutions of Florida LLC

**On-Site Inspection Start Date:** 08/17/2023

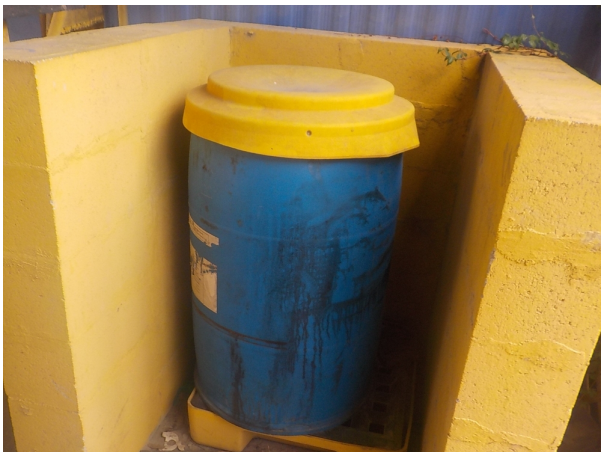
Photo 1

Wastewater is tested by the Receiving Laboratory prior to discharge to ensure compliance with the wastewater permit. Chemical Oxygen Demand (COD) 20-1500 mg/l test kits (mercuric sulfate 1%, water 25%, chromic acid 1%, silver sulfate 3%, sulfuric acid 90%; flashpoint listed as not applicable) are used in this process. Spent COD vials are D002/D007/D009/D011 hazardous waste. Spent COD vials are collected in a 55-gallon drum stored on a spill pallet just outside of the Receiving Laboratory (Photo 1). The drum was closed, in good condition and labeled.

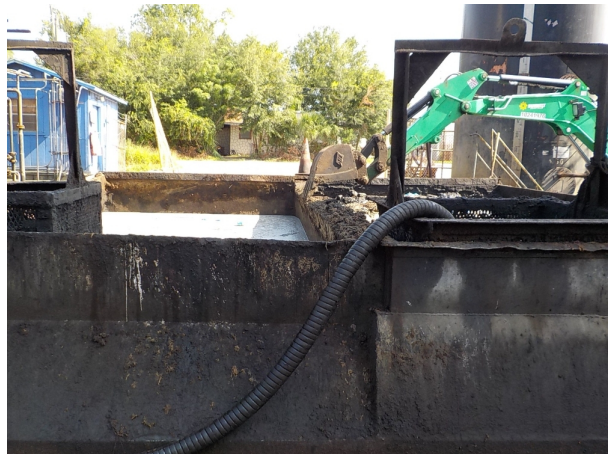
Photo 6

Two open, concrete and steel lined Tanks, 61 and 62, are dedicated for solids and sludge solidification and have a total capacity of 16,000 gallons (Photo 6). The facility solidifies materials such as non-hazardous wastewater with high solids content, and occasionally, latex paint, etc. The facility uses the waste profile, SDS and/or analytical testing to ensure that the waste is non-hazardous. The facility is reminded that it is not permitted to accept any hazardous waste. A heavy screen cage is used to physically separate the liquids from the solids in each tank. Facility staff use a large suction hose to transfer the liquid portion of wastewaters to one of the oily water tanks. Removal of liquid oily waste from the tank during the solidification process reduces the overall waste volume. Off-specification products, paints and other non-wastewaters would not be suctioned and would be solidified directly. Bails of absorbent paper dust material are used for solidification. Waste solids are placed into a roll-off container that is transported by Hull's Environmental to the Camden County, Georgia Municipal Waste Landfill approximately 10 times per month. The facility currently analyzes the waste solids

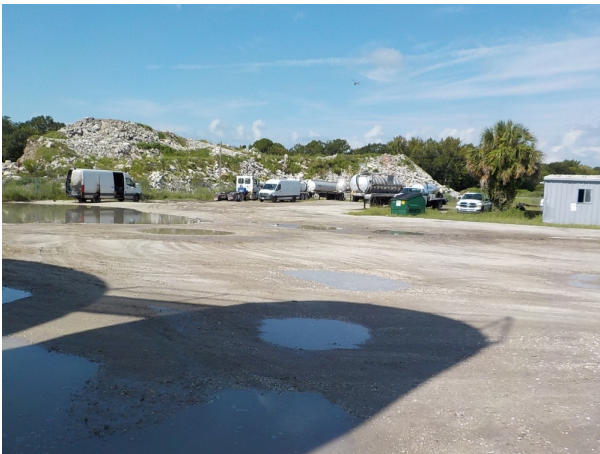
Photo 11

The Transportation Area is a large sand lot where the facility parks its tanker trucks, disconnected semi-truck trailers and tankers (Photo 11). A small building located in this area has been converted into office space and a shop for transportation activities since the previous inspection. This area is located on a separate parcel and leased from a separate party. No hazardous waste is generated in this area. Vehicles are serviced off site. There were no containers accumulating in this area.
