**Florida Department of
Environmental Protection
Hazardous Waste Inspection Report**

Facility Name: Ranger Construction Ind Inc

Routine Inspection for Used Oil Transporter Facility

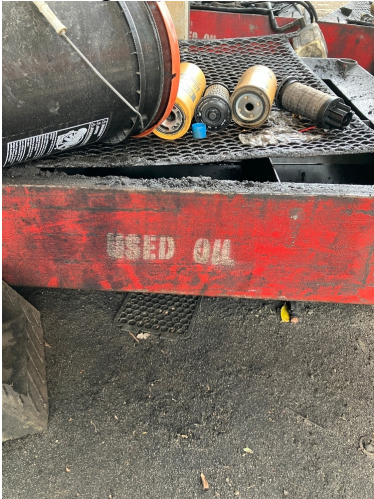
- One closed 55-gallon drum of "Uncrushed Used Oil Filters".
- Two large "Used Oil" caddies that had used oil filters draining on top of them. The representative informed the inspector that they try to drain them before placing them into the drum. The used oil is then pumped from the caddies into the tank.

Draining Used Oil Filters

properly labeled with the words "Used Oil Filters" [62-710.850(3) F.A.C.], photo of used oil filters being drained in a closed container not exposed to the elements [62-710.850(3) F.A.C.], photo of small caddies labeled "Used Oil" [40 CFR 279.22(c)(1)], and waste profile/determination of stained pile near small caddies and stained area outside the Used Oil Tank storage area and photo of it cleaned up if used oil [40 CFR 279.43(c)].

Type: Violation
Rule: 62-710.850(3)(b), 62-710.850(5)(a)
Explanation: At the time of the inspection there were used oil filter drums without labels and used oil filters draining on caddies that were exposed to the environment..
Corrective Action: Compliance assistance was provided onsite and in the exit interview to provide photos of used oil filters in closed containers and with the label/mark of "Used Oil Filters".

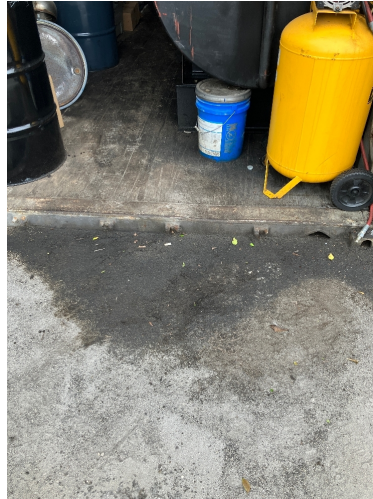
- Three small used oil caddies that were not labeled with the words "Used Oil".
- Next to the small caddies was a pile of semi-wet dark stained material possibly contaminated soil with used oil. Various other dark stains on the ground were observed throughout the area under the covering as well. Representative informed inspector that the rainwater does go throughout the facility since it is just an overhang.

Type: Violation
Rule: 279.43(c)
Explanation: At the time of the inspections there were various dark stained spots on the ground and a small pile of stained dirt on-site.
Corrective Action: Compliance assistance was provided on-site and in the exit interview to provide waste determinations/profiles and if used oil provide photos and documentation of clean up.

Used Oil Stain on Ground

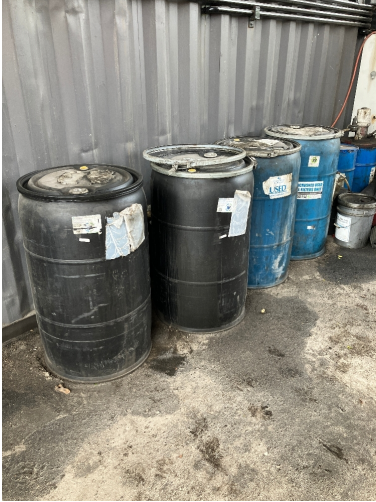
- Three closed 55-gallon drums of used oil filters. Two drums were not labeled, and one drum was labeled incorrectly labeled as "Used Absorbent Material Only".

Used Oil Filter Drum Without Label

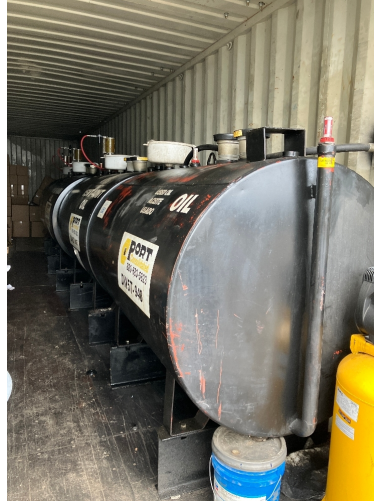
- One closed 500-gallon "Used Oil" tank. Representative informed inspector that the tank has a measuring device that informed employees when it is close to being full. When it gets close, they call their transporter Crystal Clean to have it pumped out.
- Two closed 500-gallon tanks with new oil to fill up the trucks.
- One open and overflowing 55-gallon drum of used oil rags. Drum did not have any labels. Representative informed inspector that oily absorbent materials get picked up by their used oil and used oil transporter.
- One box of spill kit material – absorbent pads.
- Under "Used Oil" tank was a used absorbent pad and just outside the doors of the cargo was dark staining on possible soil or broken asphalt.

500-Gallon Used Oil Tank

Compliance assistance was provided on-site and in the exit interview photo of used oil absorbent pad under used oil tank cleaned up and to identify and explain cleanup process of staining just outside the cargo doors [40 CFR 279.43(c)]. Suggested as a best management practice was to keep the used oil absorbent pads drum closed and label it "Used Absorbent Material" and provide a photo if done. Additional questions were asked in the exit interview regarding the facility's type of ground material and its permeability, as well as how long the used oil and used oil filters are on-site since the facility is not a registered transfer facility.
