**Florida Department of
Environmental Protection
Hazardous Waste Inspection Report**

Facility Name: Alta Construction Florida LLC

On-Site Inspection Start Date: 12/07/2023

Routine Inspection for Used Oil Transporter Facility

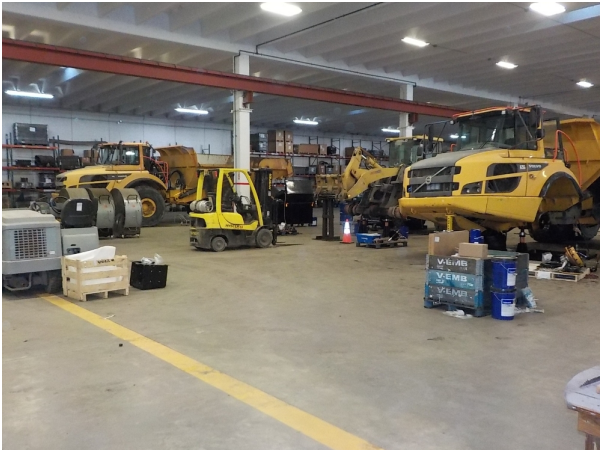
Photo 1

The majority of the main building is used for maintenance activities (Photo 1). Offices are along the eastern side of the building. Equipment and materials are stored around the southern and western perimeter of the building, and in the northeastern corner of the building. The remainder of the building is used for maintenance on diesel powered trucks and heavy equipment. Used oil is drained into drip pans or mobile carts located throughout the area. Several of the used oil containers were not labeled "Used Oil" (Photos 2 and 3) [40 CFR 279.22(c)(1)]. Used oil is drained from the drip pans and mobile carts into a larger collection container in the center of the area and then pumped to a double-walled 500-gallon aboveground storage tank located against the wall of the maintenance area. The tank was closed, labeled and in good condition. Used oil filters and oily absorbents are accumulated in 55-gallon drums located inside the maintenance area. All of the used oil filter drums and containers were closed and labeled. Oily absorbents are managed as non-hazardous waste. If antifreeze has to be drained from a vehicle, the facility collects the antifreeze and re-uses it in the vehicle once maintenance is complete. If the antifreeze is not reusable, it is collected and disposed on an as-needed basis.

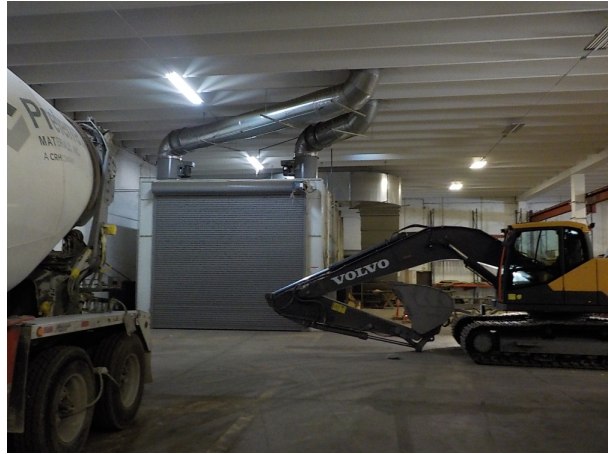
Photo 4

In 2023 Alta installed a walk-in paint booth to prepare for an increase in its painting operations (Photo 4). Mr. Northcraft stated that the City of Jacksonville had reviewed the operation of the booth for applicable emissions standards. Excess paint is placed in the 55-gallon drum underneath the aerosol can puncturer described below. Pocket filters, masking paper, and PPE are managed as non-hazardous waste. The facility had TCLP metals analysis from August 2023 that supported this process.

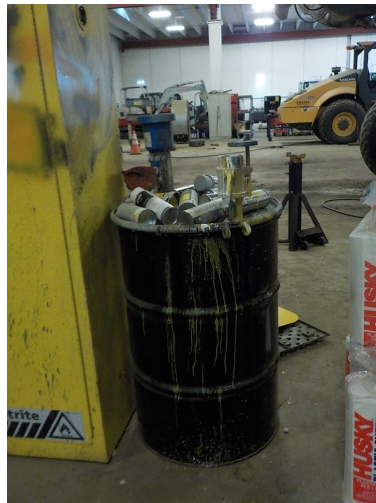
Photo 6

used during touch-up or the stenciling process. Spent aerosol cans are collected and punctured in the facility's aerosol can drum-top puncturing device located in between the paint booth and the maintenance areas (Photo 6). After puncturing, the empty aerosol cans are recycled as scrap metal. Because the puncturer was open, the hazardous waste liquid in the drum was allowed to evaporate and not be properly disposed [40 CFR 262.14(a)(5)]. The facility has not disposed of this wastestream, but is reminded that it should make an accurate waste determination on the wastestream prior to disposal for TCLP metals, TCLP VOCs, and flashpoint.

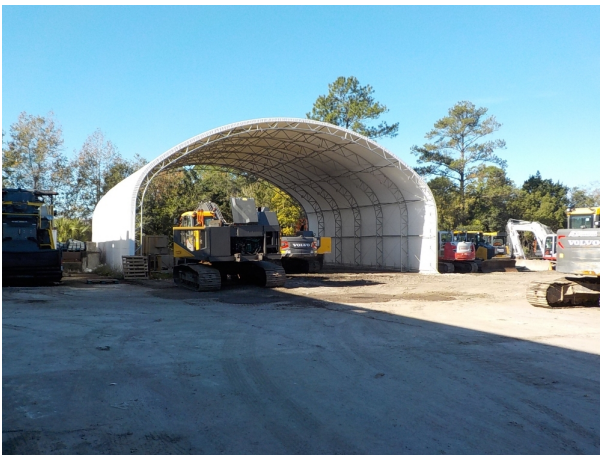
Photo 7

In 2022 Alta installed an ESD Waste-2-Water closed-loop wash rack (Photo 7) to clean heavy equipment. The wash rack is operated under an Industrial Wastewater Facility permit (#FLAB07216). The system is designed to process suspended solids through a mechanical separation and filtration system that drops the solids out of suspension to be collected in a separate hopper (Photo 8) and allows the wash water to be recycled. Sun Professional Super Wash (pH 11.9-12.4) is diluted according to manufacturer's instructions and hand-sprayed on equipment and then rinsed off. Mr. Northcraft said that the system is cleaned out periodically to prevent buildup and the wash water and solids are managed as non-hazardous waste by Heritage-Crystal Clean. The facility has not made a hazardous waste determination on these wastestreams to support this process [40 CFR 262.11].

Type:	Violation
Rule:	262.11
Explanation:	<p>The facility failed to make a hazardous waste determination on the following wastestreams:</p> <ol style="list-style-type: none">1. Solid debris generated from cleaning the ESD Waste-2-Water wash rack;2. Wash water generated from cleaning ESD Waste-2-Water wash rack; and3. Spent abrasive garnet media generated from blasting operations in the Outside Yard.
Corrective Action:	<p>In order to return to compliance, the facility should conduct and fully document a hazardous waste determination by having a representative sample of the wastestreams listed below analyzed separately for the following:</p> <ol style="list-style-type: none">1. Solid debris: Toxicity Characteristic Leaching Procedure (TCLP) for RCRA metals pursuant to 40 CFR 261.24, via method 6010;2. Wash water: TCLP for RCRA metals pursuant to 40 CFR 261.24, via method 6010; and corrosivity pursuant to 40 CFR 261.22, via method 9040; and3. Spent abrasive media: the spent media on the ground should be collected in a roll-off or individual containers and a representative sample should be collected from the container(s) and analyzed for TCLP for RCRA metals pursuant to 40 CFR 261.24, via method 6010.

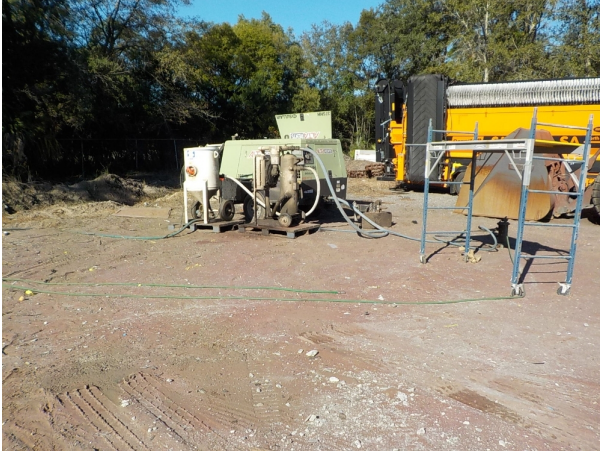
Photo 9

The facility had recently begun an abrasive blasting process in this open area of the yard north of the wash rack area. A portable blaster that uses RockRidge Garnet media is used to remove rust from painted and unpainted buckets and wheel rims on heavy equipment (Photo 9). The blast media had been allowed to accumulate on the soil. The facility has not made a hazardous waste determination on the spent media [40 CFR 262.11]. Even if the spent blast media is determined to be non-hazardous waste, it is a solid waste and cannot be discarded on the soil so the facility should ensure it implements routine maintenance procedures to contain, clean-up, and properly dispose of the spent media to ensure compliance with solid waste regulations and stormwater best management procedures. The Department will provide additional information on compliance requirements for these programs in separate correspondence.

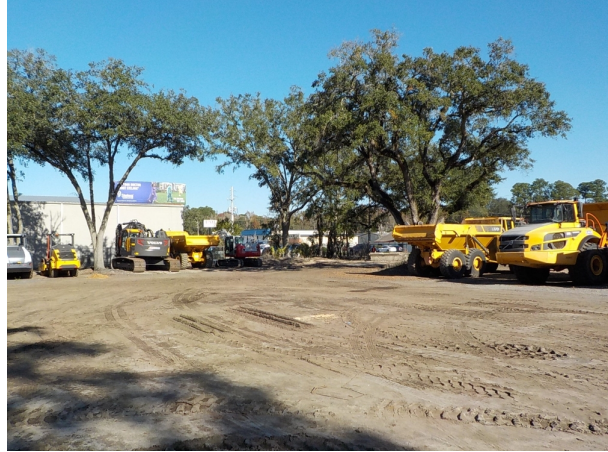
Photo 10

The remainder of the Outside Yard is used as a laydown area for materials and to stage equipment for sale, lease and/or maintenance (Photo 10). Dumpsters for solid waste and scrap metal are also located in this area. No maintenance is performed in the yard but one 5-gallon bucket that was unlabeled but appeared to be used oil was observed in the area (Photo 11) [40 CFR 279.22(c)(1)]. An oil filter was also observed on the ground in the area, but Mr. Northcraft retrieved the filter and determined that it was unused.

Type: Violation
Rule: **279.22(c)(1)**
Explanation: The facility failed to properly label containers of used oil with the words "Used Oil" in the Maintenance Area and in the Vehicle Storage and Staging Yard.
Corrective Action: No further action is required. The facility returned to compliance with emails on 12/20/2023 and 02/21/2024.
