**Florida Department of
Environmental Protection
Hazardous Waste Inspection Report**

Facility Name: Liquid Environmental Solutions of Florida LLC
On-Site Inspection Start Date: 05/07/2019 **On-Site Inspection End Date:** 05/07/2019
ME ID#: 33798 **EPA ID#:** FLD981928484
Facility Street Address: 1640 Talleyrand Ave, Jacksonville, FL 32206-5436
Contact Mailing Address: 1640 Talleyrand Ave, Jacksonville, FL 32206-5485
County Name: Duval **Contact Phone:** (904) 438-2138

Inspection Date: 05/07/2019

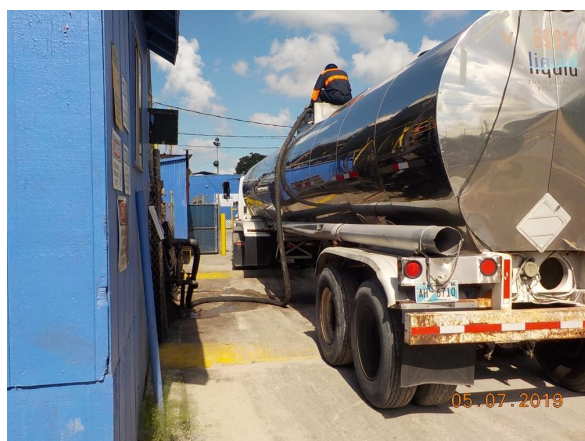
Photo 1

Prior to trucks being off-loaded at one of three off-loading stations (Photo 1), LES personnel collect samples from all incoming liquid waste using a Composite Liquid Waste Sampler (COLIWASA) for fingerprint analysis. After sampling, the COLIWASA is placed in a secondary containment sump (Photo 2) located outside and adjacent to the Receiving Laboratory for continuous use. Accumulated liquids are automatically pumped to one of the process tanks. There was one step-can for the collection of oily rags located adjacent to the COLIWASA sump. Rags are laundered weekly by Aramark.

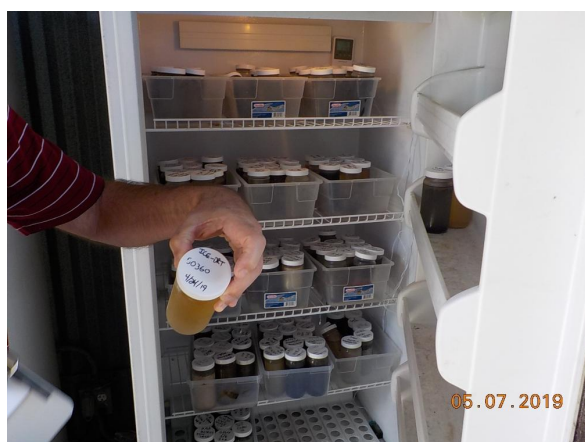
Photo 3

A portion of all used oil samples is maintained for 30 days in a refrigerator located outside the entrance of the Receiving Laboratory (Photo 3). The excess used oil that is not saved is accumulated in a 5-gallon container located outside and adjacent to the Receiving Laboratory (Photo 4) and managed as used oil. The container was covered, properly labeled and stored in a secondary container which appeared to meet the requirements. The facility is reminded that secondary containment for used oil containers is required to have a capacity of 110% of the volume of the largest container within the containment area. When full, the container is emptied into either Tank 51, 52 or 62 and managed as used oil.

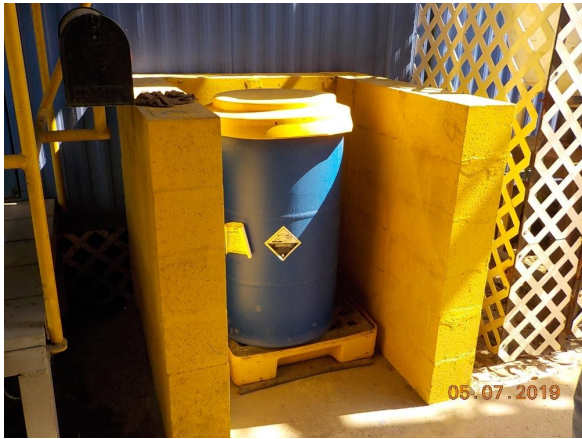
Photo 5

Wastewater is tested by the Receiving Laboratory prior to discharge to ensure compliance with the wastewater permit. Chemical Oxygen Demand (COD) 20-1500 mg/l test kits (mercuric sulfate 1%, water 25%, chromic acid 1%, silver sulfate 3%, sulfuric acid 90%; flashpoint listed as not applicable) are used in this process. Spent COD vials are D002/D007/D009/D011 hazardous waste. Spent COD vials are collected in a 55-gallon drum stored on a spill pallet outside of the Receiving Laboratory (Photo 5). The drum was closed, in good condition and labeled.

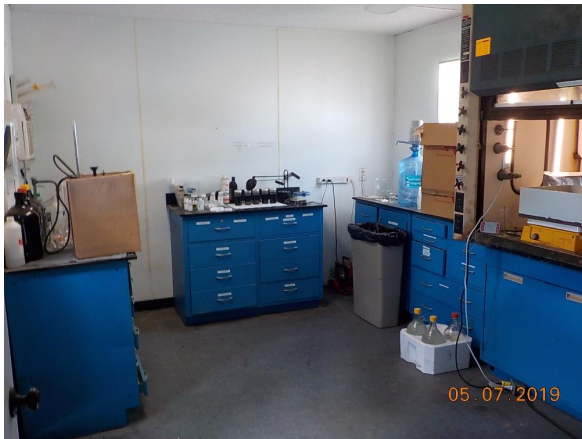
Photo 7

The Back Laboratory (Photo 7) performs used oil treatability testing. Demulsifiers and heat are used to conduct the testing. No hazardous waste is generated in this area.

There was one fire extinguisher observed in the Back Lab. The SPCC/Contingency Plan referenced in the permit application indicates four fire extinguishers should be present in the building. In addition, the maintenance shop has been relocated from the building. These changes were not reflected in the current SPCC/Contingency Plan. The facility is reminded that amendments permitted to be made by the owner/operator should be incorporated as soon as practicable or within six months, as required by the Plan. The list of required emergency equipment in the SPCC/Contingency Plan should be kept up-to-date and the equipment available as described.

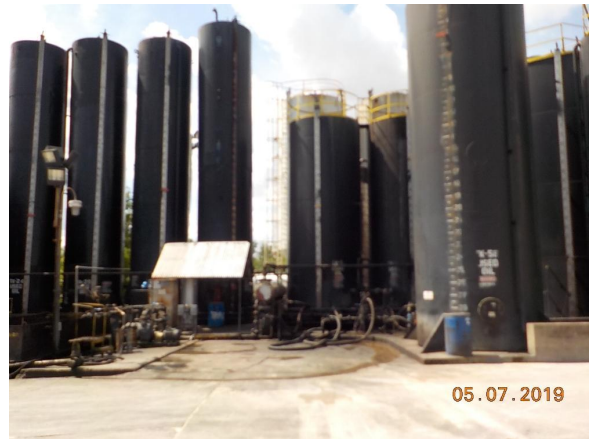
Photo 8

The Used Oil Processing Area (Photo 8) is primarily located in the southwest corner of the facility. Twenty aboveground tanks are dedicated for used oil processing with a total capacity of 312,175 gallons. The facility is authorized to store and use 95% of the total capacity which is 296,566 gallons of used oil. Mr. Turovsky said that approximately 10% of all incoming shipments are used oil. Shipments of used oil are off-loaded into Tanks 51 and 52 that have a capacity of 15,000 gallons each.

All used oil tanks were properly labeled as "Used Oil" and appeared to be in good condition. Tank 22, although labeled as "Used Oil," was also labeled as "Diesel Fuel." The facility is reminded to ensure that all tanks and containers are properly labeled only with their contents.

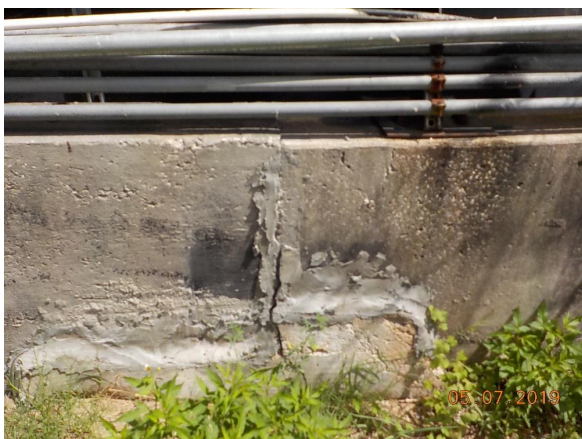
Photo 9

There were significant cracks, gaps and areas of disrepair located along the south wall of the used oil secondary containment area, both behind the used oil tanks and behind the wastewater tanks (Photos 9, 10 and 11). At the time of inspection these areas had not been repaired [Permit Condition, Part II #7, and 40 CFR 279.54(d)(2)]. It appeared that the area behind the used oil tanks had been repaired in the past, but the concrete patch used for the repair was failing and separating from the wall. In addition, there was vegetation

and debris observed along the interior south wall in the area where the foundation and vertical wall meet and along the exterior south wall, making performing an adequate inspection of the secondary containment difficult.

Explanation: There were several areas of the south wall of the used oil secondary containment system with significant cracks, gaps and areas of disrepair that could potentially allow a release. There was vegetation and debris observed along the interior south wall in the area where the foundation and vertical wall meet and along the exterior south wall, making performing an adequate inspection of the secondary containment difficult.

Corrective Action: In order to return to compliance, the facility should clear all debris and vegetation in the vicinity of all secondary containment perimeter walls to allow for adequate inspection. The facility should also repair any cracks, gaps and areas of disrepair and have the entire secondary containment area inspected and certified by a Professional Engineer as to its ability to contain a release and provide the required secondary containment.

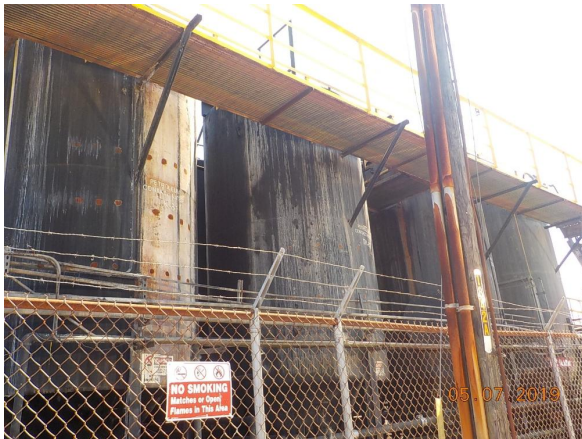
Photo 13

The facility receives PCW by tanker trucks. Incoming shipments of PCW are analyzed for pH, TOH and flashpoint. PCW is unloaded into Tanks 81 and 82 (5,000 gallons each), located to the north adjacent to the electrical shed (Photo 13). Product is phase separated, transferred to the oil processing tanks and sent off-site. Water associated with the product is treated as necessary prior to discharge to the POTW. The volume of PCW stored at the facility in Tanks 81 and 82 does not exceed 10,000 gallons at any given time. PCW remains on-site for 2-3 weeks before the recovered product is transported off-site. Outgoing shipments of recovered product are checked for percent water, TOH, and flashpoint and are shipped as off-specification fuel to a marketer. Mr. Turovsky stated that there are never any residual solids in the bottom of the PCW tanks.

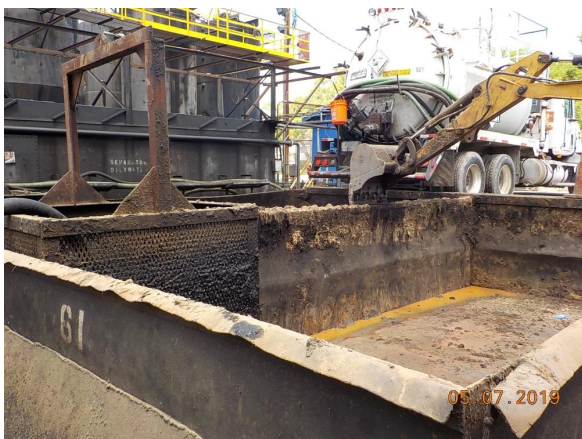
Photo 15

Two open, concrete and steel lined Tanks, 61 and 62, are dedicated for solids and sludge solidification and have a total capacity of 16,000 gallons (Photo 15). The facility is authorized under its solid waste permit to generate wastewater treatment solids and oily solids waste from the facility's wastewater treatment processes and used oil processing.

A heavy screen cage is used to physically separate the liquids from the solids in each tank. Facility staff use a large suction hose to transfer the oily waste liquid to the oil/water separator. Removal of liquid oily waste from the tank during the solidification process reduces the overall waste volume. Bails of absorbent paper dust material are used for solidification of leftover tank sludge. Waste solids are placed into the same roll-off containers used for the PFFP waste solids that are transported by Advanced Disposal Jacksonville to the Camden County, Georgia Municipal Waste Landfill approximately four to five times per week. The most recent TCLP analytical report dated April 1, 2019 and April 30, 2019, were reviewed, and the results indicated that the waste solids were non-hazardous.

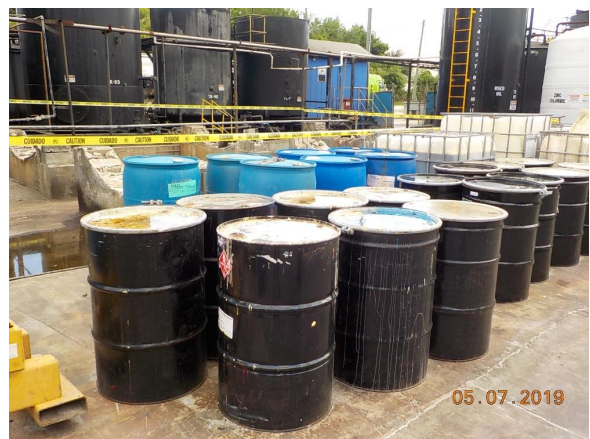
Photo 16

The Container Storage Area is approximately 1,000 square feet (Photo 16). The facility stores non-hazardous waste, oil contaminated solid waste and other waste for solidification in this area. The facility also stores chemicals, such as off-specification caustics, that can be used in the process. All drums were stored on an oil-impervious surface.

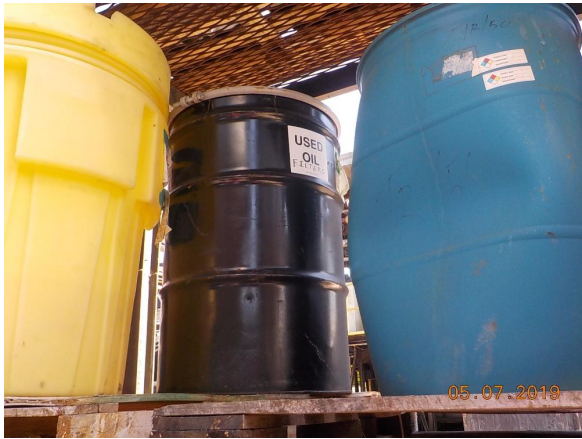
Photo 17

After removal of any free liquids, the drums are placed onto a rack in the Used Oil Filter and Container Storage Area until they can be picked-up for management by Safety Kleen (FLD 980 847 214). At the time of the inspection, the facility had one drum of used oil filters onsite (Photo 17). The drum was closed, properly labeled with the words "Used Oil Filters" and stored on an oil-impervious surface.

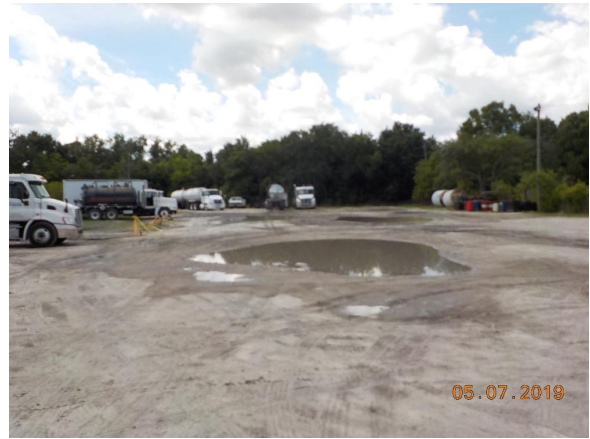
Photo 18

The Transportation Area is a large sand lot where the facility parks its tanker trucks, disconnected semi-truck trailers and tankers (Photo 18). Several empty drums, tanks and grease receptacles were also observed in this area. Empty drums that cannot be used are disposed of as scrap metal.

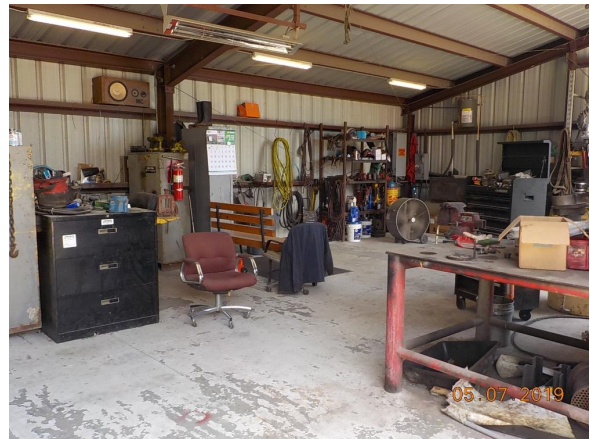
Photo 20

The maintenance shop has been relocated to the far northeastern corner of the facility adjacent to Seventh Street (Photo 20). The maintenance shop performs routine and preventative maintenance for the facility. A small amount of painting and welding is conducted. Xylene (flashpoint 86°F) is used to thin paint. Xylene used for paint cleanup would generate a D001/F003 hazardous waste. Unused xylene would generate a D001 hazardous waste. Unused paint may also generate a D001 hazardous waste. A hazardous waste determination should be conducted prior to disposal of unused paint to determine if additional hazardous waste codes are required. No rags are used for painting.

No used oil is generated by the maintenance shop. There was, however, one used oil rag step can located in the shop. Rags are laundered weekly by Aramark.
