**Re: Perma-Fix of Florida, Inc.**  
**EPA/DEP ID: FLD980711071**  
**Alachua County – Hazardous Waste**

**Florida Department of  
Environmental Protection  
Hazardous Waste Inspection Report**

**Facility Name:** Perma-Fix Of Florida Inc

**On-Site Inspection Start Date:** 08/24/2023

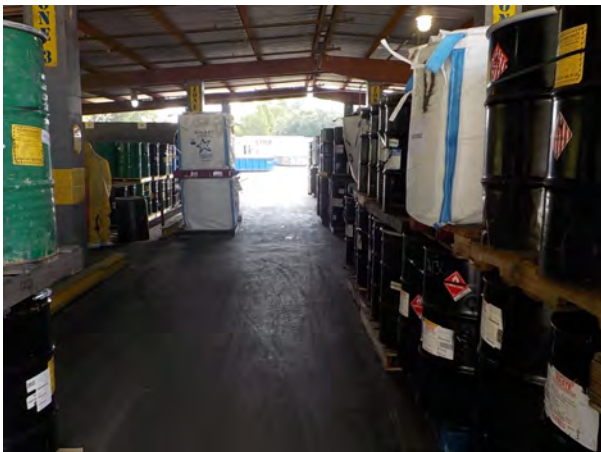
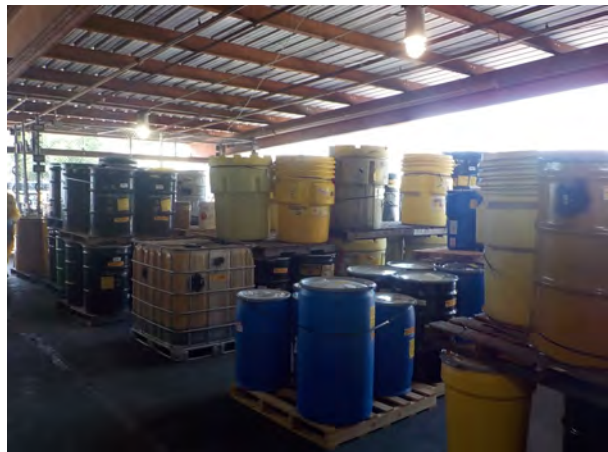
Photo 1

The area is not enclosed but is under a roof and has a containment system and concrete curbing with three different zones for storage of waste (Photos 1 and 2). This storage area is permitted to store up to 72,105 gallons of hazardous waste with a maximum container size of 718 gallons which is equivalent to a B-25 box container. At the time of the inspection, this storage area was within its permitted volume capacity and all containers observed had been accumulating for less than one year.
