Re: Alta Construction Florida, LLC
Facility ID No.: FLR000213694
Duval – Hazardous Waste Program

**Florida Department of
Environmental Protection
Hazardous Waste Inspection Report**

Facility Name: Alta Construction Florida LLC

On-Site Inspection Start Date: 12/07/2023

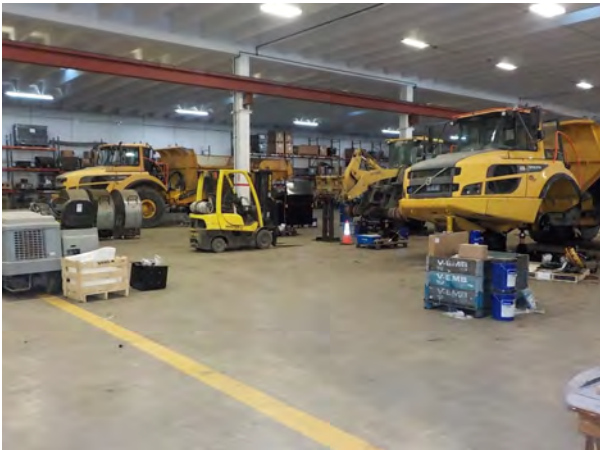
Photo 1

The majority of the main building is used for maintenance activities (Photo 1). Offices are along the eastern side of the building. Equipment and materials are stored around the southern and western perimeter of the building, and in the northeastern corner of the building. The remainder of the building is used for maintenance on diesel powered trucks and heavy equipment. Used oil is drained into drip pans or mobile carts located throughout the area. Several of the used oil containers were not labeled "Used Oil" (Photos 2 and 3) [40 CFR 279.22(c)(1)]. Used oil is drained from the drip pans and mobile carts into a larger collection container in the center of the area and then pumped to a double-walled 500-gallon aboveground storage tank located against the wall of the maintenance area. The tank was closed, labeled and in good condition. Used oil filters and oily absorbents are accumulated in 55-gallon drums located inside the maintenance area. All of the used oil filter drums and containers were closed and labeled. Oily absorbents are managed as non-hazardous waste. If antifreeze has to be drained from a vehicle, the facility collects the antifreeze and re-uses it in the vehicle once maintenance is complete. If the antifreeze is not reusable, it is collected and disposed on an as-needed basis.

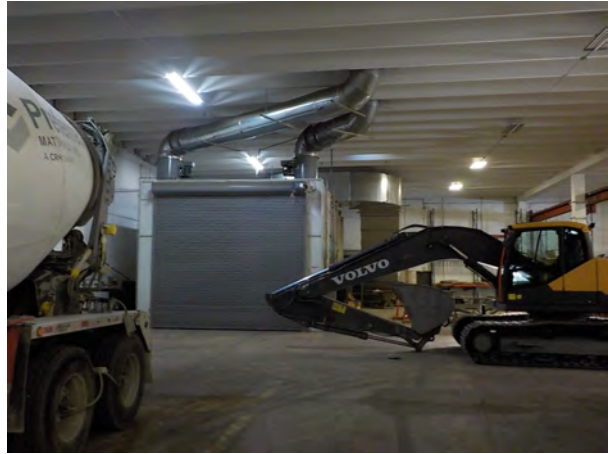
Photo 4

In 2023 Alta installed a walk-in paint booth to prepare for an increase in its painting operations (Photo 4). Mr. Northcraft stated that the City of Jacksonville had reviewed the operation of the booth for applicable emissions standards. Excess paint is placed in the 55-gallon drum underneath the aerosol can puncturer described below. Pocket filters, masking paper, and PPE are managed as non-hazardous waste. The facility had TCLP metals analysis from August 2023 that supported this process.

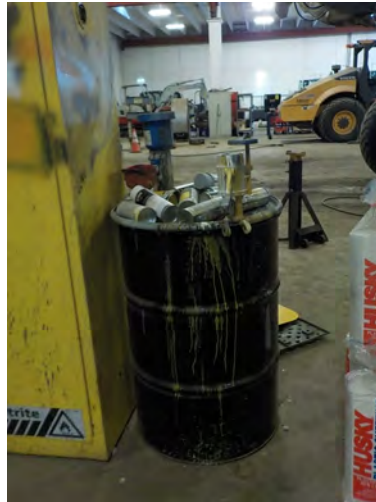
Photo 6

used during touch-up or the stenciling process. Spent aerosol cans are collected and punctured in the facility's aerosol can drum-top puncturing device located in between the paint booth and the maintenance areas (Photo 6). After puncturing, the empty aerosol cans are recycled as scrap metal. Because the puncturer was open, the hazardous waste liquid in the drum was allowed to evaporate and not be properly disposed [40 CFR 262.14(a)(5)]. The facility has not disposed of this wastestream, but is reminded that it should make an accurate waste determination on the wastestream prior to disposal for TCLP metals, TCLP VOCs, and flashpoint.

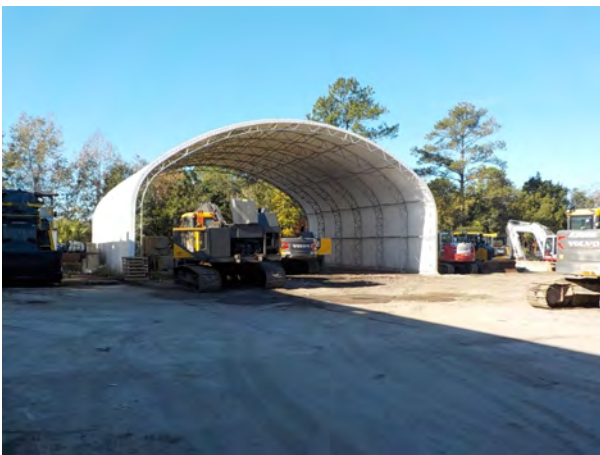
Photo 7

In 2022 Alta installed an ESD Waste-2-Water closed-loop wash rack (Photo 7) to clean heavy equipment. The wash rack is operated under an Industrial Wastewater Facility permit (#FLAB07216). The system is designed to process suspended solids through a mechanical separation and filtration system that drops the solids out of suspension to be collected in a separate hopper (Photo 8) and allows the wash water to be recycled. Sun Professional Super Wash (pH 11.9-12.4) is diluted according to manufacturer's instructions and hand-sprayed on equipment and then rinsed off. Mr. Northcraft said that the system is cleaned out periodically to prevent buildup and the wash water and solids are managed as non-hazardous waste by Heritage-Crystal Clean. The facility has not made a hazardous waste determination on these wastestreams to support this process [40 CFR 262.11].

Type:	Violation 1
Rule:	262.11
Explanation:	<p>The facility failed to make a hazardous waste determination on the following wastestreams:</p> <ol style="list-style-type: none">1. Solid debris generated from cleaning the ESD Waste-2-Water wash rack;2. Wash water generated from cleaning ESD Waste-2-Water wash rack; and3. Spent abrasive garnet media generated from blasting operations in the Outside Yard.
Corrective Action:	<p>In order to return to compliance, the facility should conduct and fully document a hazardous waste determination by having a representative sample of the wastestreams listed below analyzed separately for the following:</p> <ol style="list-style-type: none">1. Solid debris: Toxicity Characteristic Leaching Procedure (TCLP) for RCRA metals pursuant to 40 CFR 261.24, via method 6010;2. Wash water: TCLP for RCRA metals pursuant to 40 CFR 261.24, via method 6010; and corrosivity pursuant to 40 CFR 261.22, via method 9040; and3. Spent abrasive media: the spent media on the ground should be collected in a roll-off or individual containers and a representative sample should be collected from the container(s) and analyzed for TCLP for RCRA metals pursuant to 40 CFR 261.24, via method 6010.

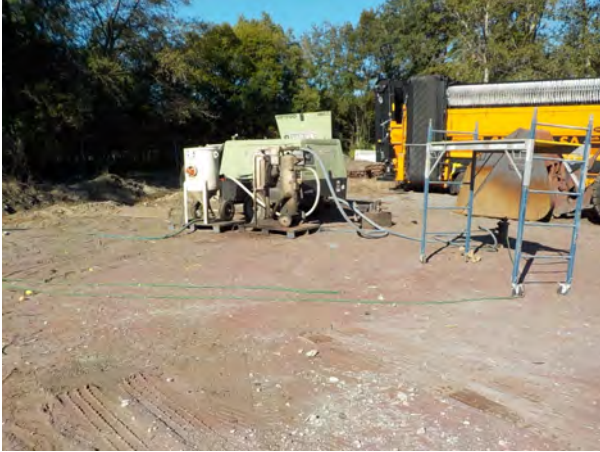
Photo 9

The facility had recently begun an abrasive blasting process in this open area of the yard north of the wash rack area. A portable blaster that uses RockRidge Garnet media is used to remove rust from painted and unpainted buckets and wheel rims on heavy equipment (Photo 9). The blast media had been allowed to accumulate on the soil. The facility has not made a hazardous waste determination on the spent media [40 CFR 262.11]. Even if the spent blast media is determined to be non-hazardous waste, it is a solid waste and cannot be discarded on the soil so the facility should ensure it implements routine maintenance procedures to contain, clean-up, and properly dispose of the spent media to ensure compliance with solid waste regulations and stormwater best management procedures. The Department will provide additional information on compliance requirements for these programs in separate correspondence.

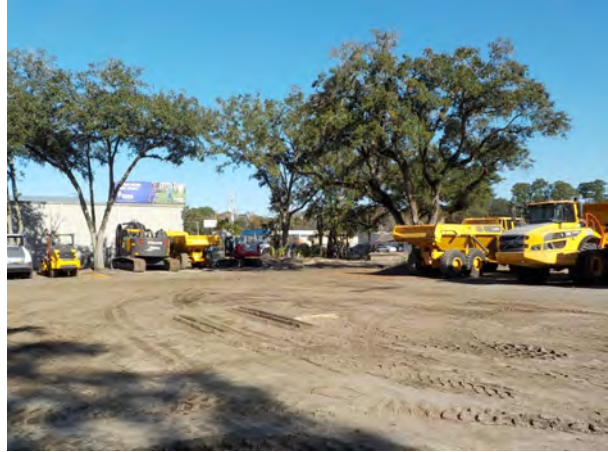
Photo 10

The remainder of the Outside Yard is used as a laydown area for materials and to stage equipment for sale, lease and/or maintenance (Photo 10). Dumpsters for solid waste and scrap metal are also located in this area. No maintenance is performed in the yard but one 5-gallon bucket that was unlabeled but appeared to be used oil was observed in the area (Photo 11) [40 CFR 279.22(c)(1)]. An oil filter was also observed on the ground in the area, but Mr. Northcraft retrieved the filter and determined that it was unused.

Type: Violation 3
Rule: **279.22(c)(1)**
Explanation: The facility failed to properly label containers of used oil with the words "Used Oil" in the Maintenance Area and in the Vehicle Storage and Staging Yard.
Corrective Action: No further action is required. The facility returned to compliance with emails on 12/20/2023 and 02/21/2024.
