SUBJ: Resource Conservation and Recovery Act (RCRA) Compliance Evaluation Inspection (CEI)  
Lighting Resources LLC  
EPA ID: FLR000070565

## **RCRA Inspection Report**

Lighting Resources LLC  
1007 SW 16<sup>th</sup> Ln  
Ocala, FL 34471

Attachment 1- Lighting Resources LLC  
RCRA CEI Photographs

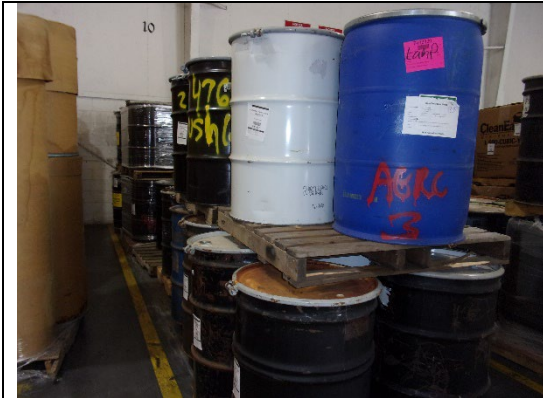
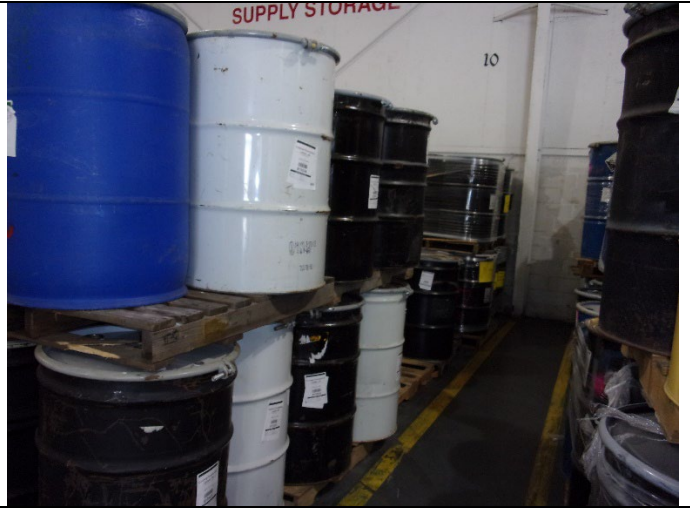
LR manages a permitted storage section in Row 10 for managing universal waste crushed lamps that is generated from line processing in the Balcan Room. The inspectors observed thirty-four (34) 55-gallon containers in this row. The containers were located in Row 10, all equipped with drum cover lids, and all closed (Figures 1 and 2). The containers were labeled crushed fluorescent lamps.

Figure 1: 11:25 AM Row 10  
Thirty-four (34) 55-gallon containers observed.

Figure 2: 11:25 AM Row 10  
Thirty-four (34) 55-gallon containers observed.

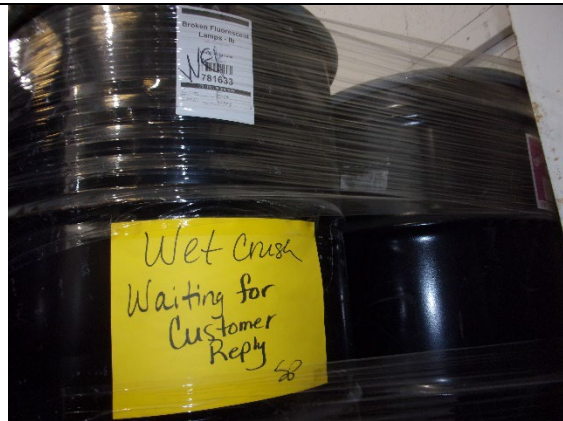
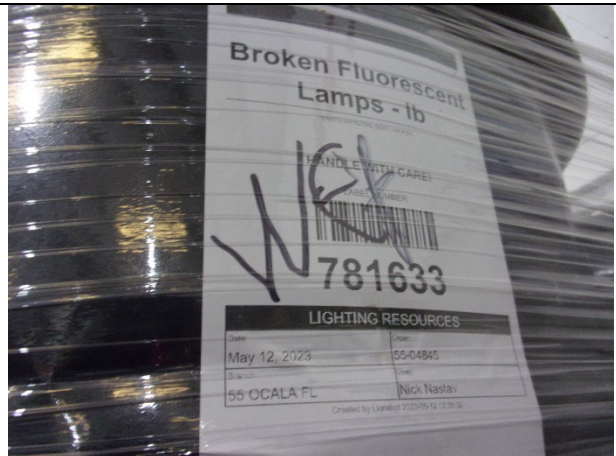
Nine (9) of the thirty-four (34) containers were rejected waste due to the contents being wet (Figure 3 and 4). Facility personnel stated it is being sent back to the respective customer client(s) for reevaluation before accepting the material again.

Figure 3: 11:25 AM Row 10  
Nine (9) of the thirty-four (34) containers in Row 10 were wet crush rejected waste.

Figure 4: 11:30 AM Row 10  
Nine (9) of the thirty-four (34) containers in Row 10 were wet crush rejected waste.

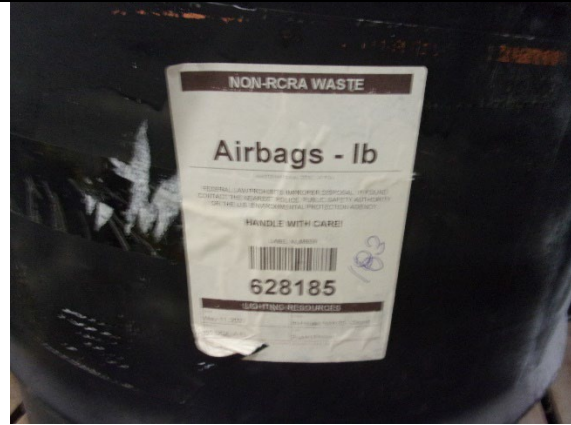
Inspectors observed one 55-gallon container of airbags (Figure 5). The date of the container was May 11, 2022. Inspectors asked facility personnel the reason for the exceeded storage time of one year in the permitted storage area. On September 13, 2023, facility personnel provided information via email claiming the airbags were not a waste and will be reclaimed at another facility once shipped. RCRA Online document 14920 states that “airbag inflators that are not used because they fail a quality control program are off-specification commercial chemical products and are exempt from RCRA regulation when legitimately reclaimed.”

Figure 5: 11:59 AM Row 6  
One 55-gallon container of airbags observed.

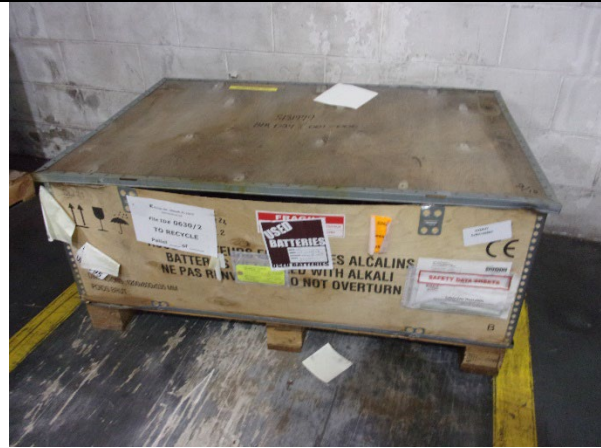
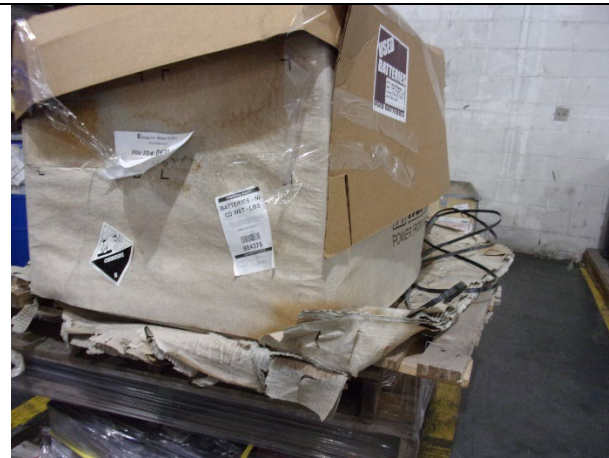
Inspectors observed 2 pallets of used batteries with no distinctive labels to distinguish a storage start date or a customer/generator label (Figures 6 and 7). In the facility permit application, the time limitations for storing batteries on-site are less than one year.

Figure 6: 12:05 PM Row 1  
One of two (2) pallets of used batteries observed.

Figure 7: 12:05 PM WMF: Row 1  
Two of two (2) pallets of used batteries observed.

**Pursuant to HW Permit 309339-004-HO, Part I – General and Standard Conditions, this permit is valid only for the specific processes and operations applied for and indicated in the approved drawings or exhibits.**

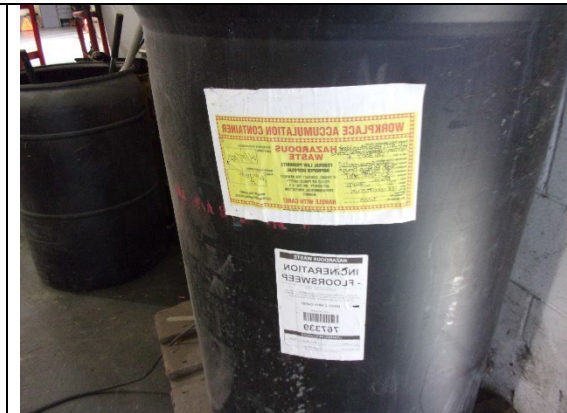
LR manages a SAA adjacent to the Battery Sorting Area for managing hazardous waste floor sweepings that is generated by waste residue accumulated on the floor after cleaning and sweeping. The inspectors observed one 55-gallon container in this SAA. The drum was located along the east wall near the bay doors, and it was equipped with a drum cover lid, which was closed. The drum was labeled D009 hazardous waste mercury contaminated debris, and not identified with an indication of the hazards of the contents (Figure 8).

Figure 8: 12:33 PM Battery Storage Area  
One 55-gallon SAA container of floor sweepings observed with no indication of the hazards of the contents.

**Pursuant to Fla. Admin. Code Ann. r. 62-730.160(1) [40 C.F.R. § 262.15(a)(5)], which is a condition of the SAA Permit Exemption, a generator is required to mark or label its containers (i) with the words “Hazardous Waste” and (ii) with an indication of the hazards of the contents.**

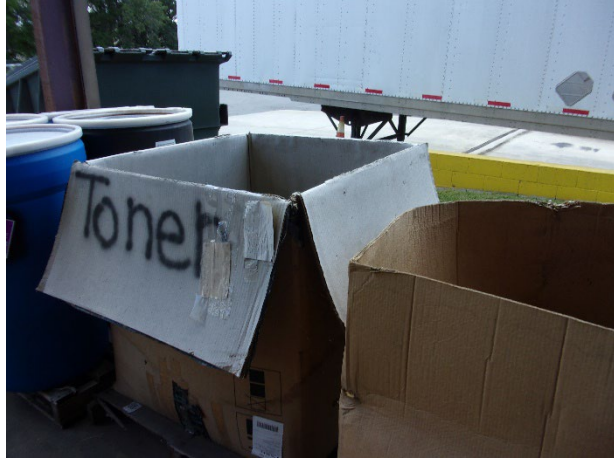
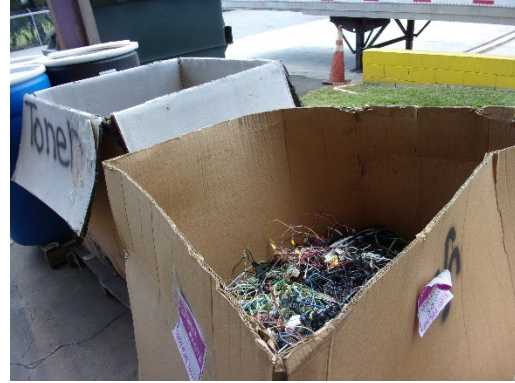
Inspectors also observed several containers and boxes of toner, wire, non-PCB capacitors, ballasts, scrap metal, and e-waste in this area (Figures 9 and 10).

Figure 9: 12:41 PM Shatter Shield Area  
One Gaylord box container of toner observed.

Figure 10: 12:41 PM Shatter Shield Area  
One Gaylord box container of wire and e-waste observed.

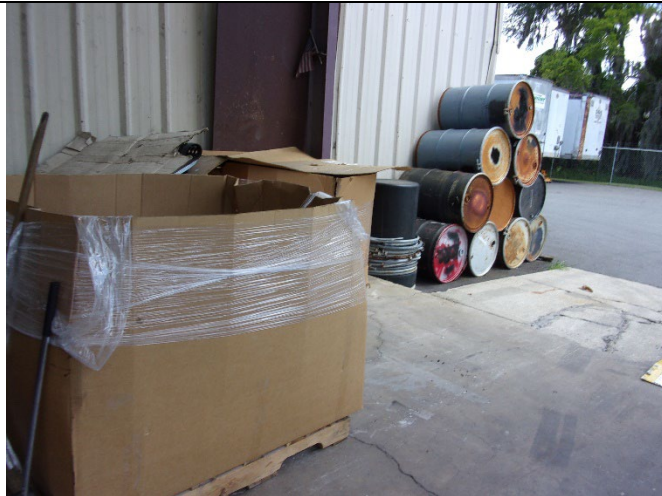
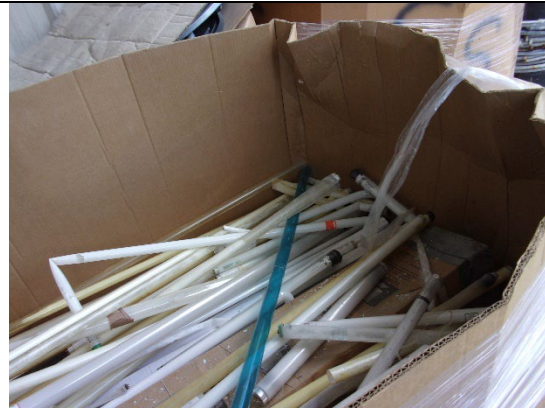
LR manages unprocessed shatter shield lamps in the Shatter Shield Area from generators' waste sent to the facility. Inspectors observed four (4) Gaylord box containers of unprocessed shatter shield lamps (Figures 11 and 12). Inspectors asked facility personnel if they store the lamps temporarily outside the permitted storage area for processing. Facility personnel stated they leave the remaining unprocessed shatter shield lamps outside under the overhead roof, and the processed lamps are stored in the permitted storage area for further processing. Inspectors recommended facility personnel to move any unfinished shatter shield lamps inside the permitted storage area at the end of each business day.

Figure 11: 12:41 PM Shatter Shield Area  
One of four (4) Gaylord box containers of unprocessed shatter shield lamps observed.

Figure 12: 12:42 PM Shatter Shield Area  
One of four (4) Gaylord box containers of unprocessed shatter shield lamps observed.

**Pursuant to HW Permit 309339-004-HO, Part II Subpart B – Specific Operating Conditions, the Permittee shall not exceed the limits identified in Table 3-3 of the permit application and incorporated as Attachment B of this permit.**

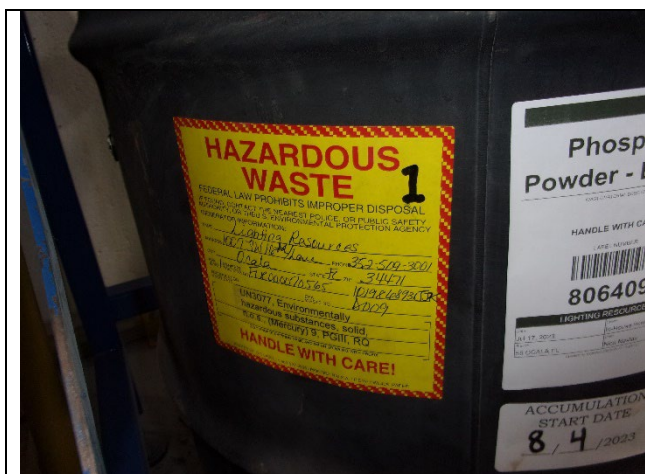
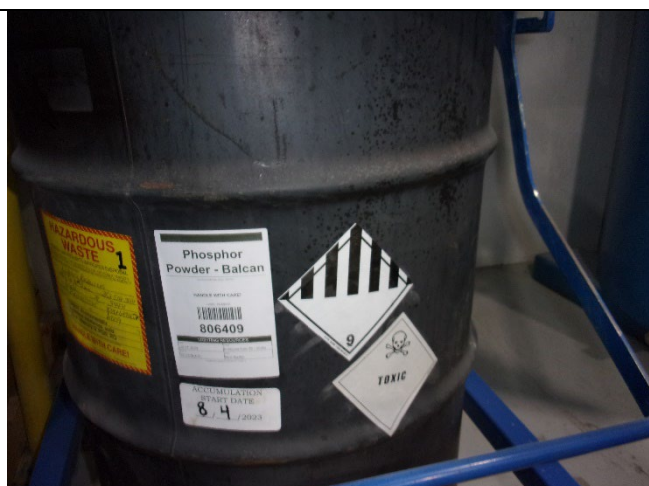
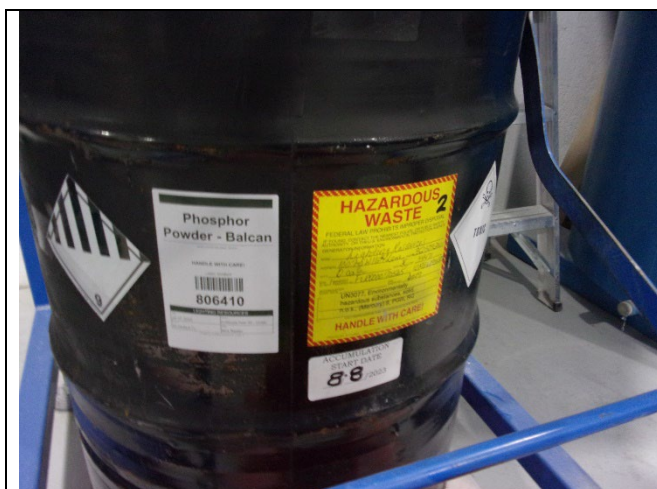
LR manages a SAA in the Balcan Room for managing hazardous waste phosphor powder that is generated by processed fluorescent lamps. The inspectors observed two (2) 55-gallon containers in this SAA. The containers were located under two (2) phosphor powder collection points for accumulating the phosphor powder, and they were equipped with a drum cover lid, which were closed. The first container was closed, dated, labeled D009 hazardous waste solid (mercury), and identified with an indication of the hazards of the contents (Figure 13 and 14). The second container observed was closed, dated, properly labeled, and identified with an indication of the hazards of the contents (Figure 15).

Figure 13: 12:47 PM Balcan Room  
One 55-gallon SAA container of phosphor powder observed.

Figure 14: 12:47 PM Balcan Room  
One 55-gallon SAA container of phosphor powder observed with hazardous waste label and indication of the hazards of the contents.

Figure 15: 12:51 PM Balcan Room  
One 55-gallon SAA container of phosphor powder observed.

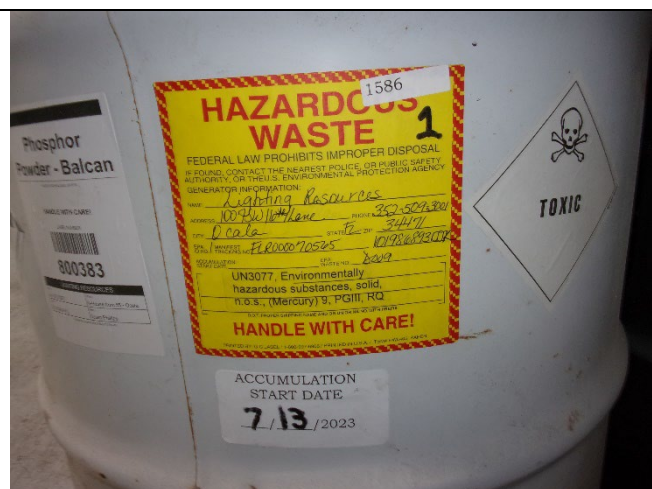
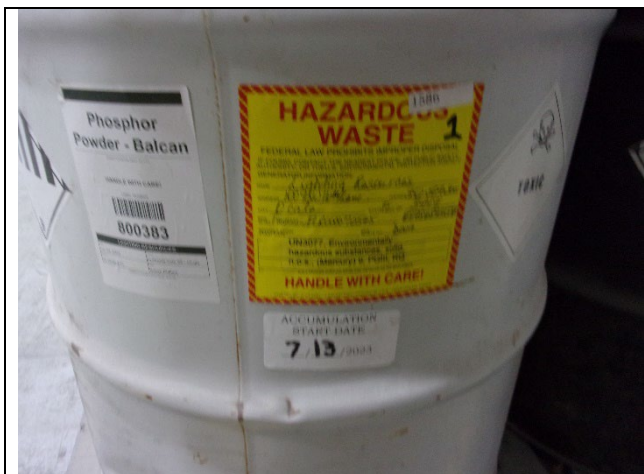
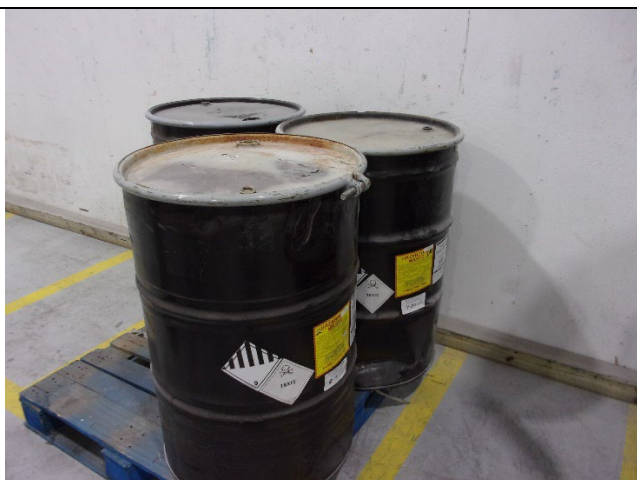
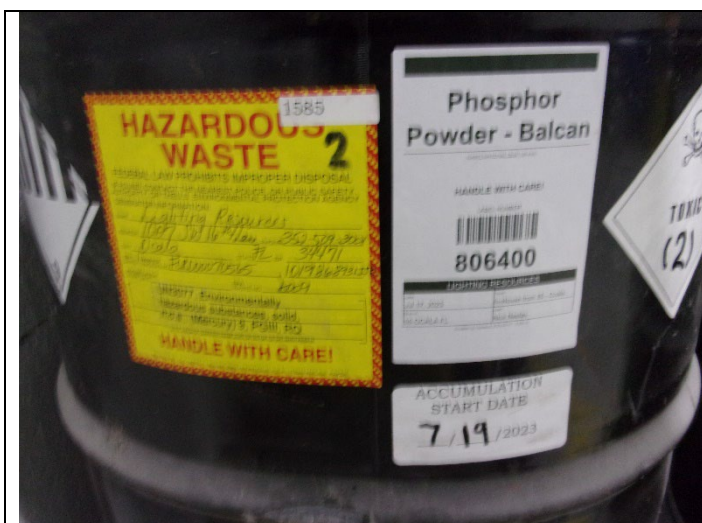
- Seven (7) 55-gallon drums of hazardous waste floor sweepings. The oldest accumulation start date was 4/5/2023;
- One 55-gallon drum of hazardous waste debris-A/C filters, spent PPE-gloves, masks, rags. The accumulation start date was 7/28/2023; and
- Eleven (11) 55-gallon drums of hazardous waste phosphor powder. The oldest accumulation start date was 7/13/2023 (Figures 16 through 19).

Figure 16: 12:57 PM Balcan Room CAA  
One of eleven (11) 55-gal containers of phosphor powder observed.

Figure 17: 12:57 PM Balcan Room CAA  
One of eleven (11) 55-gal containers of phosphor powder observed.

Figure 18: 12:58 PM Balcan Room CAA  
Two (2) of eleven (11) 55-gal containers of phosphor powder observed.

Figure 19: 12:58 PM Balcan Room CAA  
One of eleven (11) 55-gal containers of phosphor powder observed.

**Pursuant to Fla. Admin. Code Ann. r. 62-730.160(1) [40 C.F.R. § 262.17(b)], an LQG who accumulates hazardous waste for more than 90 days is an operator of a storage facility and is subject to the requirements of Fla. Admin. Code Ann. r. 62-730.180 [40 C.F.R. Parts 124, 264 through 268 and Part 270].**

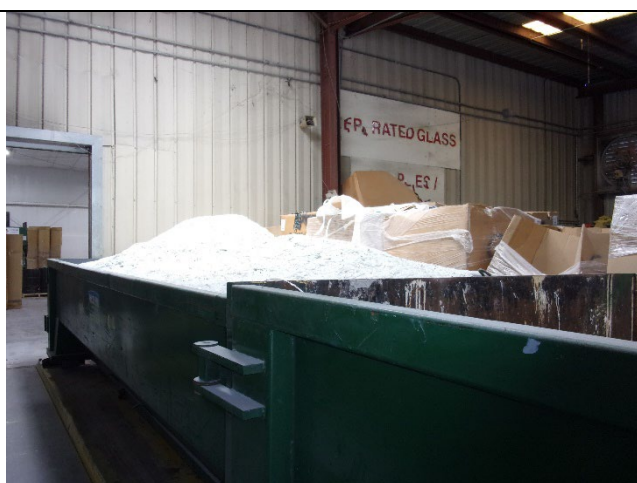
Inspectors observed glass cutlet accumulating in two (2) 20-yard roll-off containers; one was full and one was partially full (Figure 20). Sampling of glass cutlet to meet permit requirements is conducted in either the roll-off container or the tipper where the glass cutlet exits the Balcan in the Balcan Room. Inspectors asked facility personnel where exactly sampling takes place. On September 13, 2023, facility personnel stated in an email that sampling was taken at the end of two (2) process outlets from the Balcan Room.

Figure 20: 1:01 PM Warehouse C Area  
Two (2) 20-yard roll-off containers observed. One was full and one was partially full.

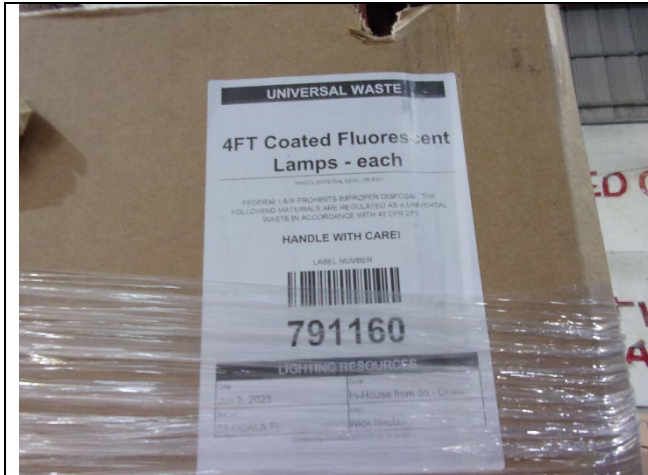
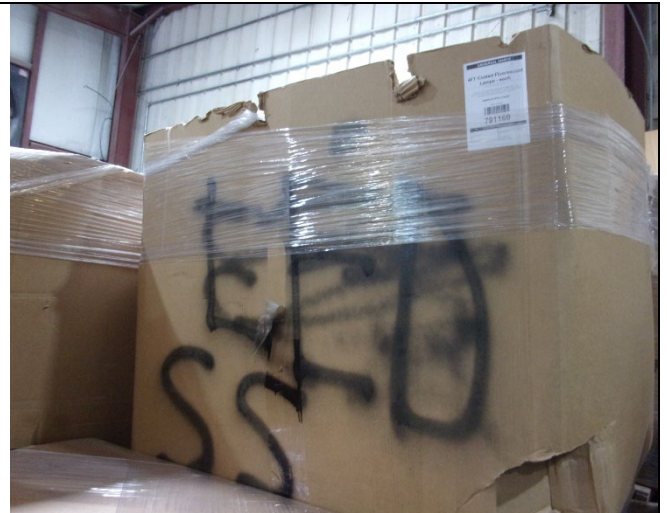
Supplies are also stored in this warehouse. Inspectors also observed containers of bulb ends, LED ballasts, X-ray film, and incandescent lamps. One Gaylord box container of fluorescent lamps with shatter shields was in this area (Figures 21 and 22).

Figure 21: 1:05 PM Warehouse C Area  
One Gaylord box container of fluorescent lamps with shatter shields observed.

Figure 22: 1:05 PM Warehouse C Area  
One Gaylord box container of fluorescent lamps with shatter shields observed.

**Pursuant to HW Permit 309339-004-HO, Part II Subpart B – Specific Operating Conditions, the Permittee shall not exceed the limits identified in Table 3-3 of the permit application and incorporated as Attachment B of this permit.**

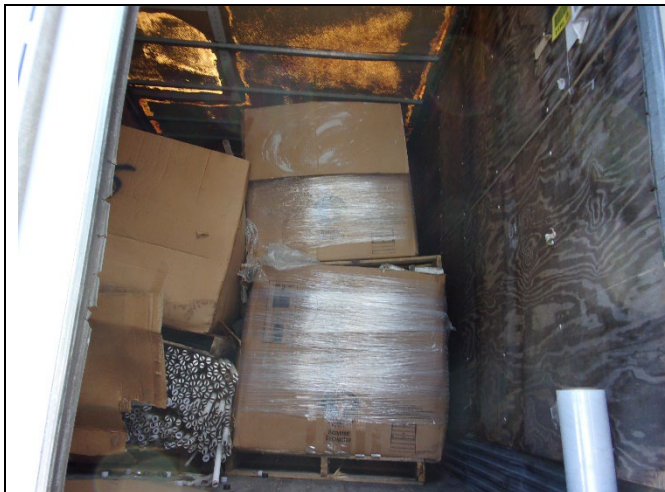
Outside Warehouse C included three (3) tractor-trailers parked on the northeast side of the building. One of the three tractor-trailers stored fluorescent lamps with shatter shields (Figure 23). Inspectors asked facility personnel if these lamps were allowed to be stored outside the permitted area. Facility personnel stated that they were temporarily staged in the tractor-trailers before being stored within the permitted storage area.

Figure 23: 1:09 PM Outside Warehouse C Area  
Observed is one of the three (3) tractor-trailers storing fluorescent lamps with shatter shields.

**Pursuant to HW Permit 309339-004-HO, Part II Subpart B – Specific Operating Conditions, the Permittee shall not exceed the limits identified in Table 3-3 of the permit application and incorporated as Attachment B of this permit.**

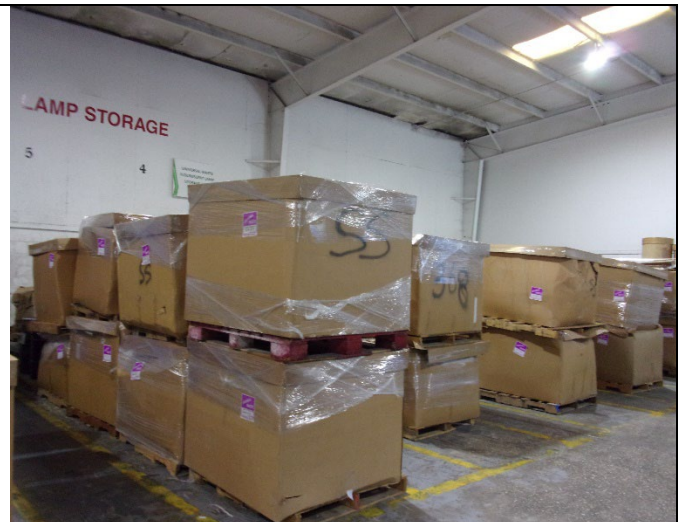
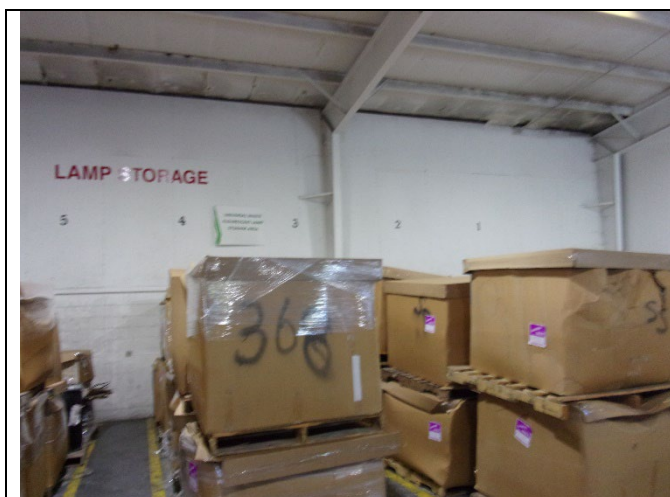
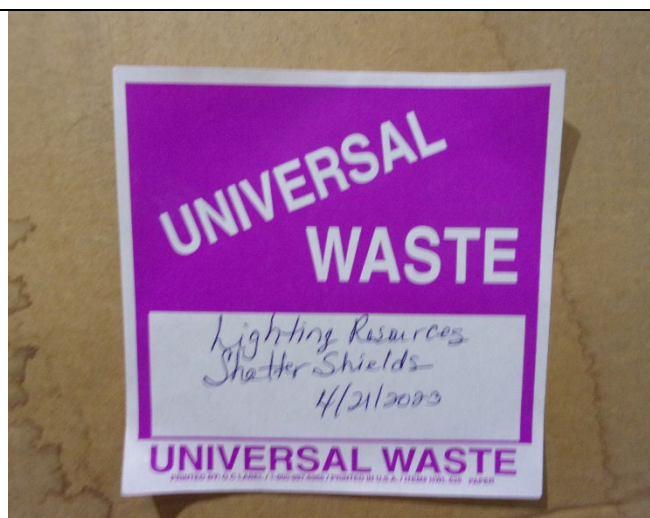
No containers were observed in these areas at the time of the facility walkthrough. However, at the end of the inspection, facility personnel notified inspectors that the facility had stored fluorescent lamps with shatter shields from one tractor trailer outside Warehouse C (Figures 24 through 26). See section titled “Outside Warehouse C” for more details.

Figure 24: 5:07 PM Rows 2 and 3  
Stored fluorescent lamps with shatter shields from one tractor trailer outside Warehouse C.

Figure 25: 5:08 PM Rows 2 and 3  
Stored fluorescent lamps with shatter shields from one tractor trailer outside Warehouse C.

Figure 26: 5:08 PM Rows 2 and 3  
Container label for one Gaylord box from tractor trailer outside Warehouse C.
