**Re: Compliance Assistance Offer
Ring Power Corporation
EPA/DEP ID: FLD 984 206 854
Columbia County – Hazardous Waste**

**Florida Department of
Environmental Protection
Hazardous Waste Inspection Report**

Facility Name: Ring Power Corporation

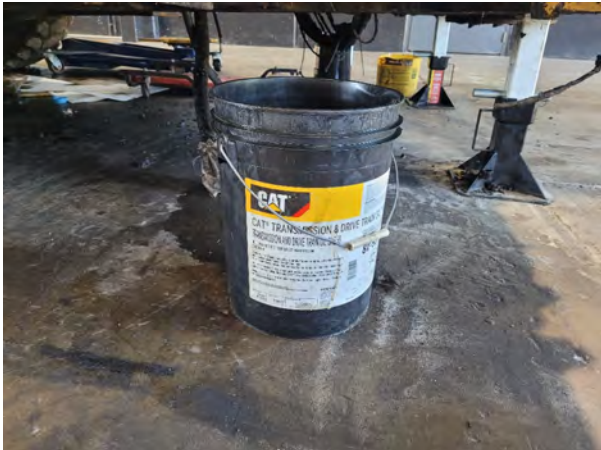
Photo 1

Used oil is drained into portable drain containers and then pumped into a 1,000-gallon double-walled tank located in the Tank Farm, described below. There was one 5-gallon container of used oil that was not properly labeled with the words "Used Oil" (Photo 1) [40 CFR 279.22(c)(1)]. The container was properly labeled during the inspection. All other used oil drain containers and the used oil tank were in good condition and properly labeled.

Type: Violation
Rule: 279.22(c)
Explanation: Maintenance and Repair Shops: one 5-gallon container was not properly labeled as "Used Oil."
Corrective Action: No further action is required. The facility returned to compliance during the inspection.

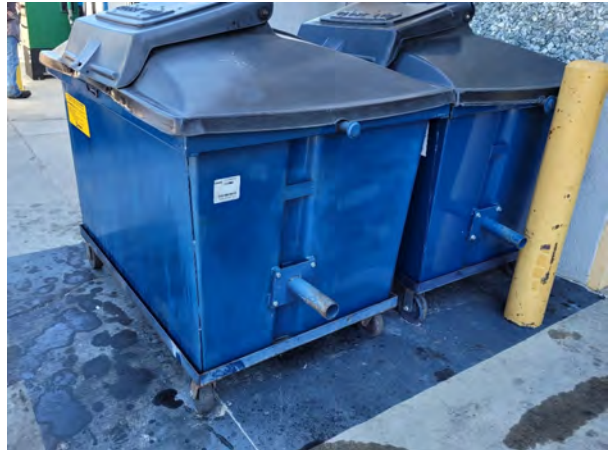
Photo 2

Used oil filters are drained into used oil containers and then accumulated in 330-gallon steel containers. There were two 330-gallon containers accumulating filters just outside of the Heavy Equipment area for Heavy Equipment and Rental Shop use. Both containers were in good condition, closed and properly labeled as "Used Oil Filters." Both containers were stored on what appeared to be an unsealed concrete surface that contained large cracks (Photo 2) [62-710.850(5)(a), FAC].

Type: Violation
Rule: 62-710.850(5)(a)
Explanation: Maintenance and Repair Shops: Two 330-gallon containers of used oil filters were not accumulating on an oil-impermeable surface.
Corrective Action: In order to return to compliance, the facility should store the containers on an oil-impermeable surface.

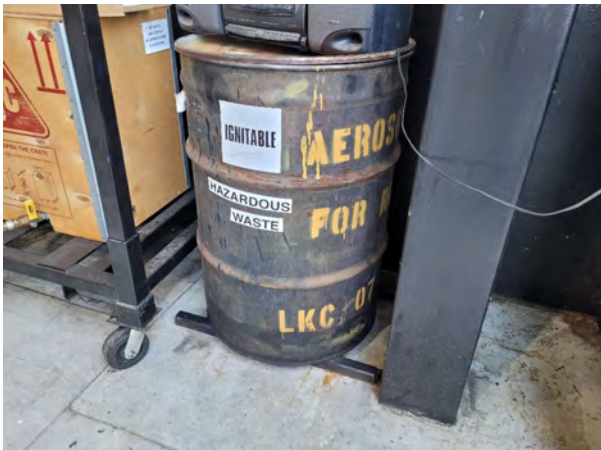
Photo 5

Aerosol cans generated in the truck shop are accumulated in a 55-gallon container before being brought to the puncturing device. The container was closed and properly labeled as "Hazardous Waste," but was not marked with an indication of the hazards of the contents (Photo 5) [40 CFR 262.15(a)(5)(ii)]. The container was marked as "Ignitable," but not "Toxic."

Type: Violation
Rule: 262.15(a)(5)(ii)
Explanation: Maintenance and Repair Shops: Two 55-gallon containers of hazardous waste were not marked with an indication of the hazards of the contents.
Corrective Action: No further action is required. The facility returned to compliance via an email dated July, 18, 2024.

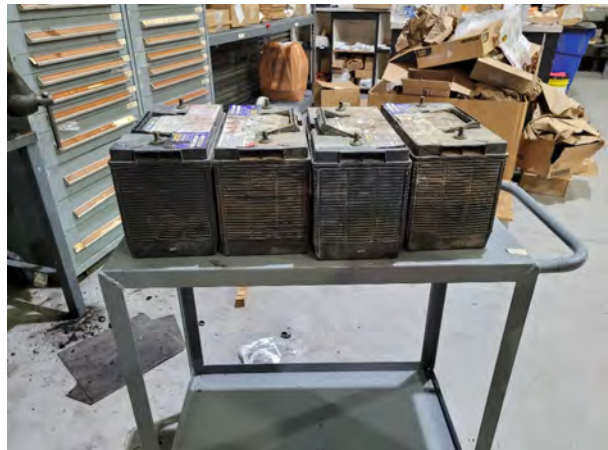
Photo 6

The Parts Warehouse contains parts, equipment and materials for shipping and receiving. There were four lead acid batteries accumulating in this area at the time of the inspection (Photo 6). The batteries are transported by East Penn Manufacturing, Inc. for recycling.

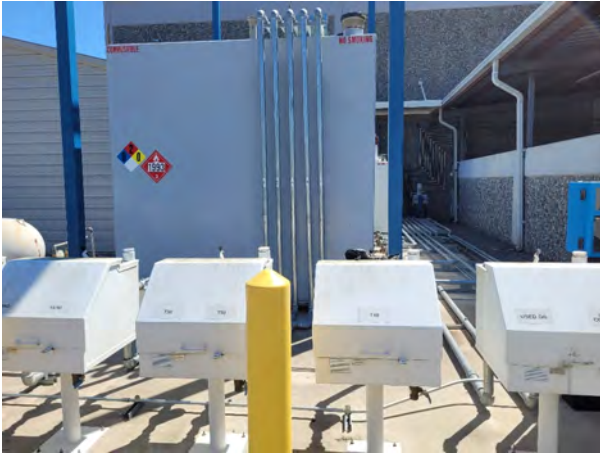
Photo 7

There is one 1,000-gallon used oil tank and one 500-gallon used coolant tank located within a secondary containment structure located outside (Photo 7). The used oil tank appeared to be in good condition, was closed and properly labeled as "Used Oil." There are also five additional tanks within the secondary containment structure used to store product oil.

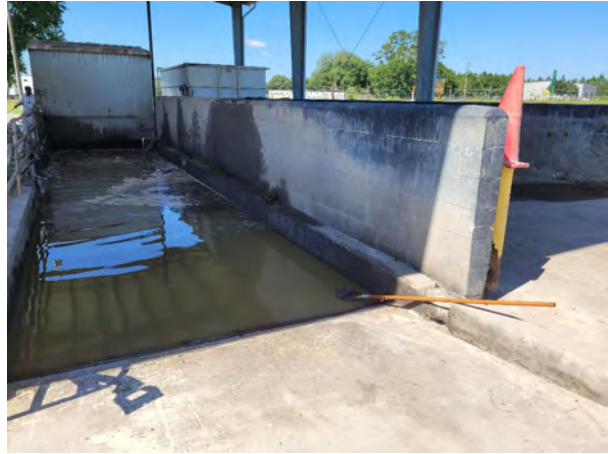
Photo 8

The Wash Rack is a covered area used to wash equipment or vehicles potentially contaminated with oil and dirt prior to service with Mean Green 9 and/or heated water (Photo 8). Wash water drains to an aerated collection pit. The collection pit contains weirs that filter particulate matter from the wash water. The accumulated dirt /debris is cleaned out of the collection pit as needed and dried in an accumulation area adjacent to the Wash Rack. Dirt/debris collected from the collection pit is disposed of as non-hazardous waste at Evergreen Landfill in Valdosta, Georgia. TCLP analysis of the dirt and debris indicates that it does not contain volatile, semi-volatile, metal, or pesticide constituents above the regulatory limits. The facility has TCLP analysis and generator knowledge that the dirt does not contain herbicides above the regulatory limits. Water is directed from the collection pit to an oil water separator. The skimmed oil accumulates in a sump where it is removed and added to used oil from other facility operations. The water is then pumped to a biofiltration unit that treats the water with microbes before returning it to the process. Sludge that accumulates in the biofiltration unit is cleaned out as needed and the filters are cleaned approximately every 1-2 years. Sludge was last disposed of on May 29, 2024, and was managed as non-hazardous waste, but the facility has not conducted and documented an adequate hazardous waste determination to support this action [40 CFR 262.11]. The facility was reminded to conduct a hazardous waste determination on the sludge before disposal in the last inspection report. The facility indicated that the TCLP analysis on the wash rack soil was representative of this wastestream, but the Department does not agree that the soil is representative of the biofiltration sludge.

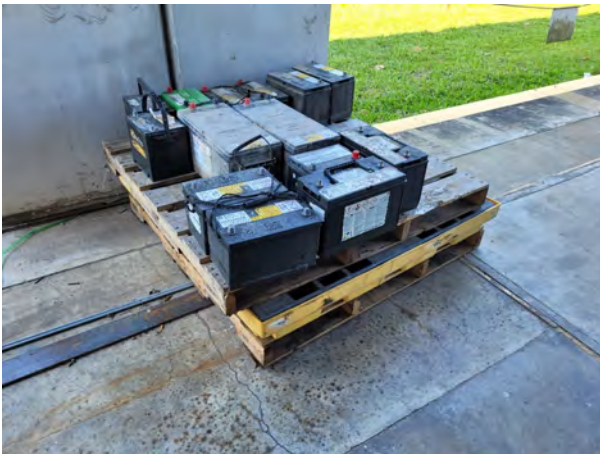
Photo 9

This area is used to store spent lead-acid batteries. There were 14 lead-acid batteries accumulating at the time of the inspection (Photo 9).
