SUBJECT: Department of Environmental Protection v. Liquid Environmental Solutions of Florida, LLC
OGC File No. 24-0068
Facility ID No. FLD981928484
Duval County

RE: Warning Letter No. WL23-225 (Significant Non-Complier)
Liquid Environmental Solutions of Florida, LLC
EPA/DEP ID: FLD981928484
Duval County – Hazardous Waste

**Florida Department of
Environmental Protection
Hazardous Waste Inspection Report**

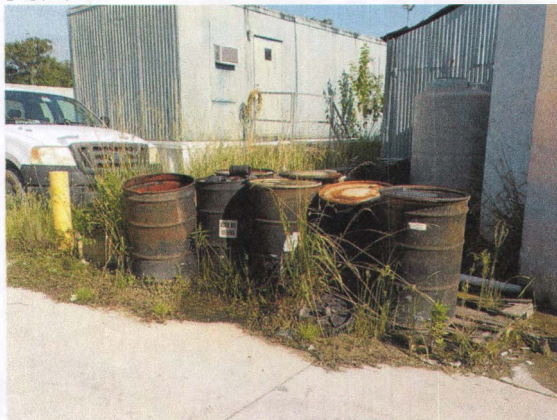
Photo 3

Waste was stored in the area between the Old Laboratory and the Used Oil Processing Area, described below. This area is within the secondary containment. There were four 55-gallon drums of used oil filters stored north of the entrance to the secondary containment (Photo 3). All of the drums were properly labeled as "Used Oil Filters," but there was one drum that was open and filled with water (Photo 4) [62-710.850(5)(a), FAC]. In addition, because this area is within the secondary containment structure, it should be maintained free of vegetation and soil to allow for proper inspection. This is an Area of Concern.

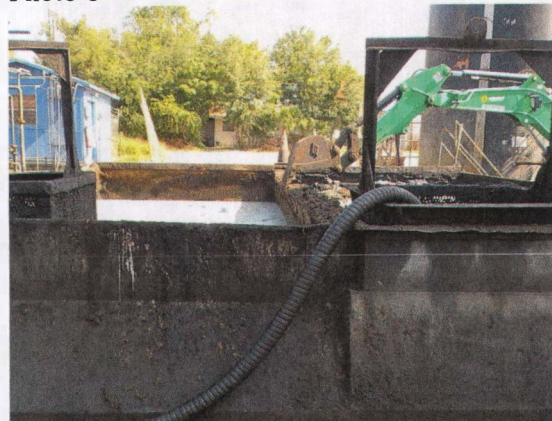
Photo 6

Two open, concrete and steel lined Tanks, 61 and 62, are dedicated for solids and sludge solidification and have a total capacity of 16,000 gallons (Photo 6). The facility solidifies materials such as non-hazardous wastewater with high solids content, and occasionally, latex paint, etc. The facility uses the waste profile, SDS and/or analytical testing to ensure that the waste is non-hazardous. The facility is reminded that it is not permitted to accept any hazardous waste. A heavy screen cage is used to physically separate the liquids from the solids in each tank. Facility staff use a large suction hose to transfer the liquid portion of wastewaters to one of the oily water tanks. Removal of liquid oily waste from the tank during the solidification process reduces the overall waste volume. Off-specification products, paints and other non-wastewaters would not be suctioned and would be solidified directly. Bails of absorbent paper dust material are used for solidification. Waste solids are placed into a roll-off container that is transported by Hull's Environmental to the Camden County, Georgia Municipal Waste Landfill approximately 10 times per month. The facility currently analyzes the waste solids

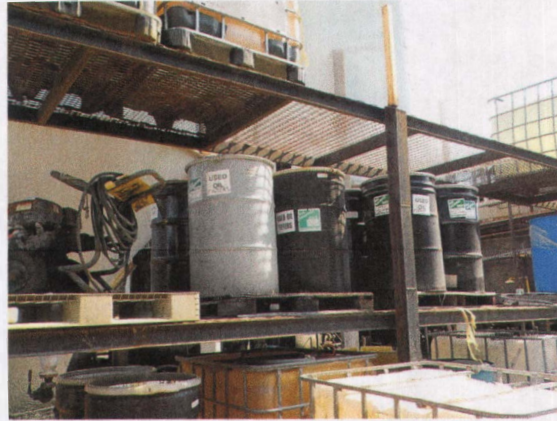
Photo 10

Used oil filters are stored on a rack adjacent to the Container Storage Area described above. The facility is a registered used oil filter processor and transporter, however, the facility does not currently transport or process the used oil filters. The facility receives a small number of used oil filters which are shipped off-site for recycling as needed. The filters arrive at the facility in drums, and any free liquids inside the drum are pumped out and processed as used oil prior to off-site disposal. After removal of any free liquids, the drums are placed onto the rack in the Used Oil Filter and Container Storage Area until they can be picked-up for management by Safety Kleen Systems, Inc. There were eight drums of used oil filters stored on the rack at the time of inspection (Photo 10). The drums were closed, properly labeled and stored on an oil-impermeable surface.

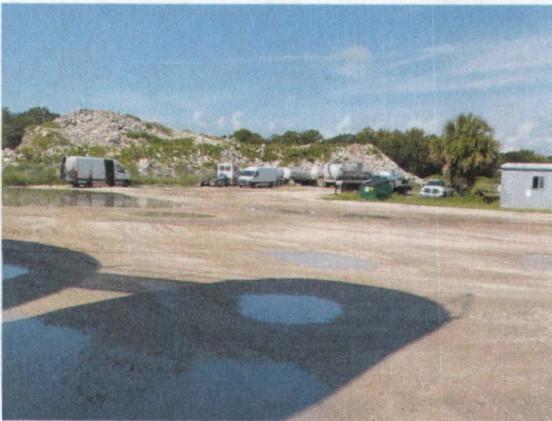
Photo 11

The Transportation Area is a large sand lot where the facility parks its tanker trucks, disconnected semi-truck trailers and tankers (Photo 11). A small building located in this area has been converted into office space and a shop for transportation activities since the previous inspection. This area is located on a separate parcel and leased from a separate party. No hazardous waste is generated in this area. Vehicles are serviced off site. There were no containers accumulating in this area.
