## **Hazardous Waste Inspection Report**

Facility Name: Jacksonville Transflo Terminal

On-Site Inspection Start Date: 11/14/2024 On-Site Inspection End Date: 11/14/2024

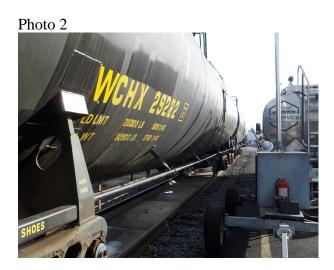
Photo 1

The facility has five loading tracks, Tracks 1 – 5. Used oil is only received for truck-to-rail transfers into one or two cars that are staged on Track 1 (Photo 1). This track is also used for rail transfers of raw products. Track 2 is used to receive product peroxide liquids, Track 3 is used to receive other products including tall oil, and Track 4 is used to receive dry bulk products. Products typically arrive by rail and are transferred to trucks for distribution. Transflo currently accepts used oil only from Heritage Crystal Clean (HCC, FLR000154278). HCC transports used oil in trucks to the rail yard where it is transferred into rail cars by Transflo contractor personnel. Used oil rail cars have a capacity of approximately 28,000 gallons, and they are loaded with used oil over numerous trips. To ensure the rail cars do not remain on-site longer than 35-days, Transflo notifies HCC when the rail car either approaches capacity or when day 35 is approaching. HCC is responsible for coordinating off-site shipment via CSX who arranges for the movement of the rail cars. The facility maintains a logbook on-site that documents the rail car number, the date of the first off-load into the rail car, the total amount off-loaded, the anticipated date of removal, and the actual date of removal. There were two used oil rail cars accumulating on Track 1 at the time of the inspection (Photo 2).
