Re: Compliance Assistance Offer
Triumvirate Environmental Services, Inc.
HW FLD980559728
Orange County

**Florida Department of
Environmental Protection
Hazardous Waste Inspection Report**

Facility Name: Triumvirate Environmental Services LLC

On-Site Inspection Start Date: 02/19/2025

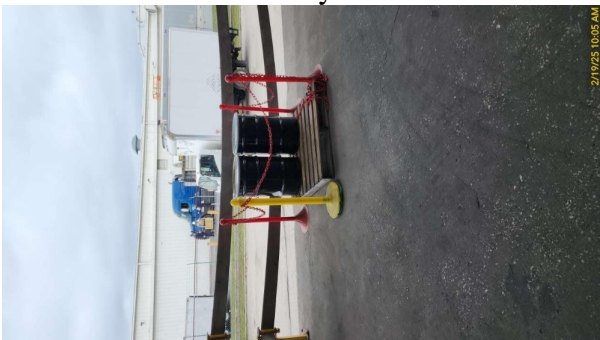
Photo 1 - Transfer facility waste

The 10-day transfer facility was located on the west side of the loading dock. Two 55-gallon drums were located in the area. The area was demarcated with a chain strung along stanchions but was not identified with signage.

as the 10-day transfer facility (Photo 1) [403.727(1)(c), Florida Statutes (F.S.)]. Four semi-trailers were parked at the loading dock, three on the south side and one on the north side. On the south side, one was being loaded and the other two were empty. The semi-trailer on the north side was awaiting off-loading.

- Transfer facility waste on the loading dock did not have signage [permit condition Part II Subpart B Number 10]
- Approximately 28 waste containers have been stored on the loading dock for greater than ten days [Attachment II.A.1: Contingency Plan of the permit application dated May 1, 2023 which is incorporated as part of the permit]
- The labels on three waste containers in the Container Storage Building were not facing the aisle [Attachment II.B.4: Container Management of the permit application dated May 1, 2023 which is incorporated as part of the permit]
- Seven boxes of biohazard waste did not contain a barcode label indicating the wastes have been checked-in to inventory [permit condition Part II Subpart B Number 6]

Signage was immediately placed at the transfer facility waste on the loading dock.

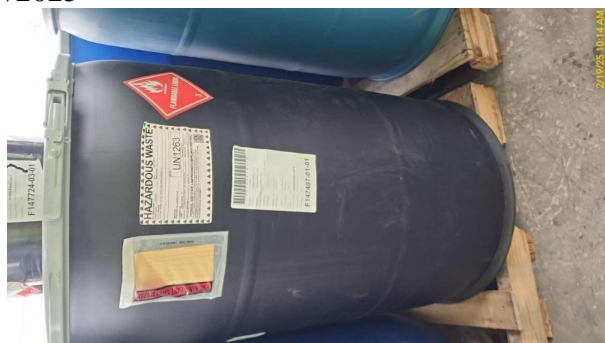
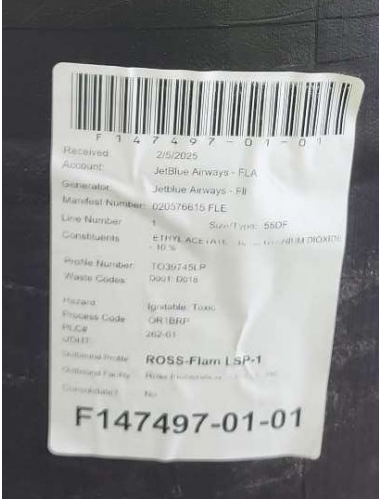
Photo 2 - Waste container on loading dock since 2/5 /2025

Photo 3 - Close-up of container label in Photo 2

On February 27, 2025, Mr. Cutshall emailed stating he talked with his team and had meetings with the regions that ship to TES that TES can only store material for ten days on the loading dock and the containers with labels not facing out has been fixed.

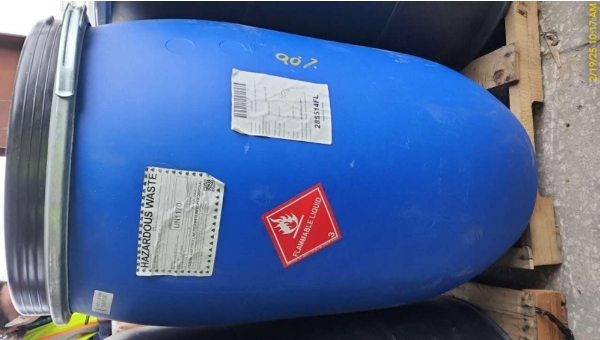
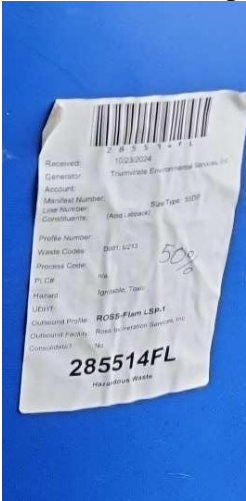
Photo 4 - Waste container on loading dock since 10/23/2024

Photo 5 - Close-up of container label in Photo 4

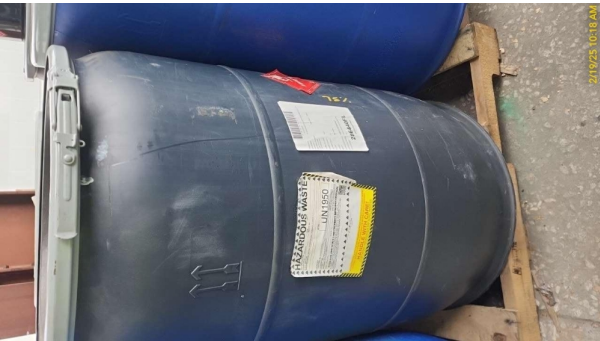
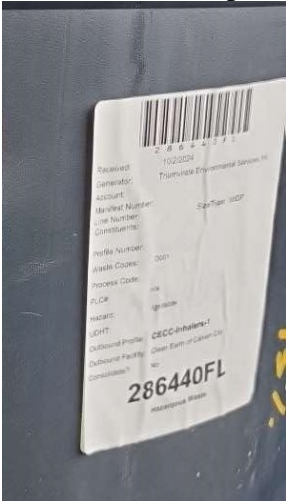
Photo 6 - Waste container on loading dock since 10/2/2024

Photo 7 - Close-up of container label in Photo 6

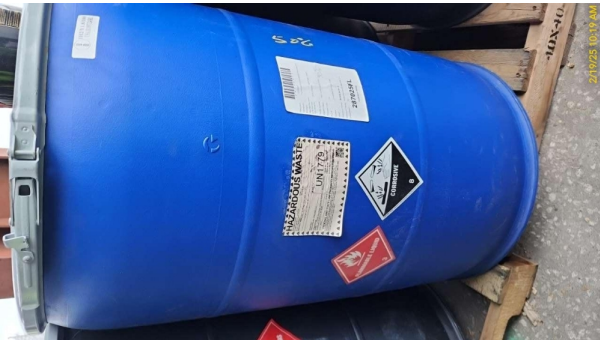
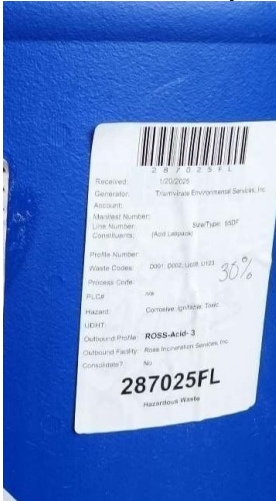
Photo 8 - Waste container on loading dock since 1/20/2025

Photo 9 - Close-up of container label in Photo 8

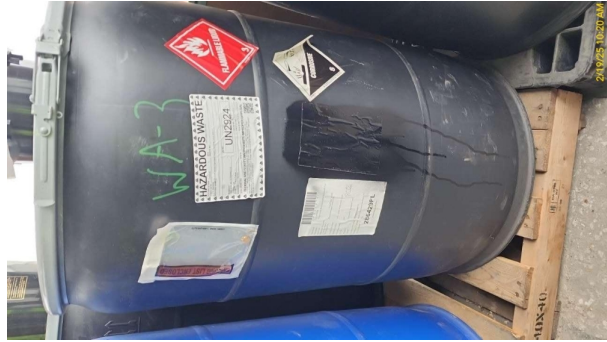
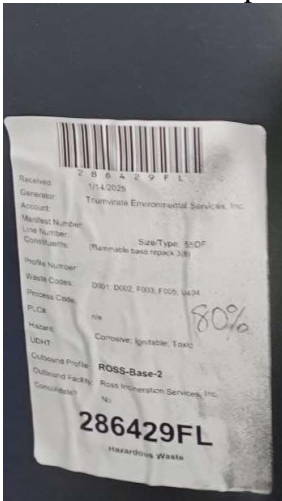
Photo 10 - Waste container on loading dock since 1/14/2025

Photo 11 - Close-up of container label in Photo 10

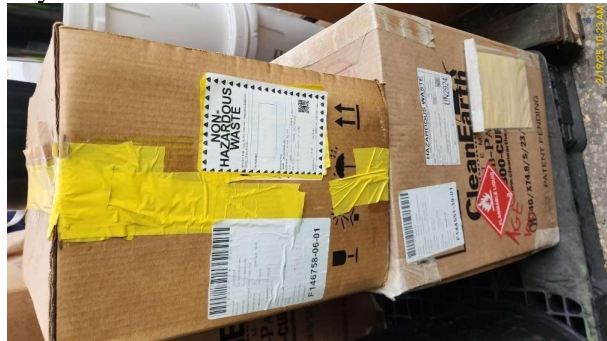
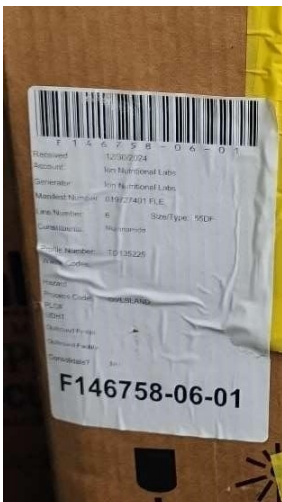
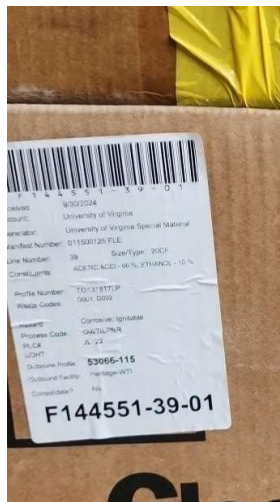
Photo 12 - Waste containers on loading dock over ten days

Photo 13 - Close-up of container label in Photo 12 dated 12/30/2024

Photo 14 - Close-up of container label in Photo 12 dated 9/30/2024

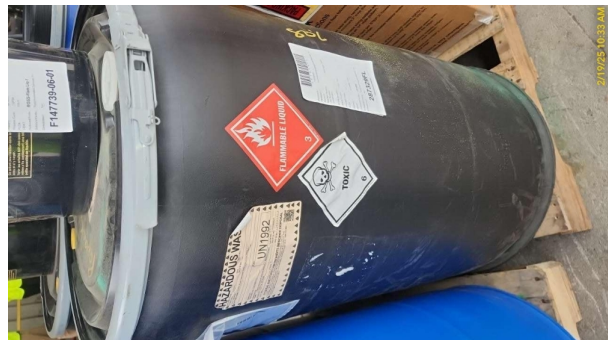
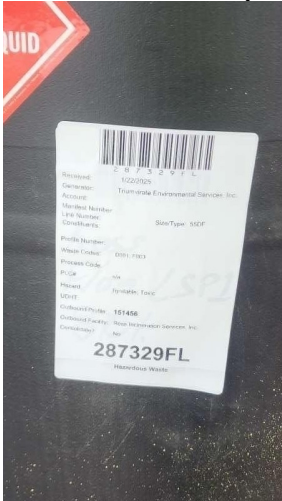
Photo 21 - Close-up of container label in Photo 20

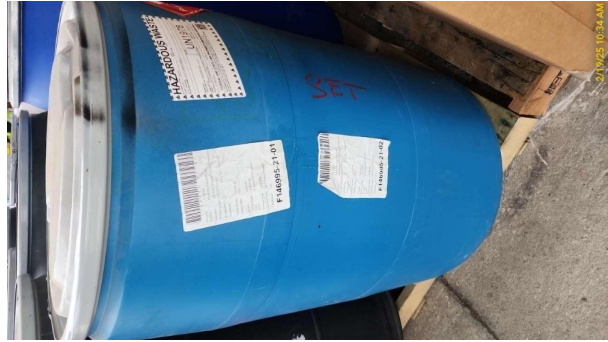
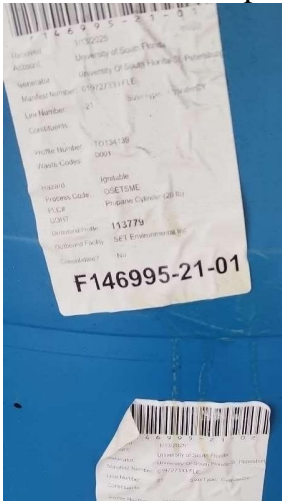
Photo 22 - Waste container on loading dock since 1/13/2025

Photo 23 - Close-up of container label in Photo 22

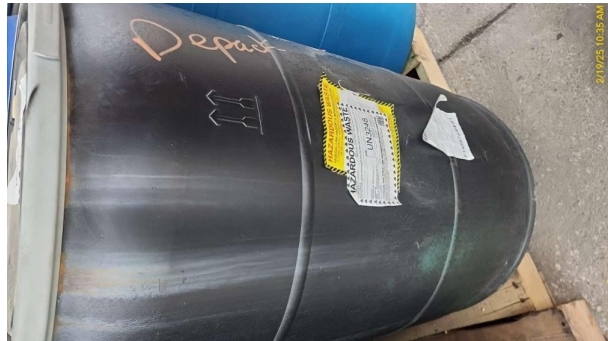
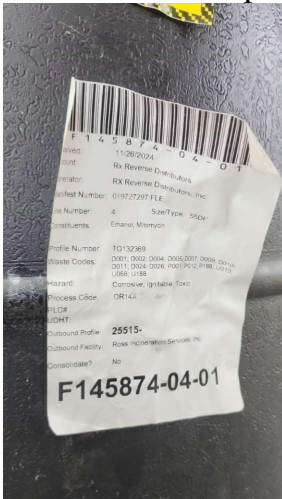
Photo 24 - Waste container on loading dock since 11/26/2024

Photo 25 - Close-up of container label in Photo 24

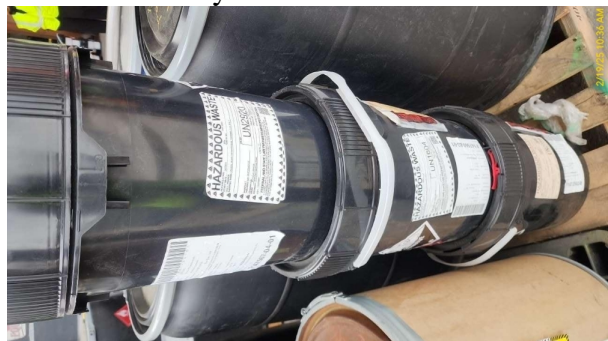
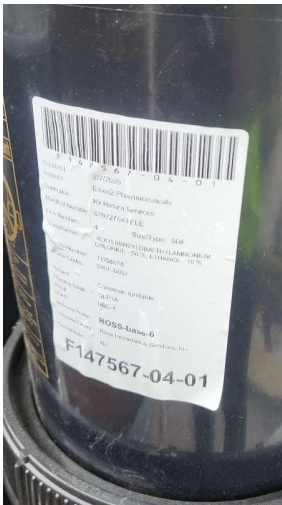
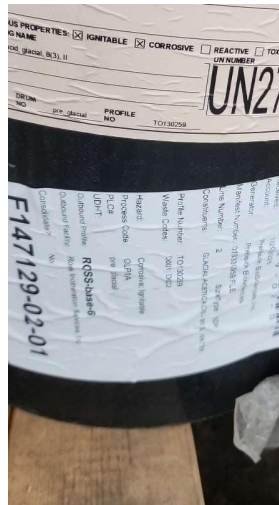
Photo 26 - Top & bottom waste containers on loading dock over 10 days

Photo 27 - Close-up of container label in Photo 26 dated 2/7/2025

Photo 28 - Close-up of container label in Photo 26 dated 1/20/2025

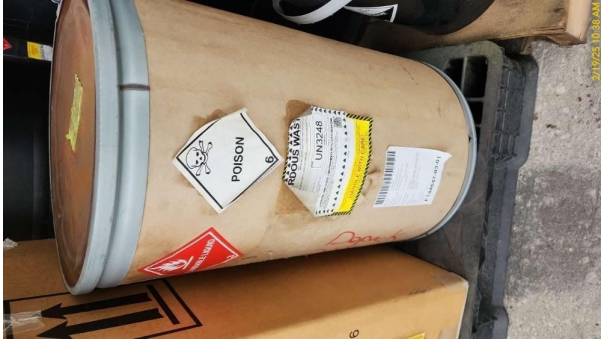
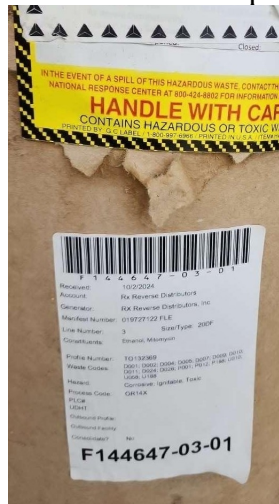
Photo 29 - Waste container on loading dock since 10/2/2024

Photo 30 - Close-up of container label in Photo 29

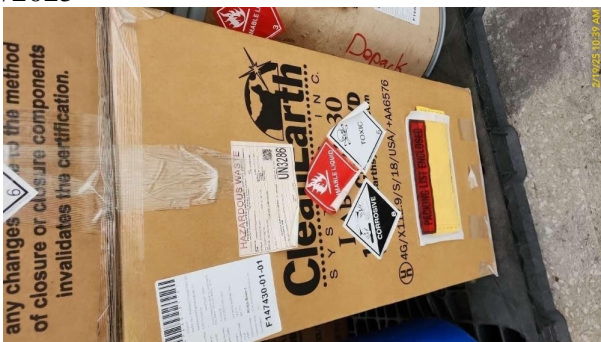
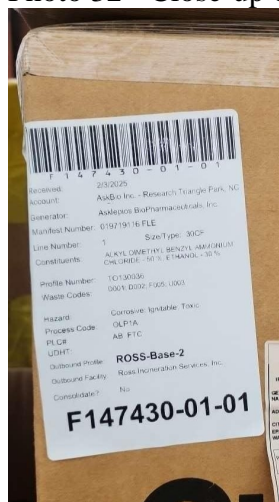
Photo 31 - Waste container on loading dock since 2/3/2025

Photo 32 - Close-up of container label in Photo 31

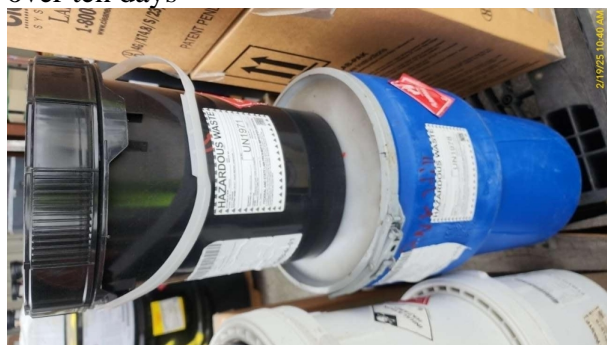
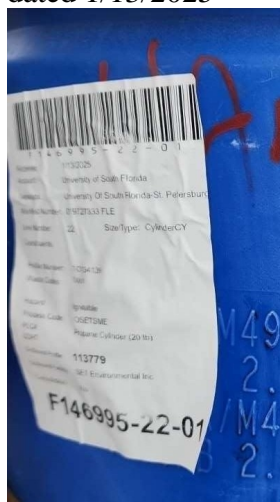
Photo 33 - Bottom waste container on loading dock over ten days

Photo 34 - Close-up of container label in Photo 33 dated 1/13/2025

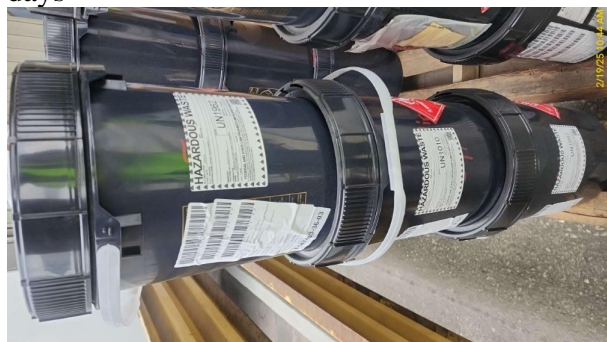
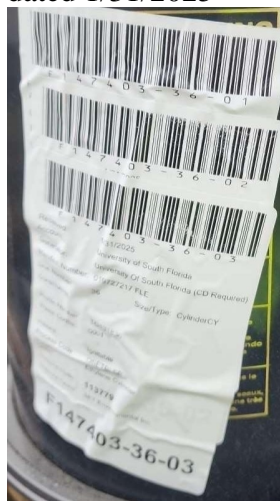
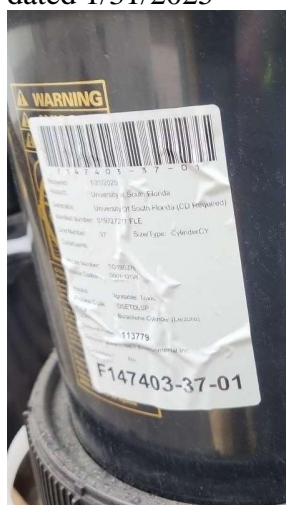
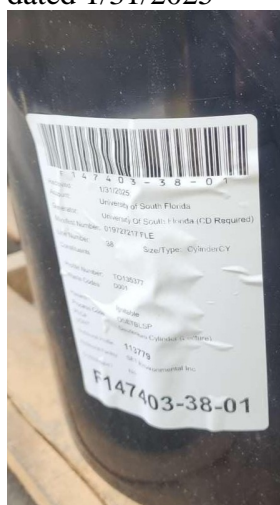
Photo 35 - Waste containers on loading dock over ten days

Photo 36 - Close-up of container label in Photo 35 dated 1/31/2025

Photo 37 - Close-up of container label in Photo 35 dated 1/31/2025

Photo 38 - Close-up of container label in Photo 35 dated 1/31/2025

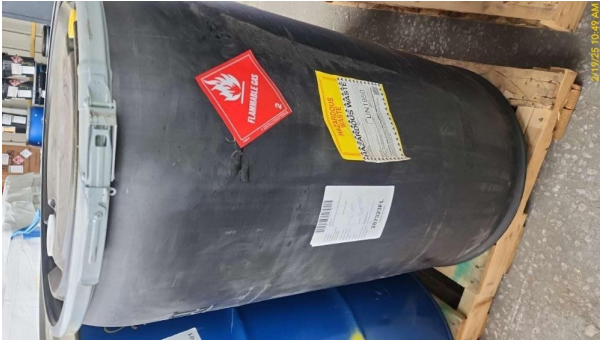
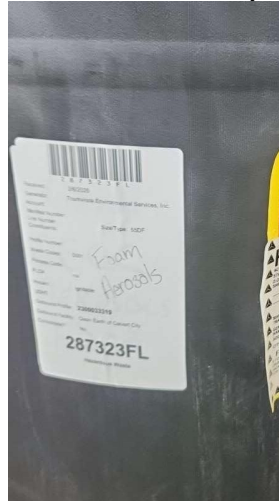
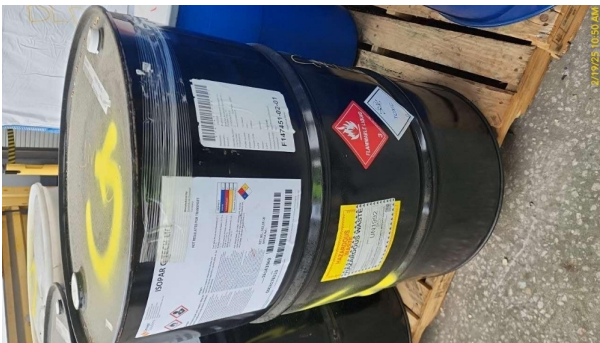
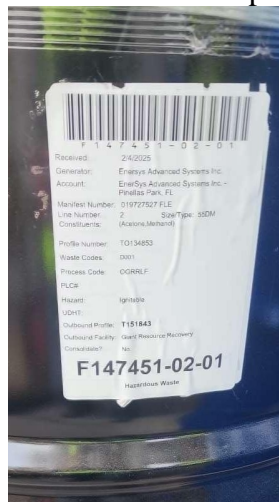
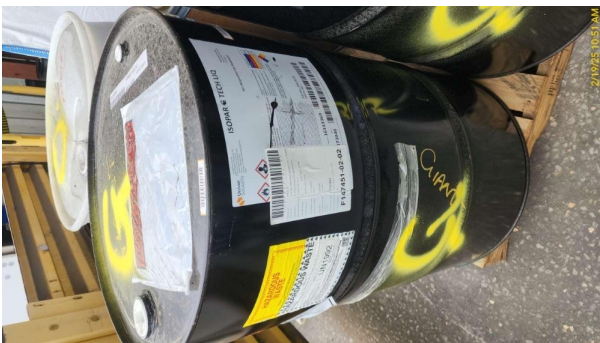
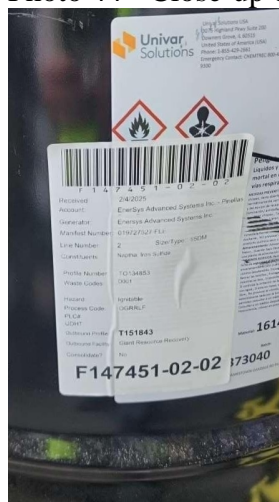
Photo 39 - Waste container on loading dock since 2/6 /2025 Photo 40 - Close-up of container label in Photo 39

Photo 41 - Waste container on loading dock since 2/4 /2025 Photo 42 - Close-up of container label in Photo 41

Photo 43 - Waste container on loading dock since 2/4 /2025 Photo 44 - Close-up of container label in Photo 43

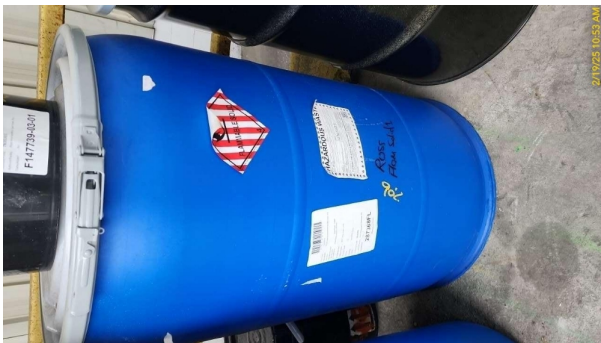
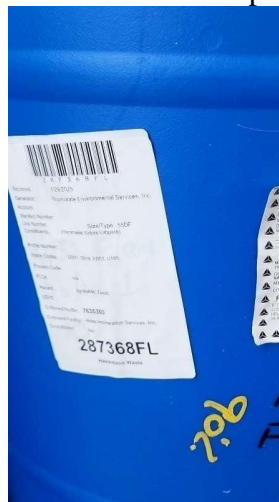
Photo 47 - Waste container on loading dock since 1 /29/2025

Photo 48 - Close-up of container label in Photo 47

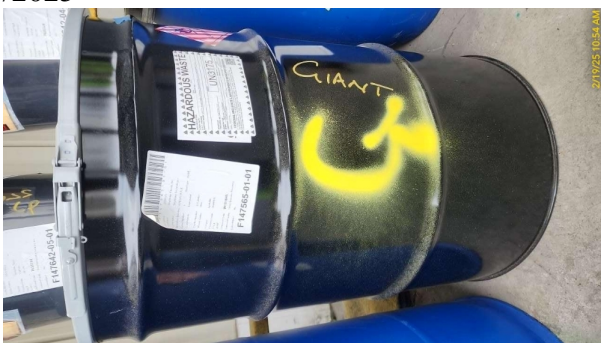
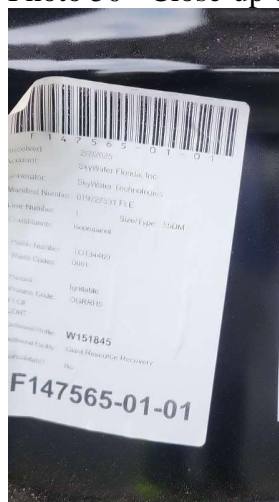
Photo 49 - Waste container on loading dock since 2/7 /2025

Photo 50 - Close-up of container label in Photo 49

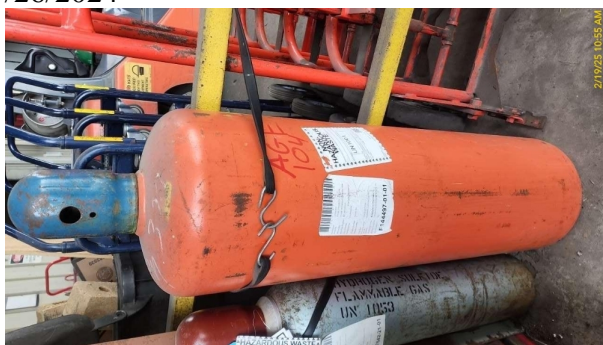
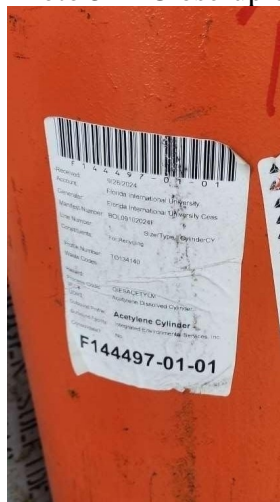
Photo 51 - Waste container on loading dock since 9/26/2024

Photo 52 - Close-up of container label in Photo 51

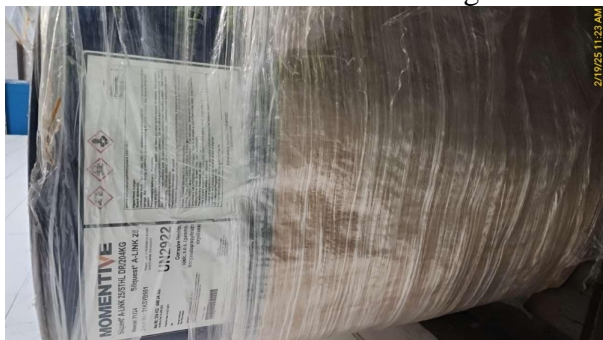
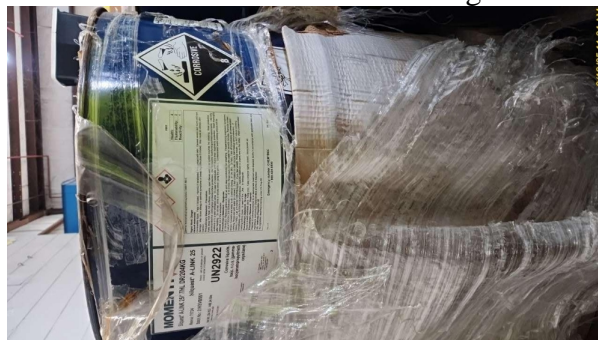
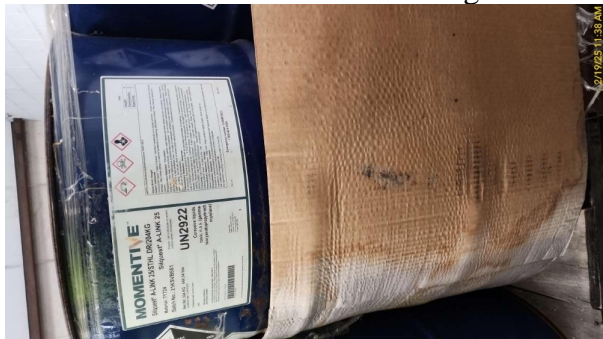
Photo 53 - Container label not facing aisle

Photo 54 - Container label not facing aisle

Photo 55 - Container label not facing aisle

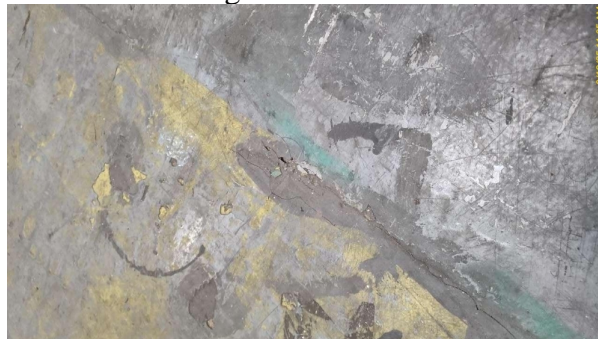
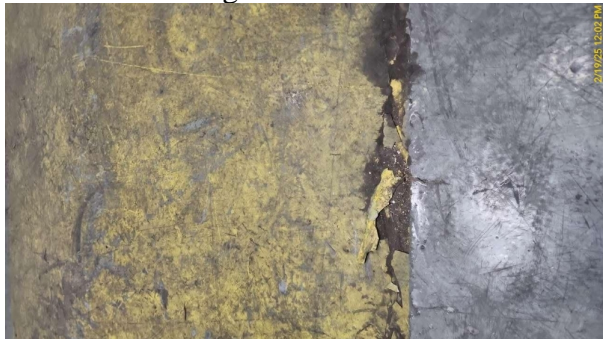
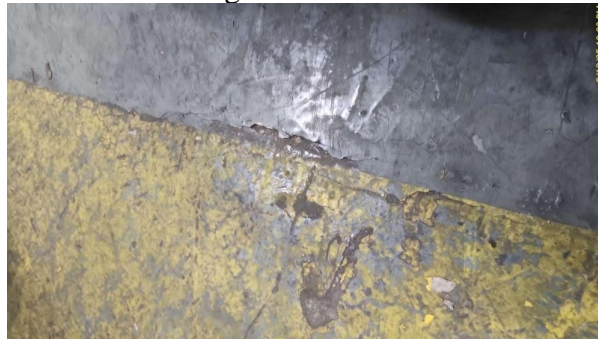
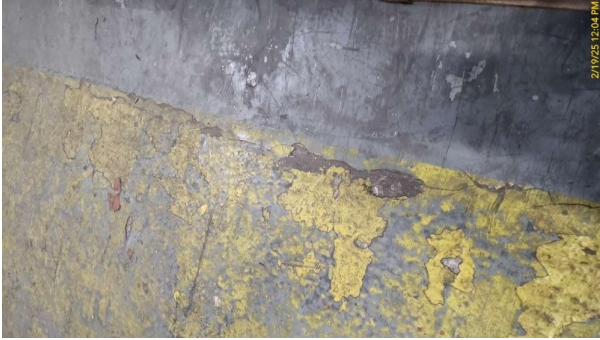
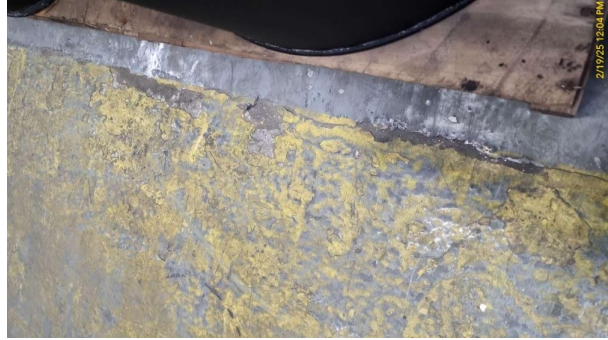
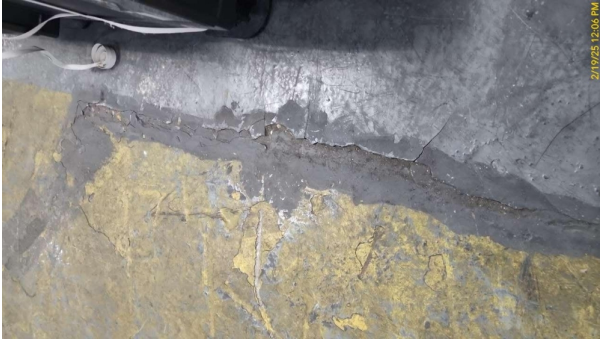
The middle of the Container Storage Building contained approximately 65 containers of varying sizes, shrink-wrapped boxes, and pallets of hazardous, non-hazardous solid, and universal wastes. Several areas of the floor in the middle of the Container Storage Building, near the roll-over berms, had damaged or cracked sealant (Photos 56 to 61).

Weekly facility inspection logs were reviewed from September 21, 2023 to February 14, 2025. No comments were entered into the logs regarding the damaged floor sealant.

NOTE: Per permit condition Part II Subpart B.2 Number 4, the permittee shall inspect the integrity of the containment area to insure [sic] that it is free of cracks or gaps, and the concrete sealant remains impervious to leaks, and Attachment II.B.5: Container Management of the permit application dated May 1, 2023 which is incorporated as part of the permit, weekly inspection requires inspection for cracks and gaps in the secondary containment.

Photo 56 - Damaged floor sealant

Photo 57 - Damaged floor sealant

Photo 58 - Damaged floor sealant

Photo 59 - Damaged floor sealant

Photo 60 - Damaged floor sealant

Photo 61 - Damaged floor sealant

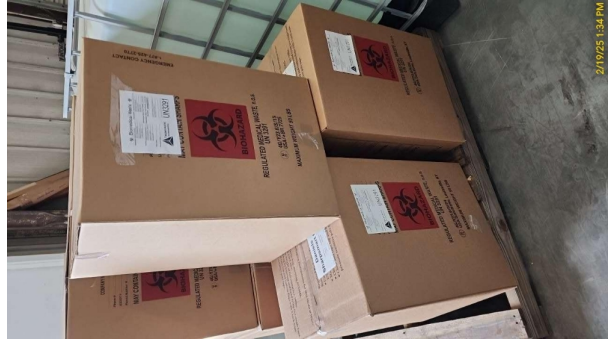
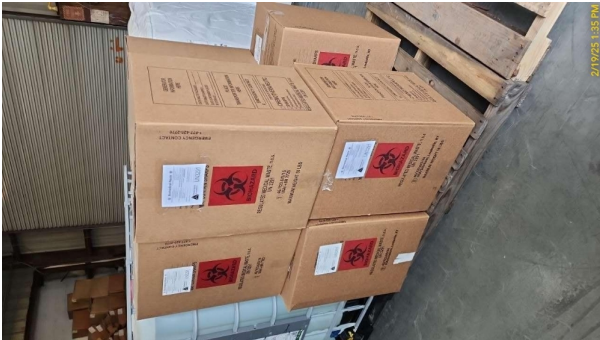
The area is currently being used for storage of supplies and hazardous, non-hazardous solid, universal, and biohazard wastes, and bottle washing. Wastes in the area included approximately 20 containers of varying sizes and boxes. Seven boxes of biohazard waste did not contain a barcode label indicating the wastes have been checked-in to inventory (Photos 62 and 63) [403.727(1)(c), F.S.].

Photo 62 - Waste containers with no barcode label

Photo 63 - Waste containers with no barcode label

Please provide documentation the boxes of biohazard waste have been provided a barcode label to the Department within 30 days from the date of your receipt of this report.

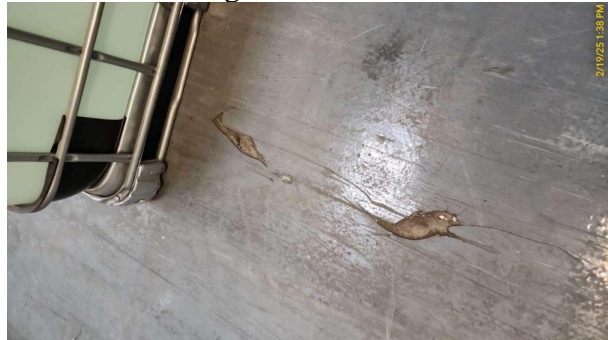
Photo 64 - Damaged floor sealant

One area of the floor on the south side of the Consolidation and Waste Stabilization Area had damaged or cracked sealant (Photo 64).

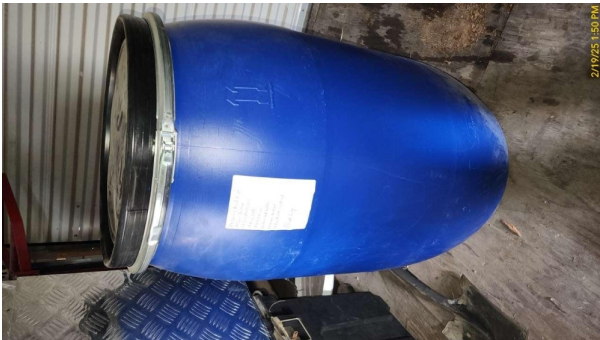
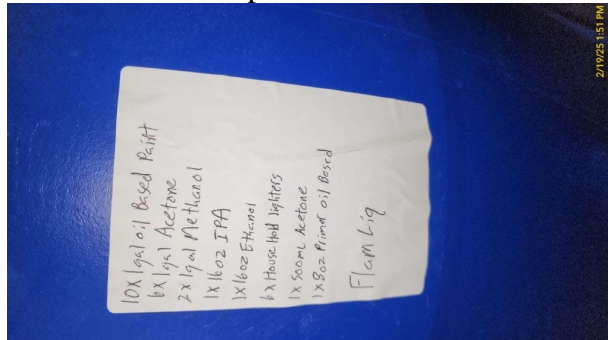
Photo 65 - Waste container in warehouse/work shed

A warehouse/work shed is located outside the east end of the building. Maintenance activities are conducted in the warehouse/work shed along with storage of supplies. One 55-gallon drum contained waste from a clean-out of the warehouse/work shed. The drum was labeled with lab pack contents and "flam liq" (Photos 65 and 66) [40 CFR 262.11]. Two empty box trucks were parked near the warehouse/work shed. Empty drum and cardboard box storage is located outside in this area.

Photo 66 - Close-up of container label in Photo 65
