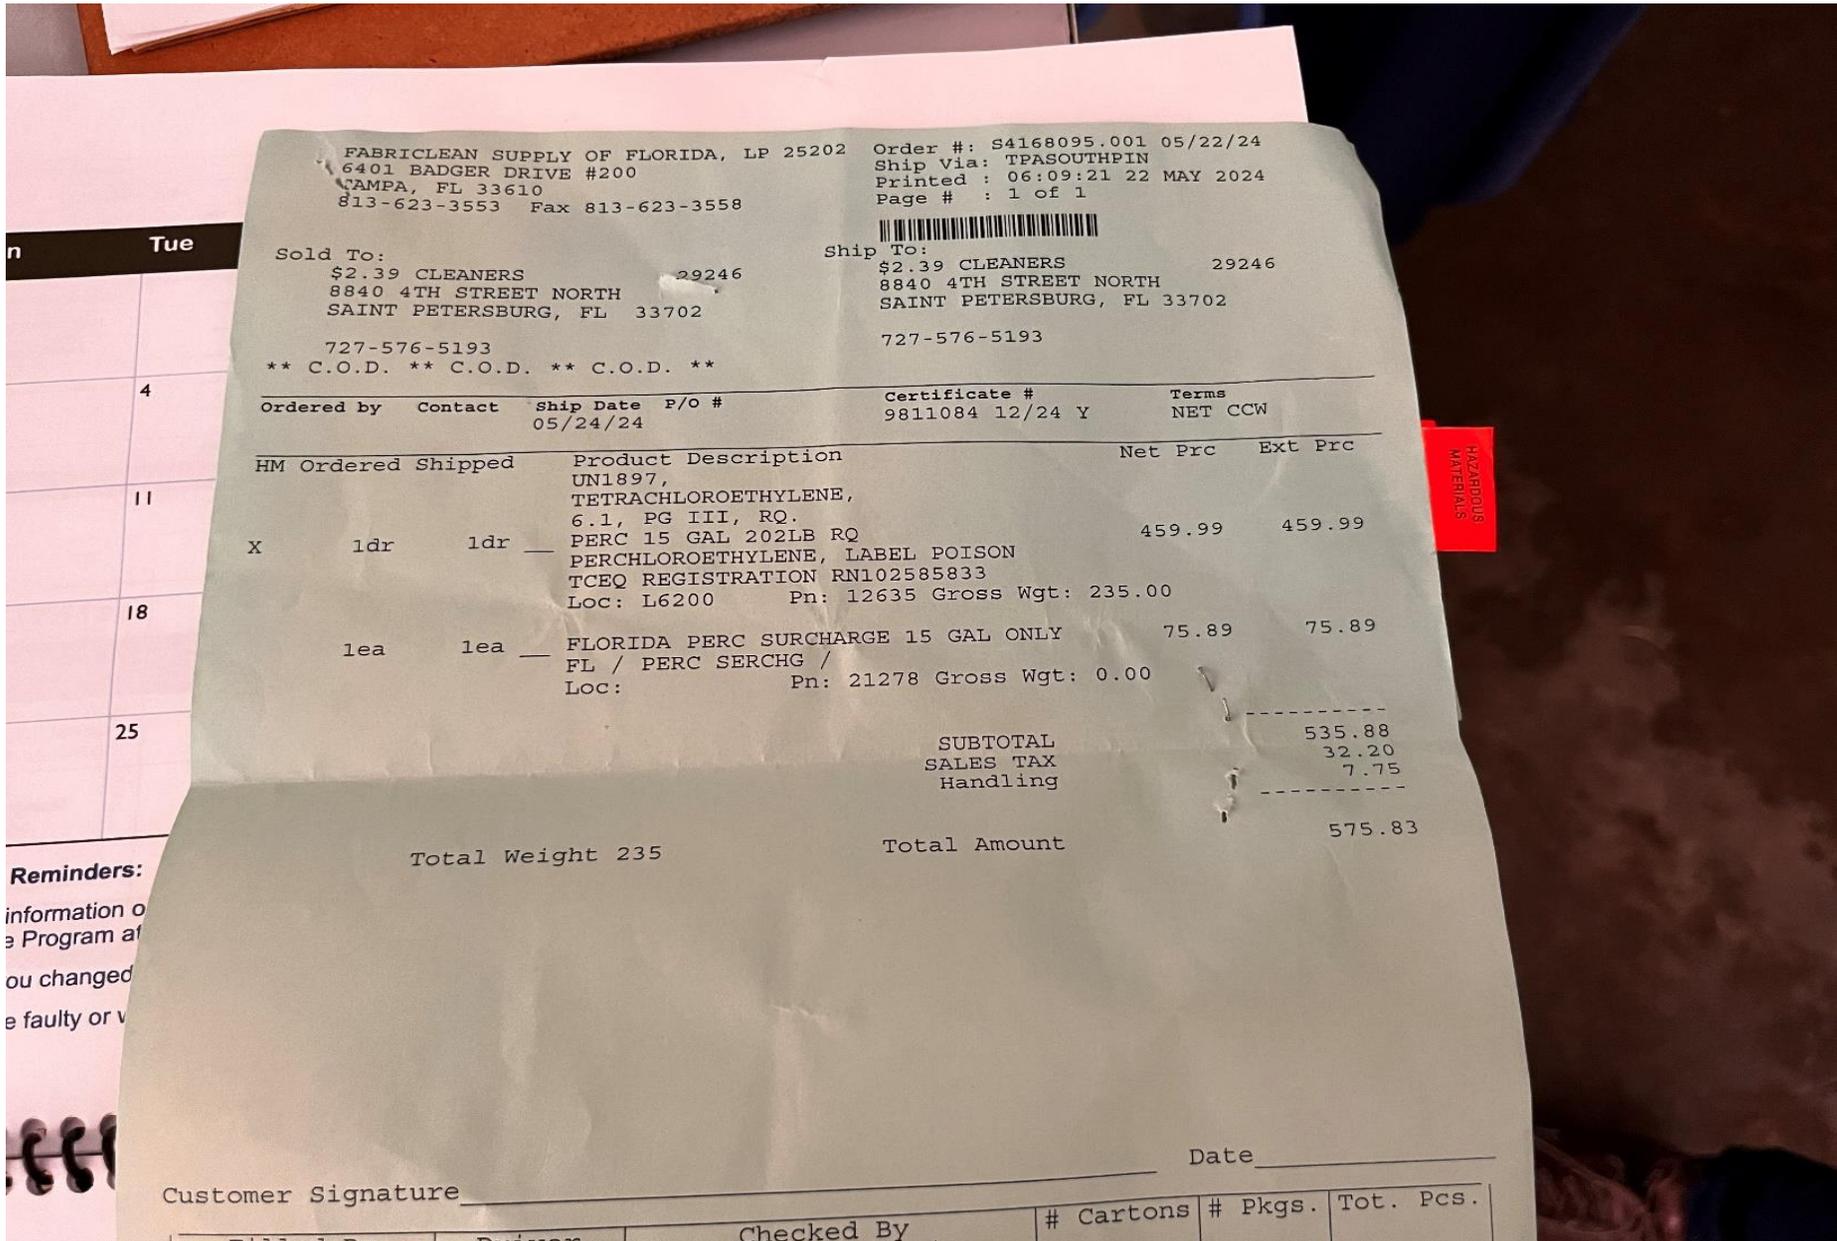
| File Name | Date Taken | Latitude | Longitude | Camera Maker | Model | Image Size (px) |
|---|---|---|---|---|---|---|
| IMG_0294.JPG | 2024:07:30 10:09:13 | 27.85316389 | -82.63910556 | Apple | iPhone 13 | 3024 x 4032 |

Description: One of the three receipts for the purchase of perchloroethylene over the last twelve months.

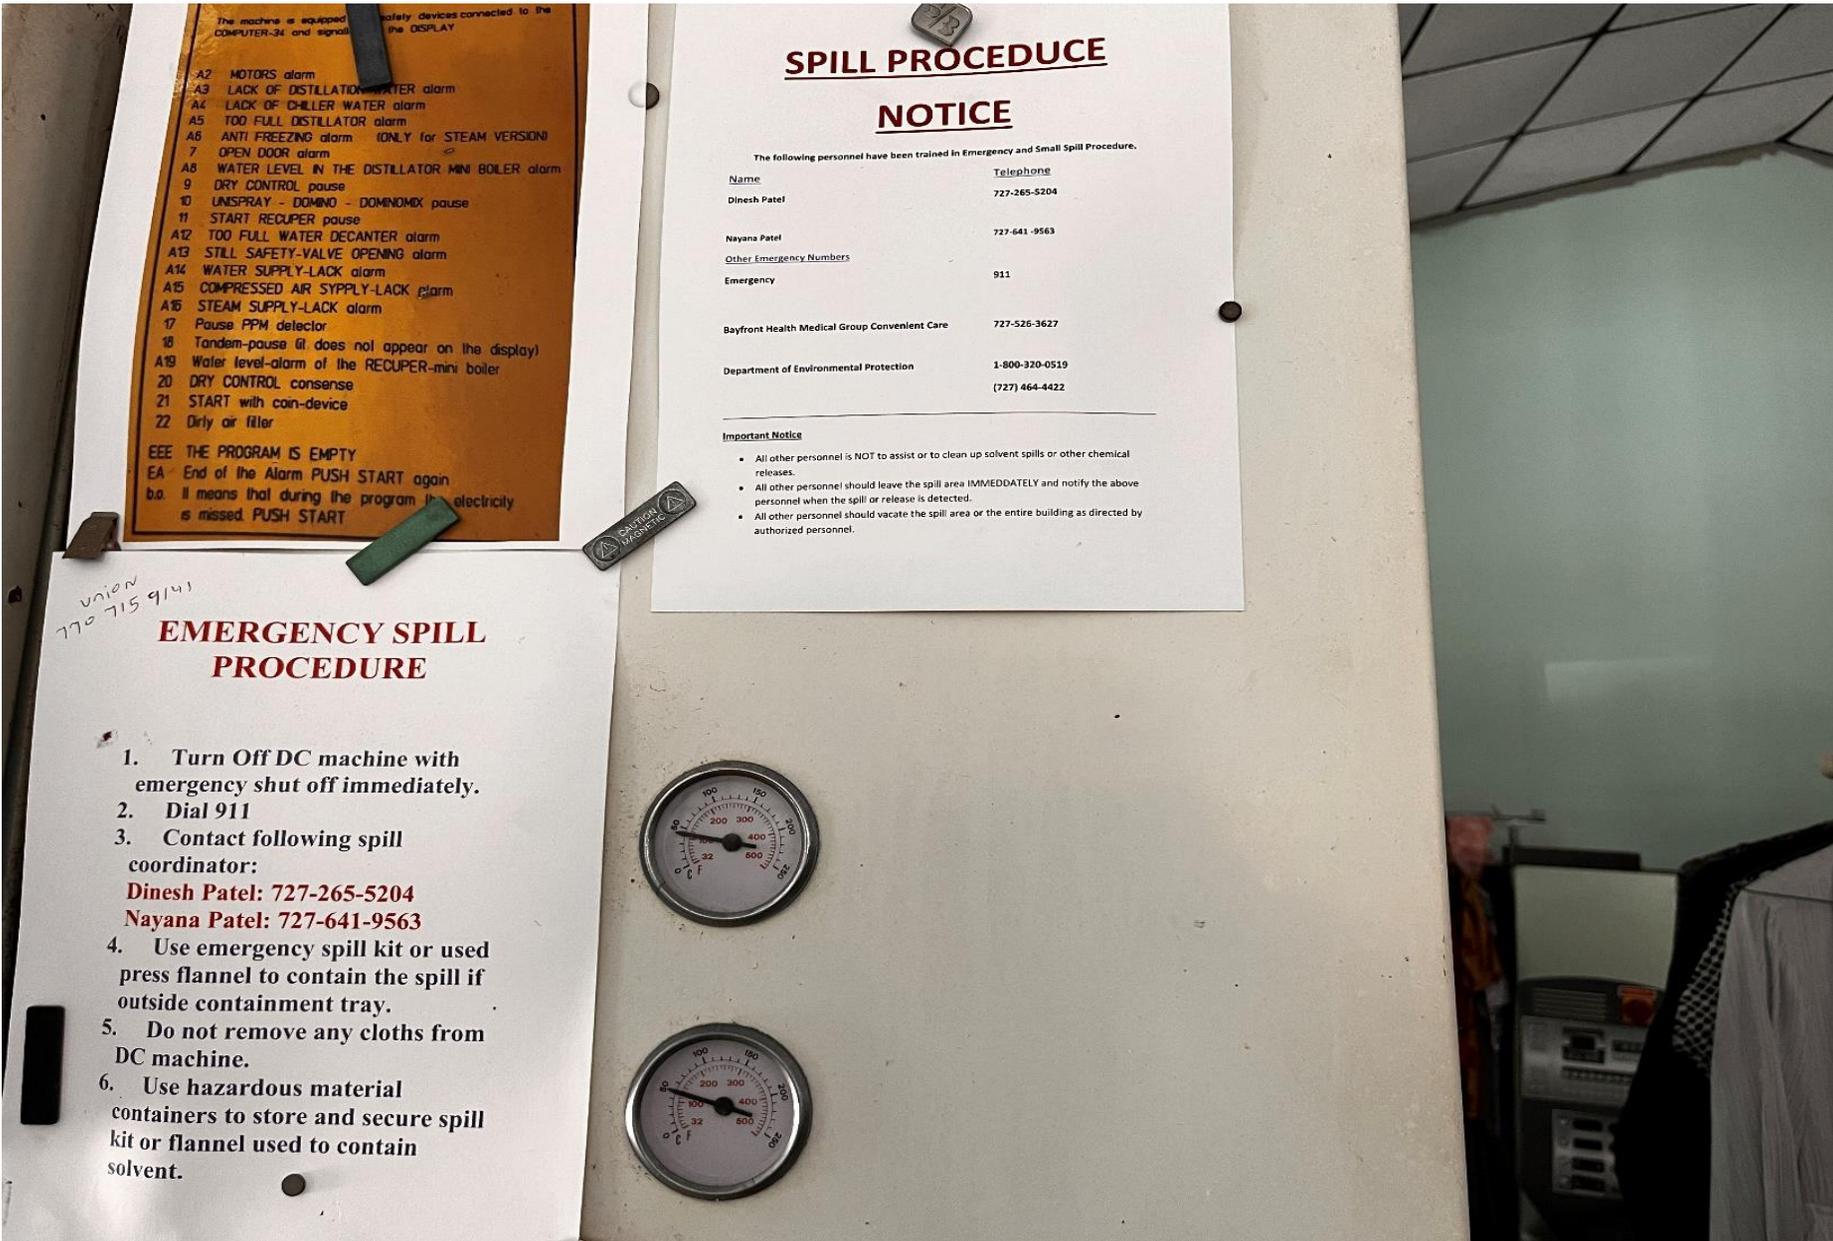
File Name Date Taken Latitude Longitude Camera Maker Model Image Size (px)
 IMG_0295.JPG 2024:07:30 10:10:11 27.85315278 -82.63911389 Apple iPhone 13 3024 x 4032
 Description: Emergency spill procedure posted on the front of the machine.

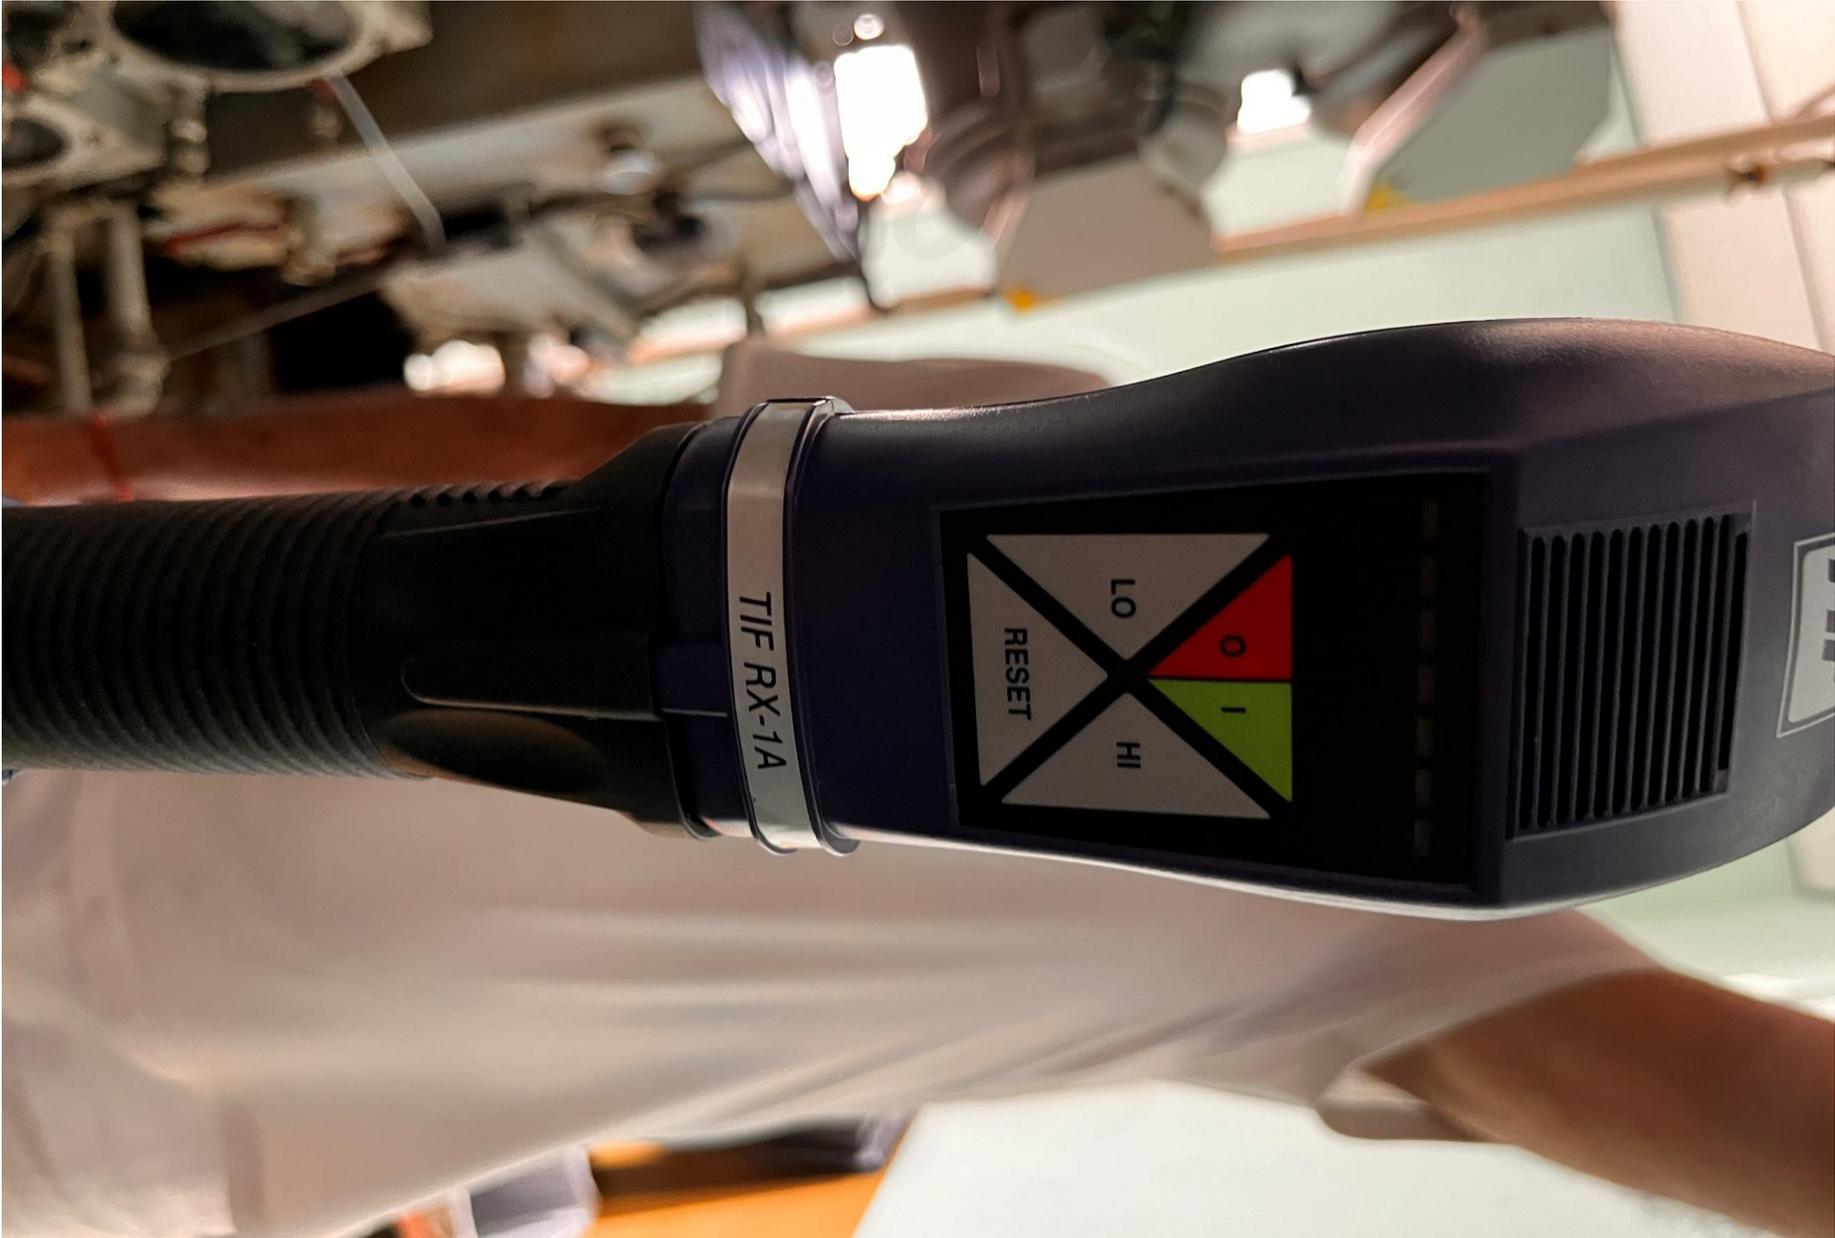
| File Name | Date Taken | Latitude | Longitude | Camera Maker | Model | Image Size (px) |
|---|---|---|---|---|---|---|
| IMG_0299.JPG | 2024:07:30 10:14:33 | 27.85312778 | -82.63910556 | Apple | iPhone 13 | 3024 x 4032 |

| File Name | Date Taken | Latitude | Longitude | Camera Maker | Model | Image Size (px) |
|---|---|---|---|---|---|---|
| Description: | The perchloroethylene detector (model TIF RX-1A) was functional and no leaks were detected. | | | | | |

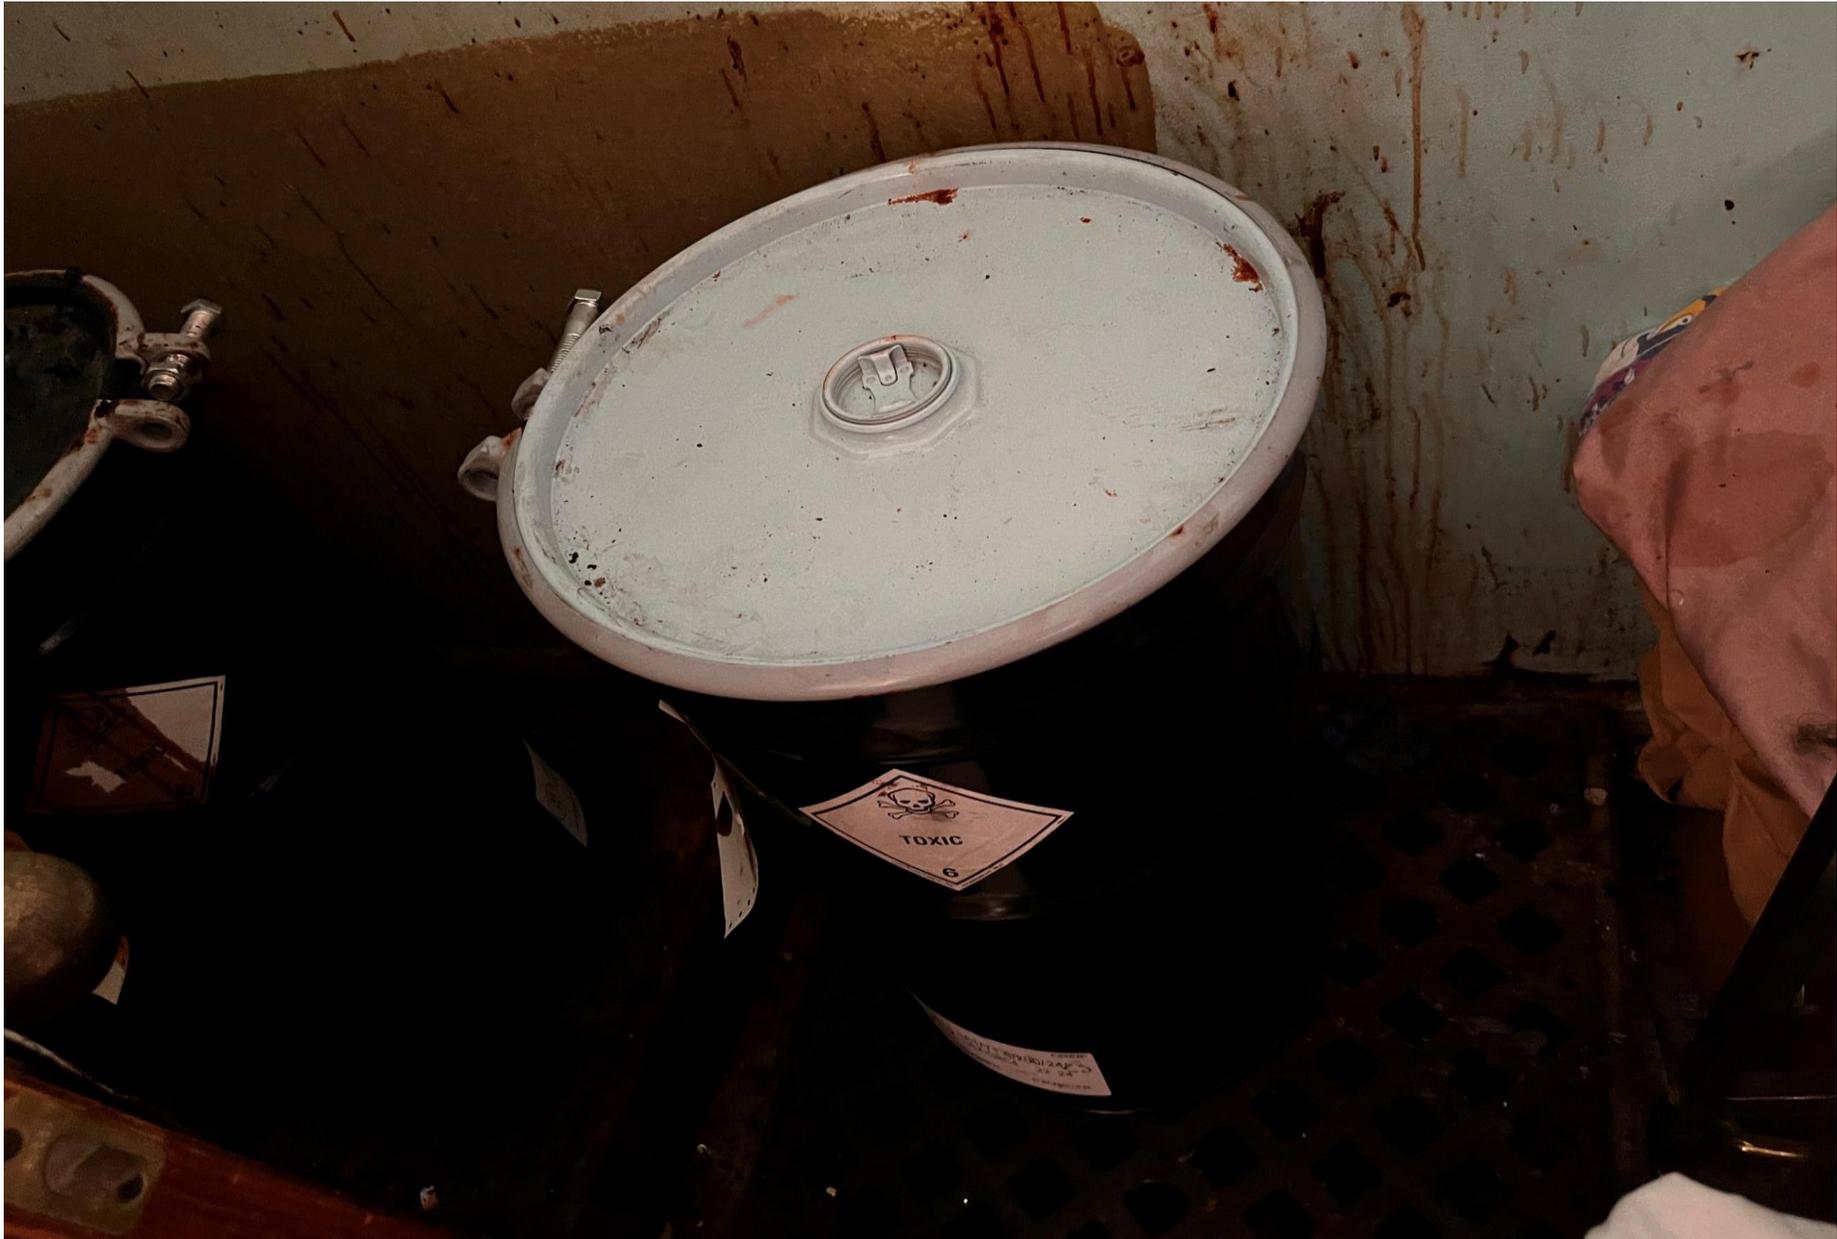
| File Name | Date Taken | Latitude | Longitude | Camera Maker | Model | Image Size (px) |
|---|--|---|---|---|---|---|
| IMG_0300.JPG | 2024:07:30 10:15:24 | 27.85313889 | -82.63913056 | Apple | iPhone 13 | 3024 x 4032 |

| File Name | Date Taken | Latitude | Longitude | Camera Maker | Model | Image Size (px) |
|---|--|---|---|---|---|---|
| Description: | Waste perchloroethylene drums were properly labeled, sealed and had secondary containment. | | | | | |

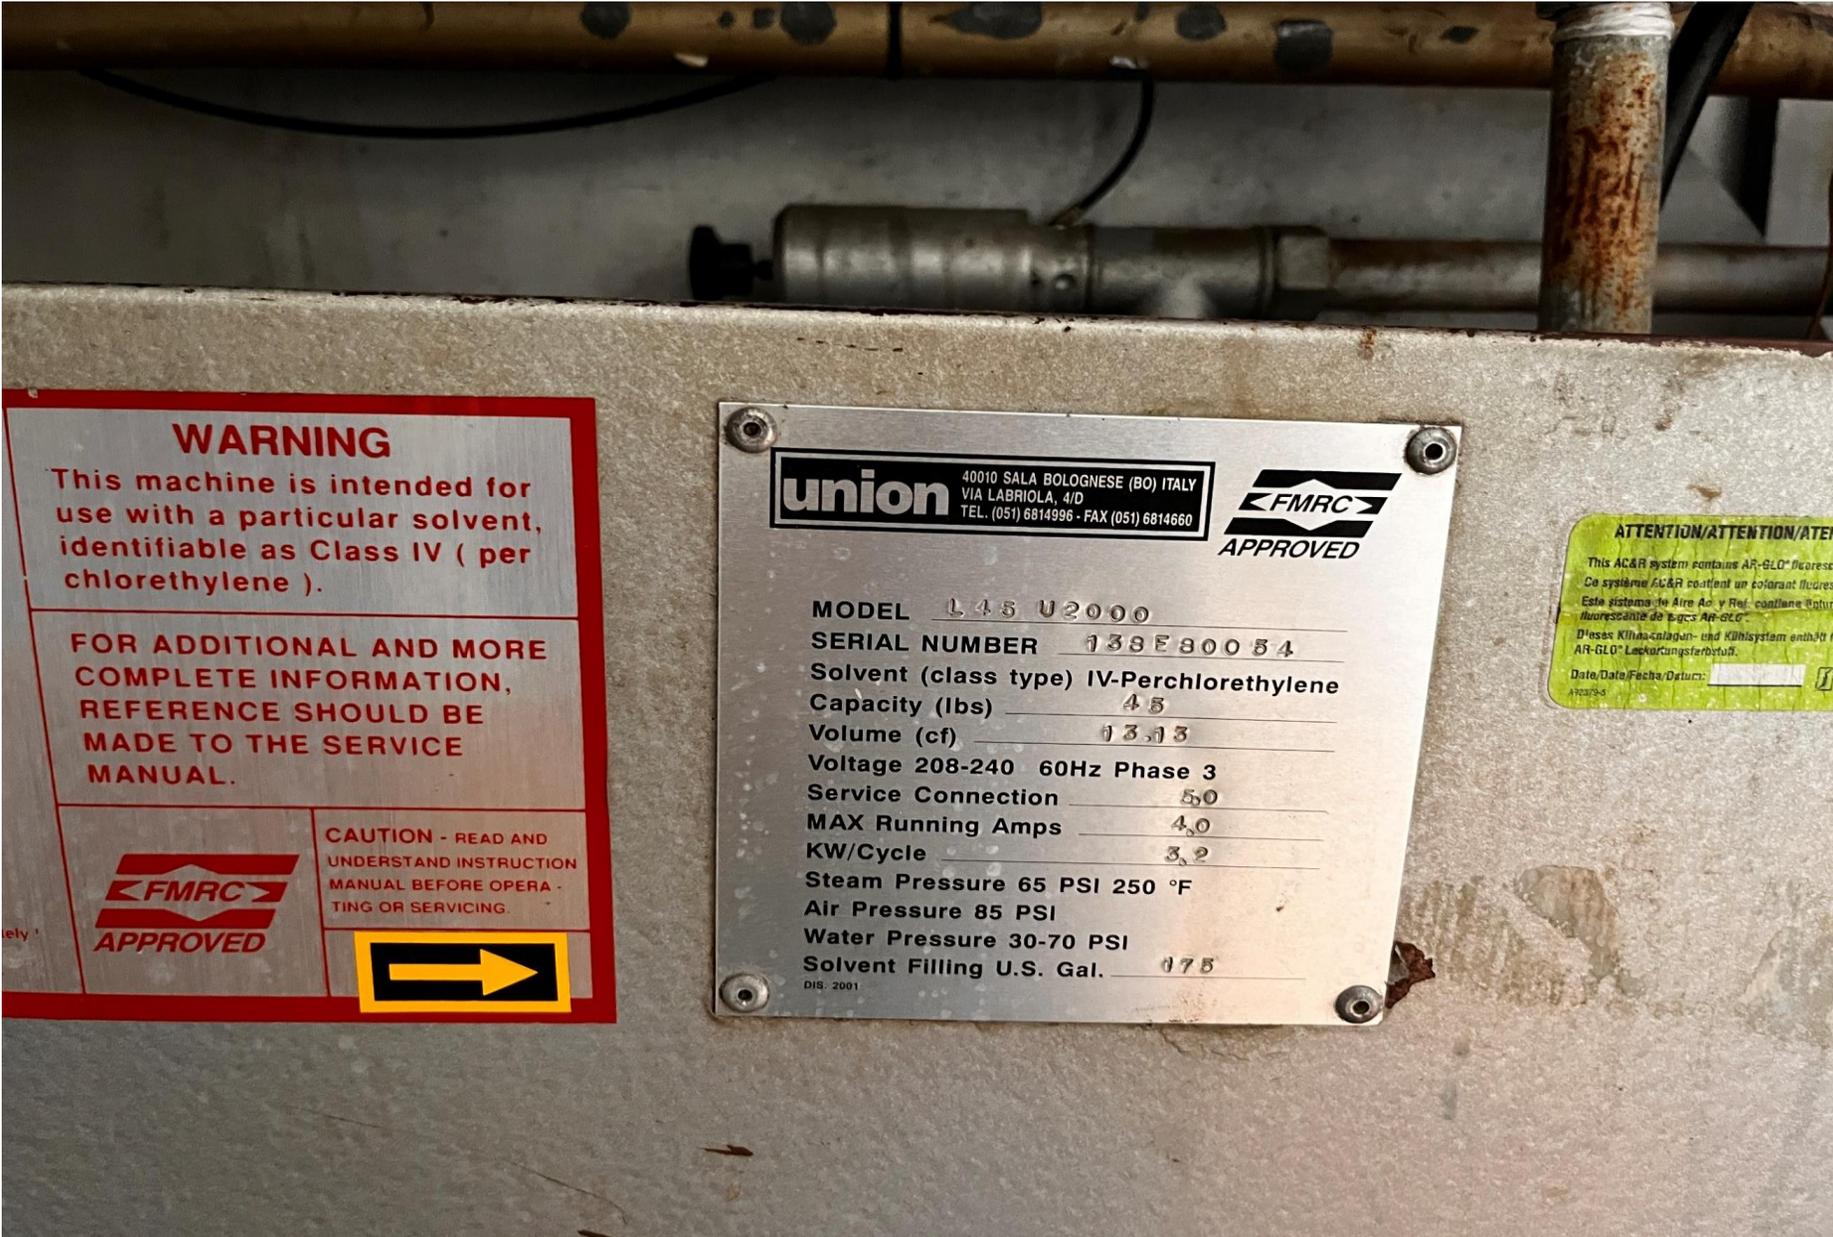
File Name Date Taken Latitude Longitude Camera Maker Model Image Size (px)
 IMG_0301.JPG 2024:07:30 10:16:27 27.853125 -82.63912222 Apple iPhone 13 3024 x 4032
 Description: Dry cleaning machine model number (Union U2000).

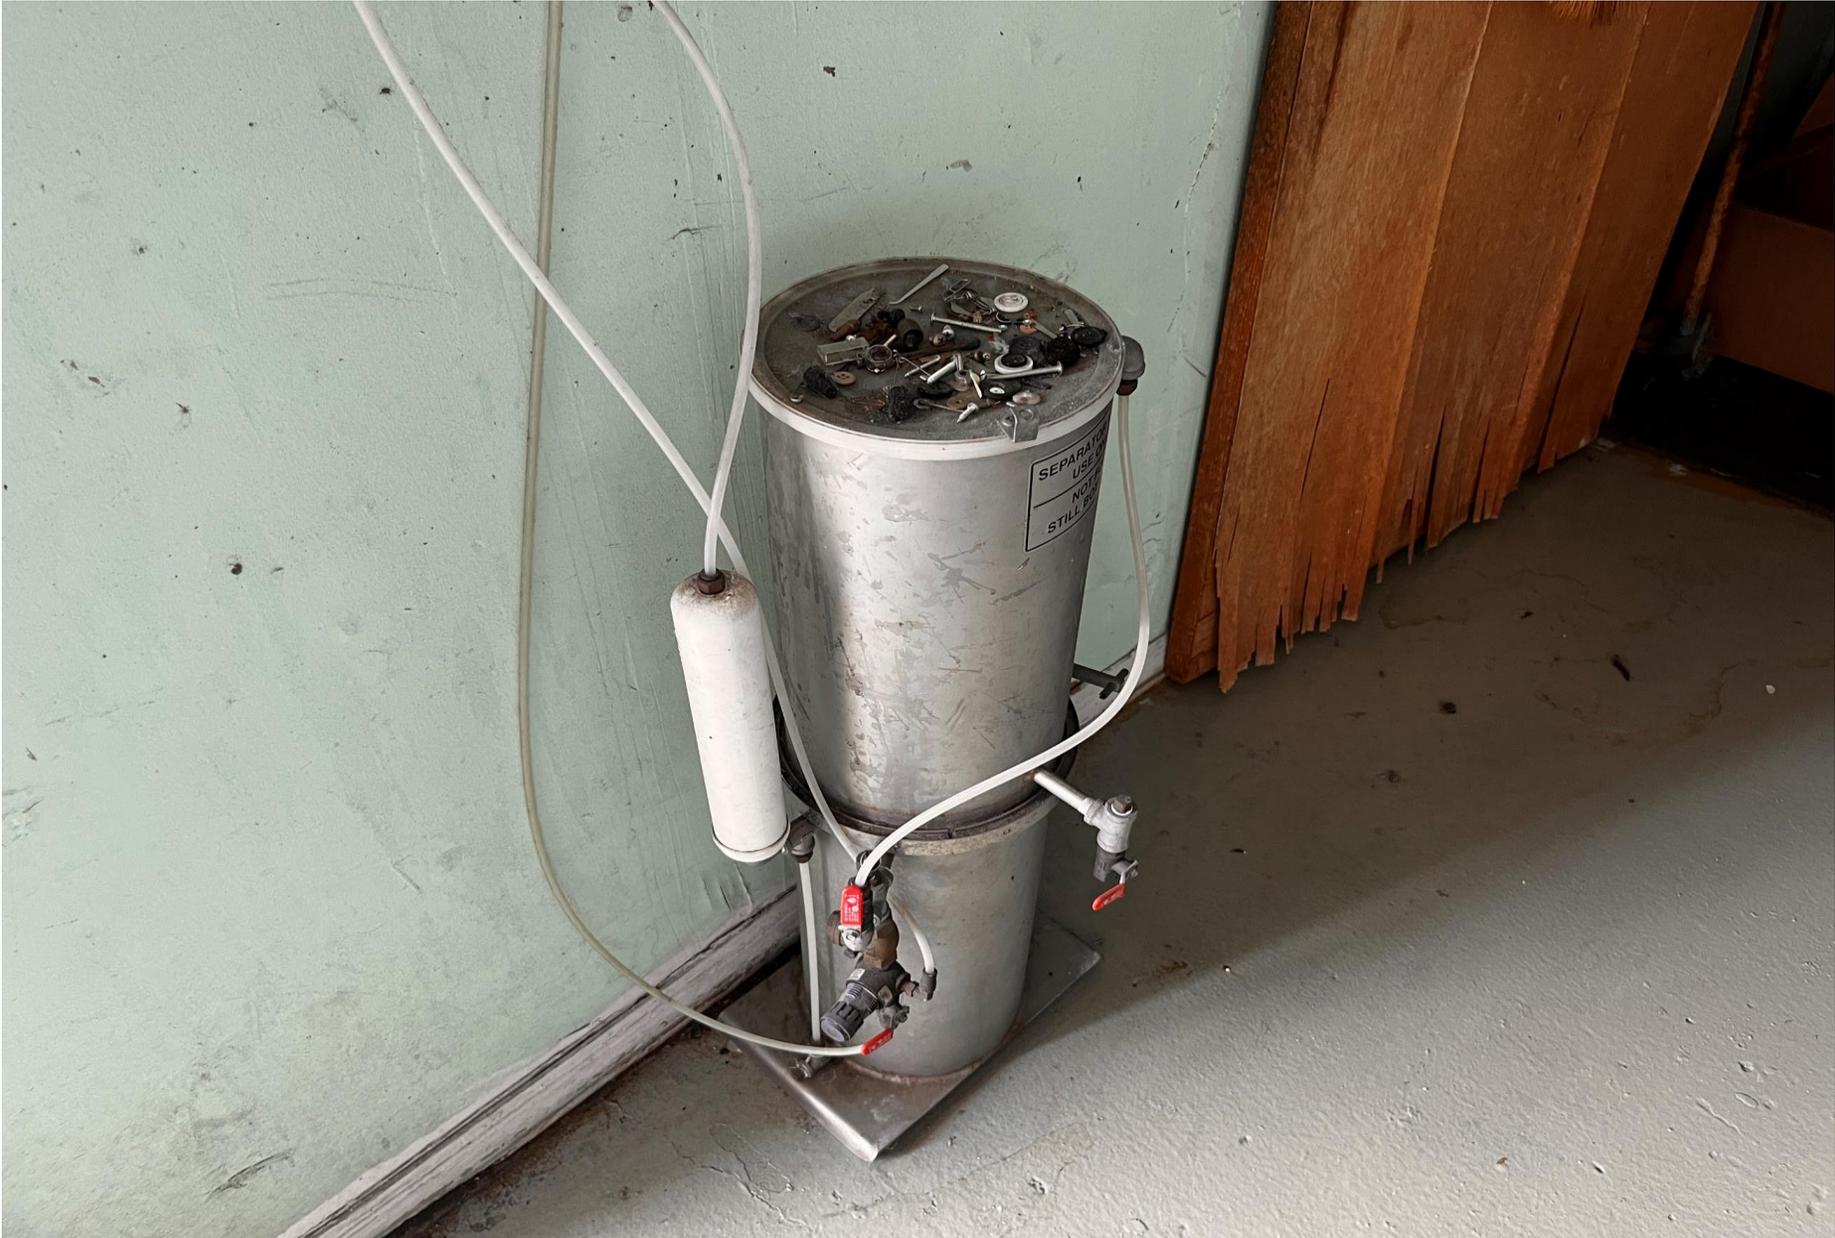
| File Name | Date Taken | Latitude | Longitude | Camera Maker | Model | Image Size (px) |
|---|--|---|---|---|---|---|
| IMG_0302.JPG | 2024:07:30 10:21:37 | 27.8531 | -82.63911389 | Apple | iPhone 13 | 3024 x 4032 |

| File Name | Date Taken | Latitude | Longitude | Camera Maker | Model | Image Size (px) |
|---|--|---|---|---|---|---|
| Description: | Facility's additional water separator. | | | | | |
