HAZARDOUS WASTE INSPECTION REPORT

FACILITY NAME: Safety-Kleen Systems, Inc. **DEP/EPA ID #:** FLD 982 133 159

STREET ADDRESS: 4426 Entrepot Boulevard, Tallahassee, Florida 32310

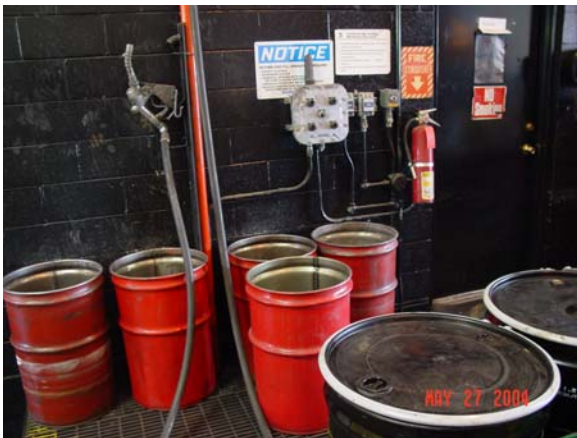
Picture A

The area was inspected mid-afternoon when no loading/unloading activity was underway. One route truck was parked in the unload area. A cross-check of the route driver's DOT shipping record and HW manifest record inventory and actual product and waste drums/containers loaded on the truck resulted in no discrepancies. The loading and unloading area was well maintained, with easy access to the emergency and safety equipment installed in this area. **See *Picture A and B.***

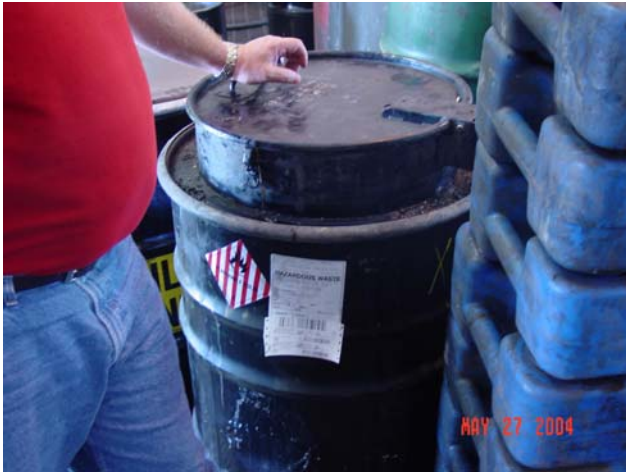
Picture C

The shelter area held no containers of hazardous waste with the exception of the satellite accumulation 55-gallon drum for hazardous waste solids/sludge from the dumpster/drum washing unit. This drum was labeled, in good physical condition and closed. This satellite accumulation drum had a new type lid installed, which allows the operators an easier method of opening and closing the container. The special lid is constructed with a raised hinged cover, which is held closed by three latch closures. This specially modified lid is moved from a full satellite drum to a new empty drum as needed. Full drums are then closed with a regular lid and moved to the TSD Storage area. **See Pictures C**

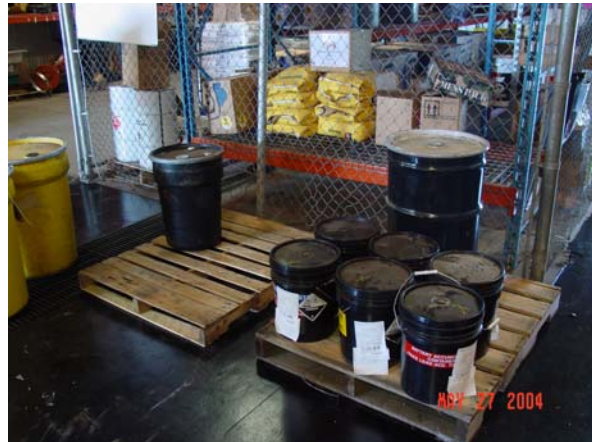
Picture E

Based on a recommendation from the 2003 calendar year inspection, non-hazardous waste containers were segregated for storage in a designated area adjacent to the 10-day Transfer Station. All containers were labeled and in good condition. **See Picture E.**

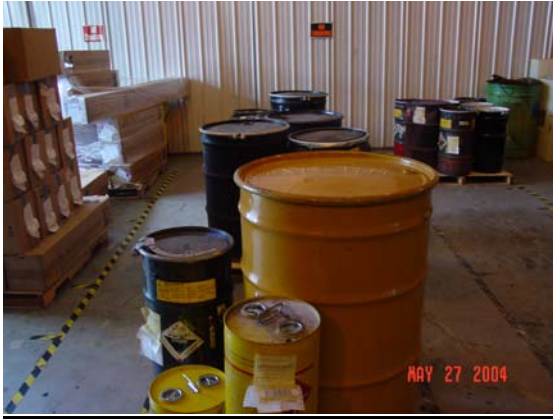
Picture F

The TSD Storage Area was well organized and aisle space maintained to allow inspection of each container. All containers were in good physical condition, closed, and labeled. **See Pictures F and G.** Two random containers were selected and a computer and hardcopy records check conducted to verify its origin, transport history and storage inventory. No discrepancies were noted. A visual inventory of drums versus computer record inventory for the TSD Storage Area was conducted by Mr. Hinsey and the Department Inspectors with no discrepancies identified.

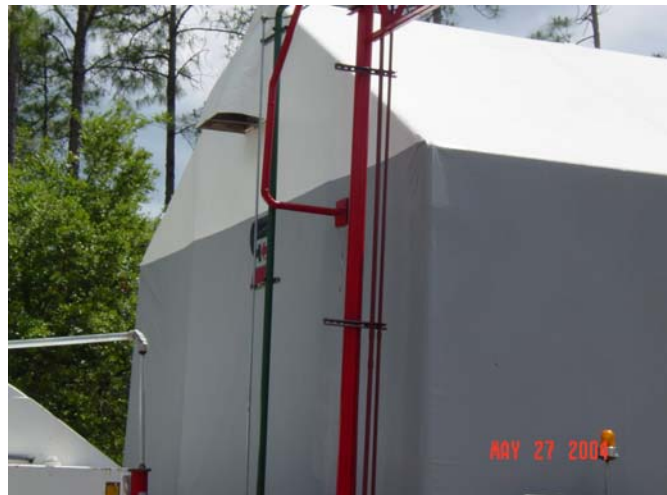
Picture H

The area was well maintained with no evidence of tank leakage noted. The load/unload pipe manifold area showed no evidence of leakage or spillage from the piping and equipage in this area. The accumulation drum located in this area was closed, labeled and in good condition.

The facility's 40 CFR 264 Subpart BB compliance procedures for the waste mineral spirits solvent management system was modified since the previous inspection. The waste mineral spirits solvent management system equipage (piping, valves, flanges, pumps, etc) was painted red to distinguish it readily from the other equipage in the facility. This allows the daily inspector of the system an easier way to track the equipage and inspect for liquid leaks. **See Picture H.** Duplicate brass numbering tags had been removed from the system in order to eliminate possible confusion with new and current numbering system. The daily inspection logs were reviewed for the previous year with no discrepancies noted.
