## HAZARDOUS WASTE INSPECTION REPORT

**FACILITY NAME:** Safety-Kleen Systems, Inc. **DEP/EPA ID #:** FLD 982 133 159

**STREET ADDRESS:** 4426 Entrepot Boulevard, Tallahassee, Florida 32310

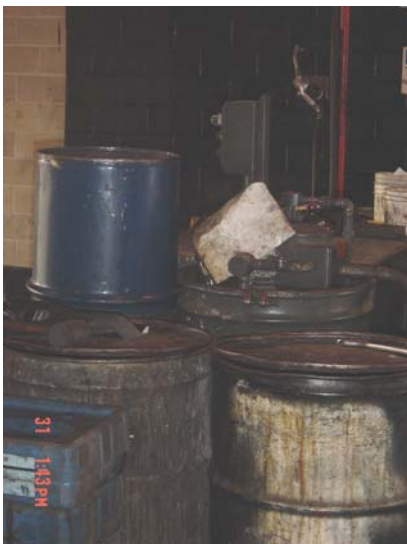
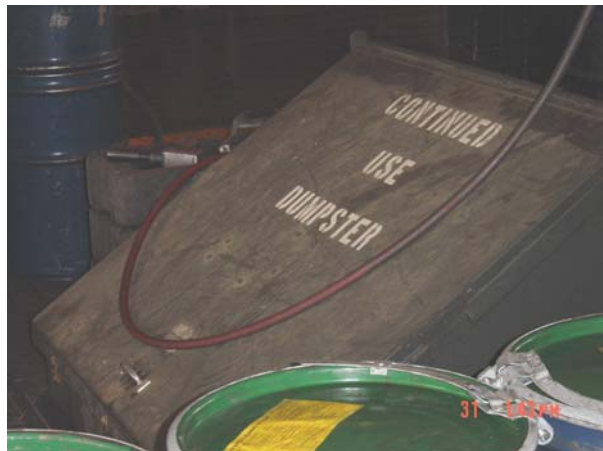
The area was inspected mid-afternoon when no loading/unloading activity was underway. No route truck was parked in the unload area. The loading and unloading area was well maintained, with easy access to the emergency and safety equipment installed in this area. **See Pictures A and B.**

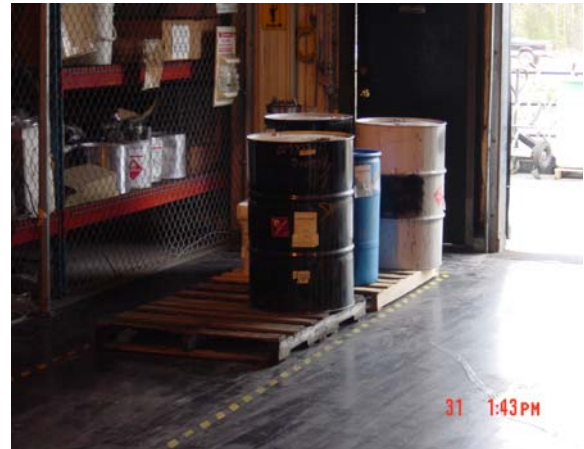
**Picture C**

The Transfer Station area held five containers of HW awaiting follow-on transport to final TSD facilities. See **Picture C**. The oldest date noted on any container was March 29, 2005, which matched the wall-board for this area noting the oldest dated container as March 29, 2005. All containers were in good physical condition, closed, and labeled. Adequate aisle space was available to inspect each container. The daily inspection record for the 10-day Transfer Station was checked. A visual inventory of drums versus computer record inventory for the 10-day Transfer Station was conducted with no discrepancies identified: One random container was selected and a computer and hardcopy records check conducted to verify its origin, transport history and storage inventory. No discrepancies were noted.

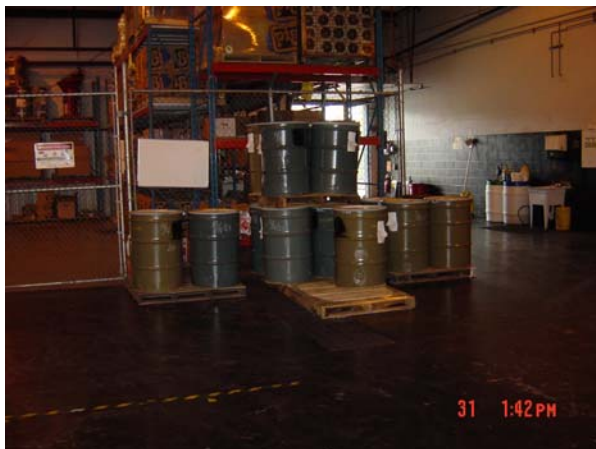
**Picture D**

Non-hazardous waste containers were segregated for storage in separate designated areas. All containers were labeled and in good condition. Immediately adjacent to the Transfer Station (See **Picture D**) was an area which contained fourteen 55-gallon drums of non-hazardous drilling sand. Adjacent to the TSD Storage Area were five one-cubic yard boxes and one 55-gallon drum of used oil absorbent; a pallet of numerous "empty", yellow, 5-gallon, paint cleaning solvent containers; one open top 55-gallon drum of used aluminum plates (from printing processes); and one open top 55-gallon drum of large sheet, used x-ray film (for silver reprocessing). See **Picture E**.

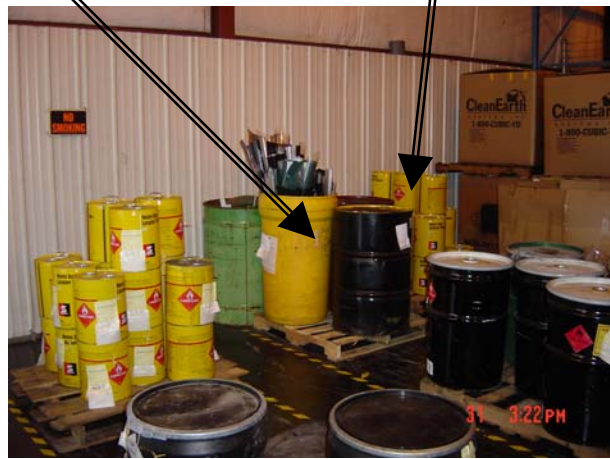
**Picture E**

Open top drums                      "empty" 5-gallon paint solvent

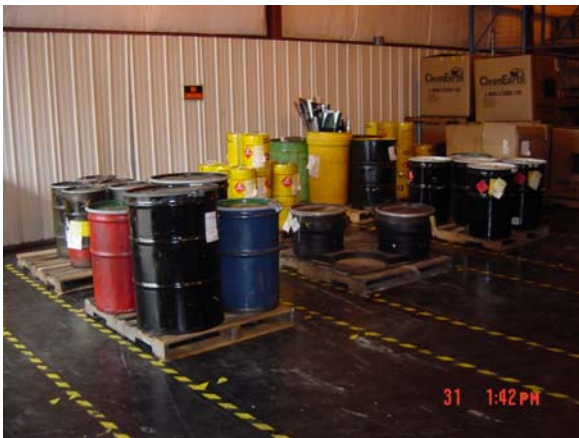
Picture F

The TSD Storage Area was organized and aisle space maintained to allow inspection of each container. All containers were in good physical condition, closed, and labeled. **See Picture F.** Two random containers were selected and a computer and hardcopy records check conducted to verify their origin, transport history and storage inventory. No discrepancies were noted. A visual inventory of drums versus computer record inventory for the TSD Storage Area was conducted by Mr. Hinsey and the Department inspector with one discrepancy identified. One yellow, 5-gallon, paint cleaning solvent container (Item #50219024509) was incorrectly placed on the pallet with the numerous empty yellow, 5-gallon, paint cleaning solvent containers. **See Picture G.** Discrepancy corrected at time of discovery.

TSD storage

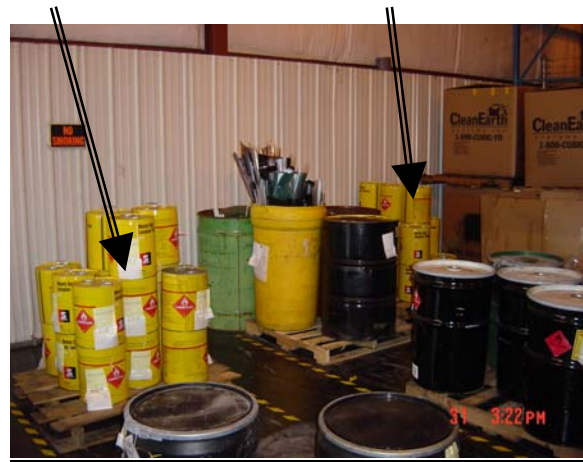
Picture G

Empty can storage

S-K Tallahassee should review and improve its procedures for the location and handling of non-hazardous containers to ensure that no inadvertent mixed storage of hazardous and non-hazardous containers occurs.

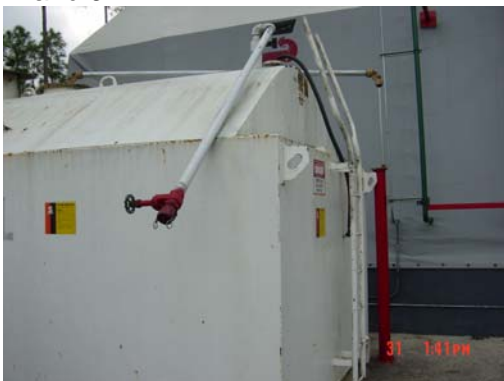
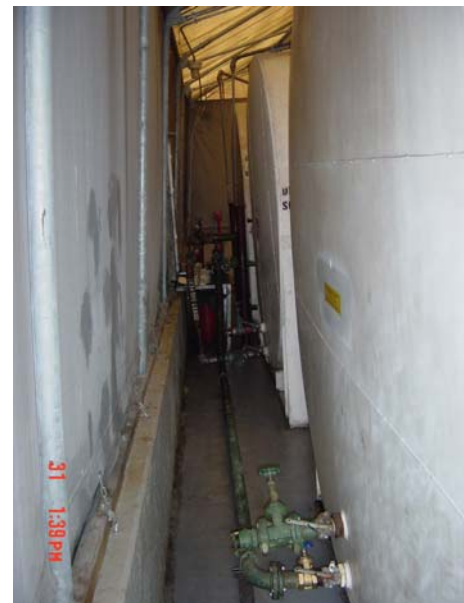
The area was well maintained with no evidence of tank leakage noted. The load/unload pipe manifold area showed no evidence of leakage or spillage from the piping and equipment in this area. The accumulation drum located in this area was closed, labeled and in good condition. The daily inspection logs were reviewed for the previous year with no discrepancies noted. See Pictures H and J.

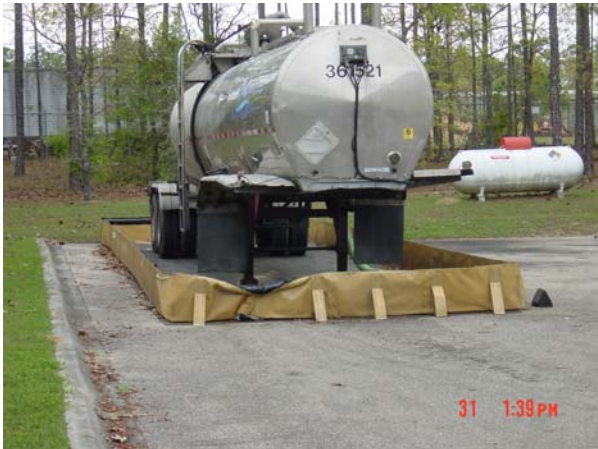
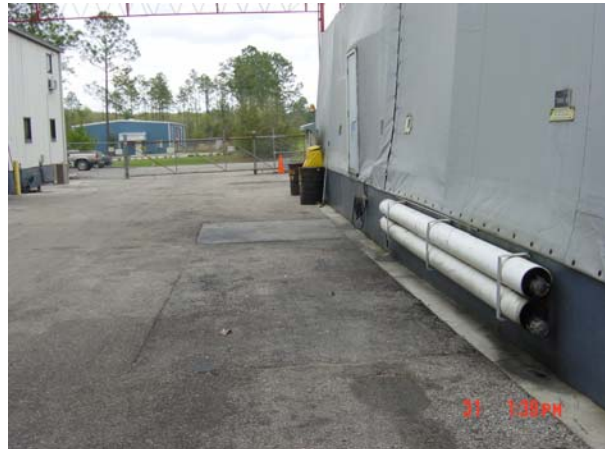
The outside storage/laydown area, driveways, vehicle parking lot, solid waste dumpsters and the perimeter fence/lawn areas were inspected with no discrepancies noted. A tanker trailer is parked within a temporary secondary containment at the southwest corner of the rear asphalt parking area. This tanker will be used for on-site consolidation of wastes collected daily in the vacuum truck and then transferred and stored on-site in the tank trailer until a full 5000-gallon load makes it necessary for transport to the follow-on processor. All other security and safety equipment was installed in accordance with the permit and operational. (See Pictures K and L)
