**RE: Warning Letter No. WL23-225 (Significant Non-Complier)**  
**Liquid Environmental Solutions of Florida, LLC**  
**EPA/DEP ID: FLD981928484**  
**Duval County – Hazardous Waste**

**Florida Department of  
Environmental Protection  
Hazardous Waste Inspection Report**

**Facility Name:** Liquid Environmental Solutions of Florida LLC

Routine Inspection for Used Oil Transporter Facility  
Routine Inspection for Used Oil Transfer Facility Facility  
Routine Inspection for Used Oil Processor Facility  
Routine Inspection for VSQG (<100 kg/month) Facility

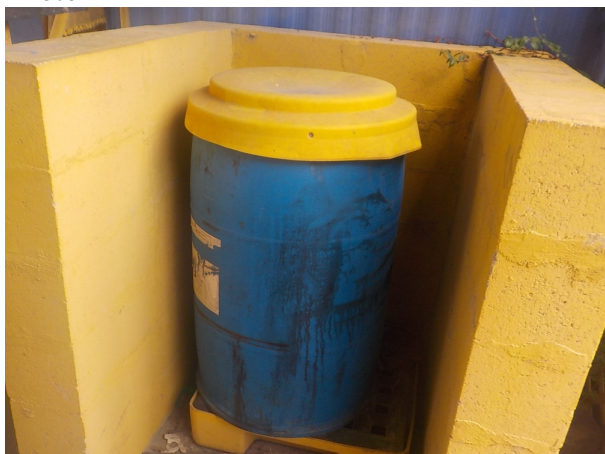
Photo 1

Wastewater is tested by the Receiving Laboratory prior to discharge to ensure compliance with the wastewater permit. Chemical Oxygen Demand (COD) 20-1500 mg/l test kits (mercuric sulfate 1%, water 25%, chromic acid 1%, silver sulfate 3%, sulfuric acid 90%; flashpoint listed as not applicable) are used in this process. Spent COD vials are D002/D007/D009/D011 hazardous waste. Spent COD vials are collected in a 55-gallon drum stored on a spill pallet just outside of the Receiving Laboratory (Photo 1). The drum was closed, in good condition and labeled.
