From: Casey Stephens [Casey.Stephens@bocc.citrus.fl.us]
Sent: Thursday, April 29, 2010 12:16 PM
To: Pelz, Susan
Cc: Martin, Lee; Madden, Melissa; Tedder, Richard
Subject: RE: Specific Condition A.9.b
Attachments: 0426 DRA #4 erosion looking west.JPG; 0429 sediment being further eroded.JPG

This email shall serve as notification under Specific Condition A.9.b of the discovery of an erosional feature located at the east end of DRA #4 on the closed 60-acre site. I believe that this erosional feature is the result of the unusually rainy weather that we experienced in Citrus County during March 2010. However, in the event that this feature is indicative of sinkhole activity or subsurface instability, we are notifying FDEP pursuant to the above referenced permit condition.

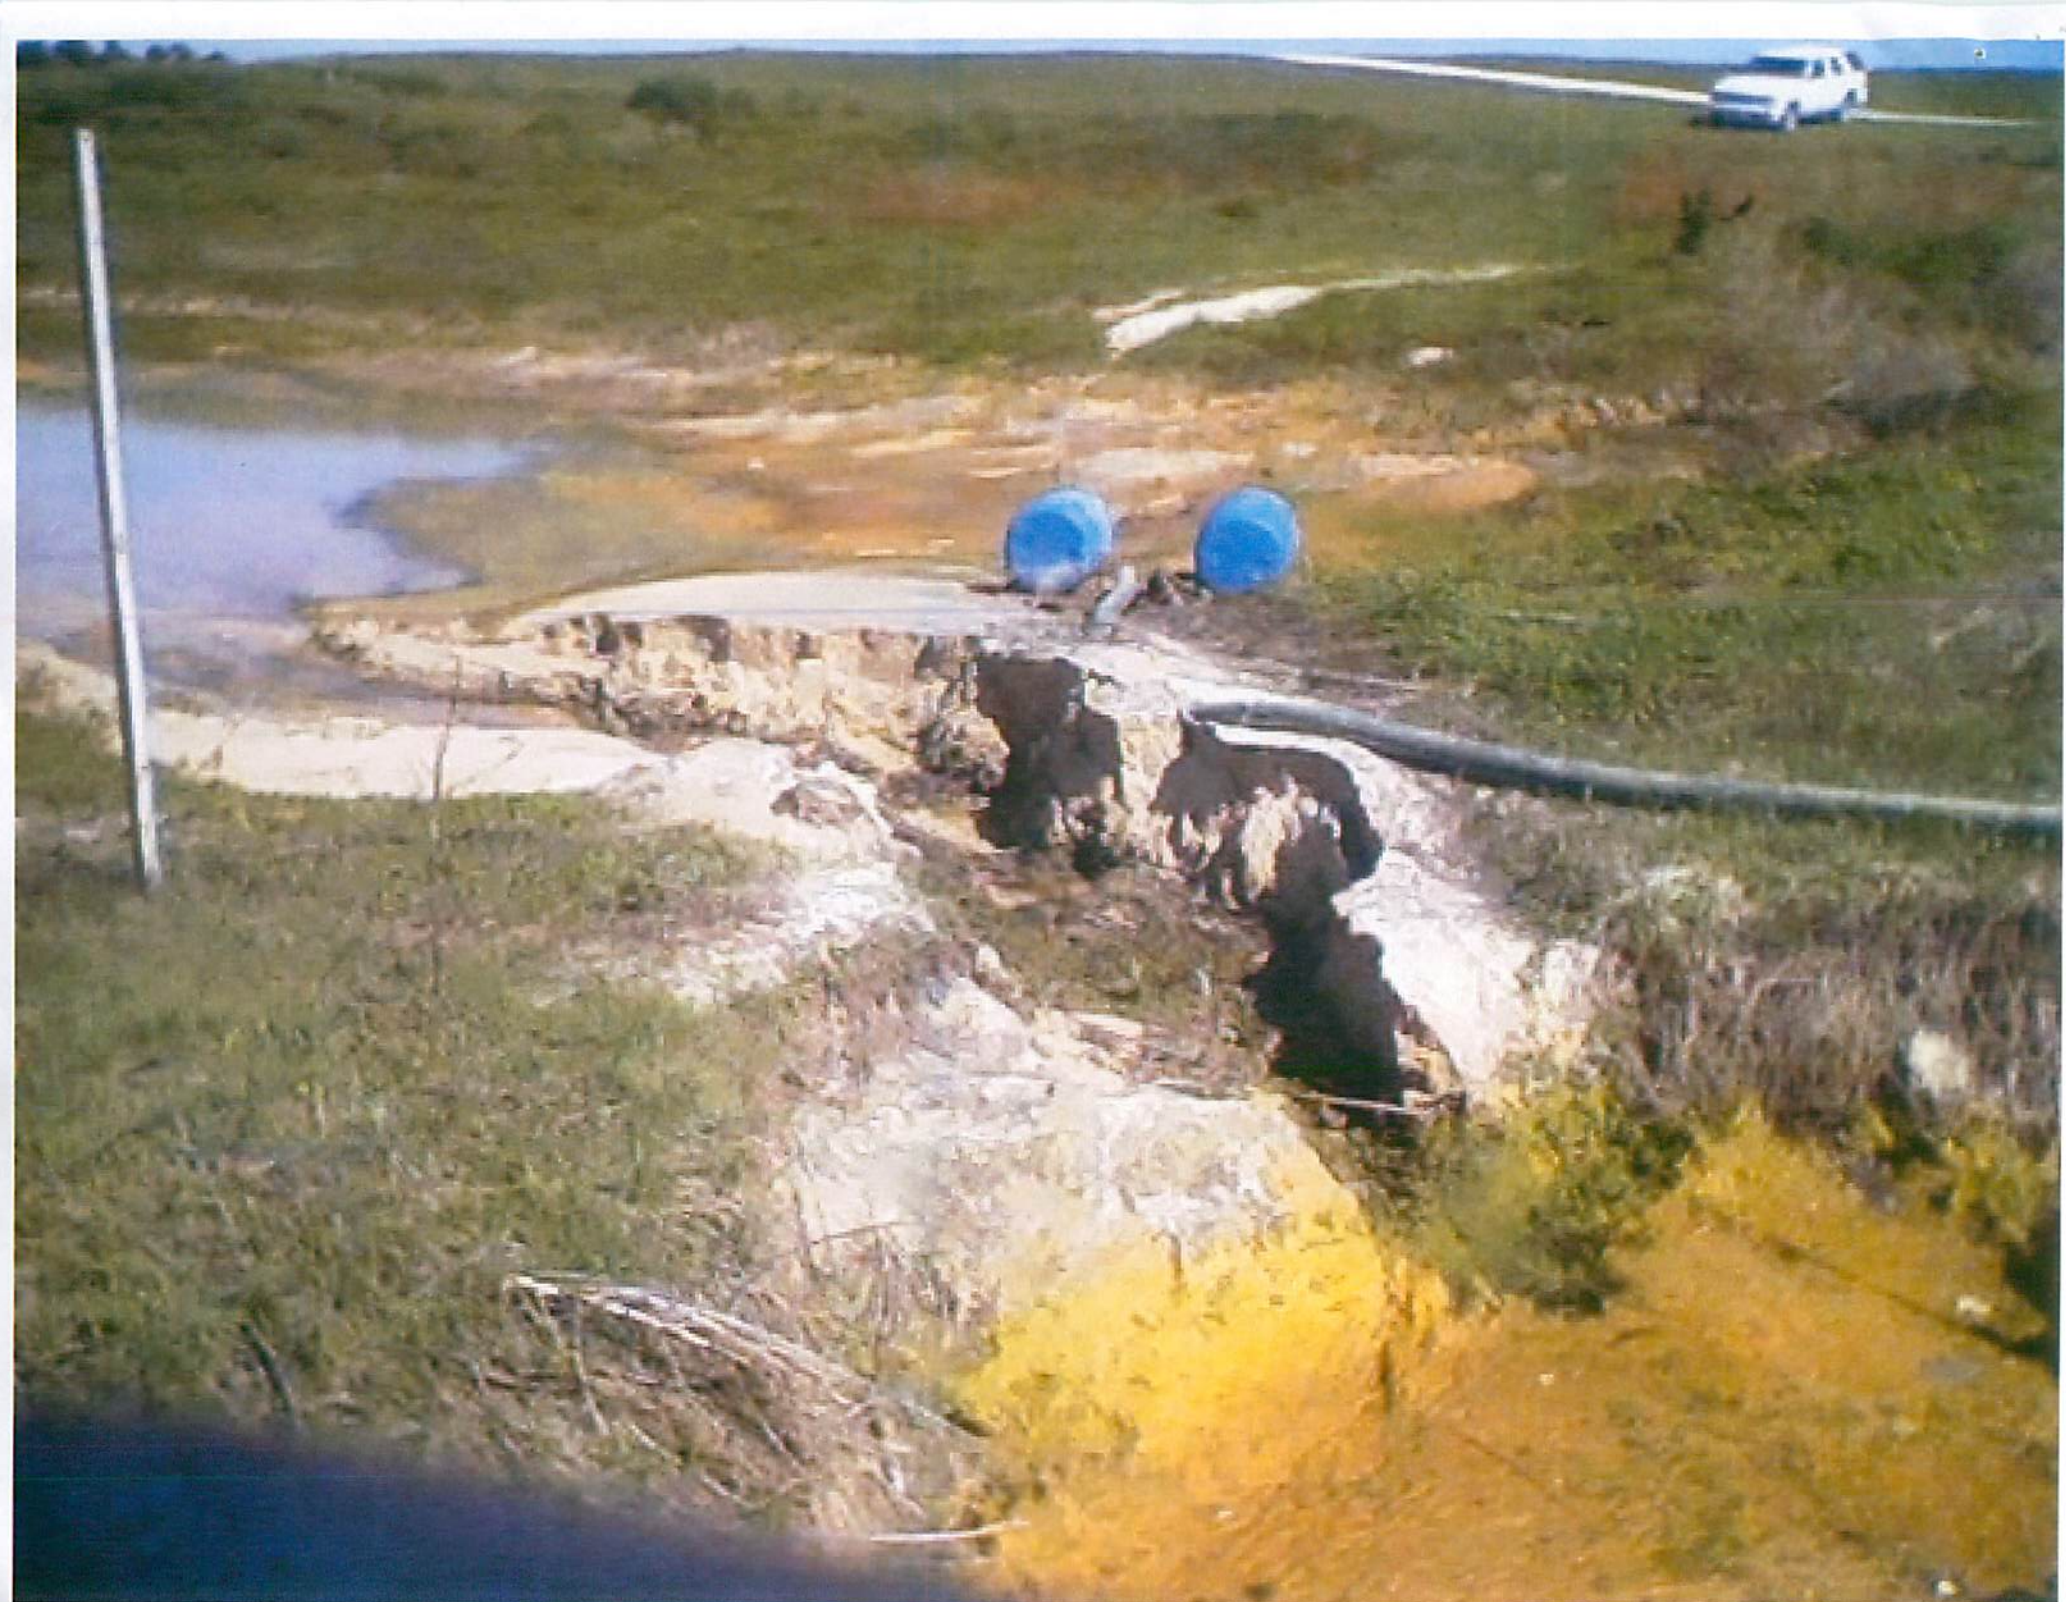
The attached photo looking west toward the pond was taken on 4/26 and shows the edge of the depression in the foreground and the deposition of the sediment in DRA #4. The second photo taken this morning shows that same sediment being eroded and re-deposited further east following some on site water management activities where we were pumping into the conveyance swale south of the erosional feature. For reference, the thickness of the deposit being eroded is > 3' in the shaded area which lines up with the left most barrel. Let me know if you need any additional photos.

We still contend that this is nothing more than an erosional washout as a significant amount of sediment has been deposited just downstream of the erosional feature in the bottom of DRA #4. I also request that you reconsider our plan to repair the erosional feature as we believe that it would be easier to observe and document any changes in the feature if we repair it and start with a clean slate (as it were).

Our plan is repair the erosional feature and observe the area for evidence of re-occurrence. Please advise.
