RE: Enterprise Recycling and Disposal Facility
Cell 7 Construction Completion Report
Angelo's Aggregate Materials, Ltd.
FDEP Permit Nos. 177982-019-SC/T3
WACS No.: 87895
Pasco County, Florida

This report contains the Certification of Construction Completion (Certification) and Construction Quality Assurance (CQA) data for Cell 7 of the Enterprise Class III landfill and is being submitted to the Florida Department of Environmental Protection (Department) for review and approval.

Engineer of Record Narrative Report

**Enterprise Recycling and Disposal Facility
Cell 7 Construction**

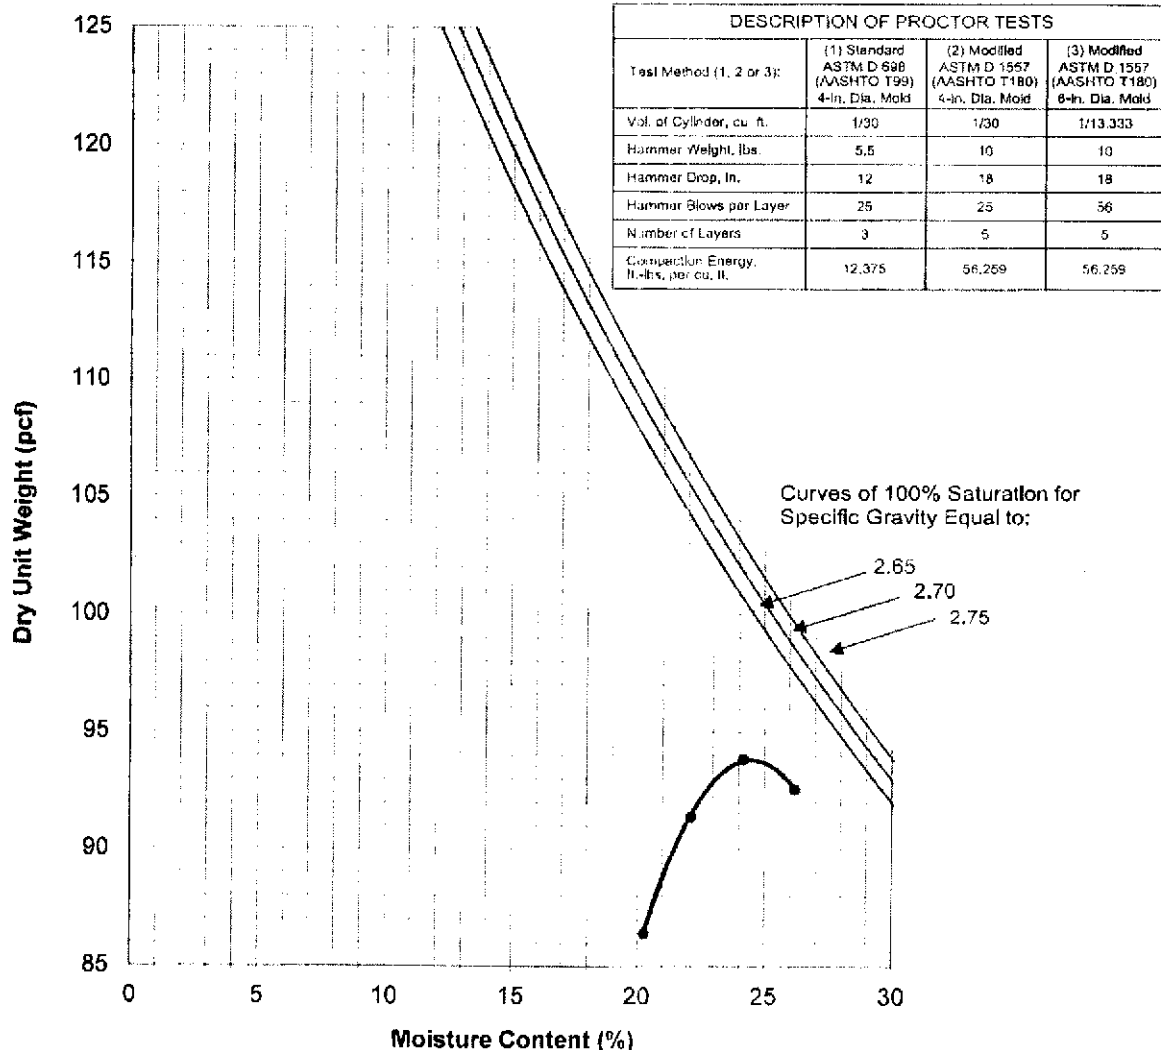
SUMMARY OF TEST RESULTS

Lab Number: 16-P352
 Test Method: AASHTO T-99 (2)
 Maximum Dry Density, pcf: 93.8
 Optimum Moisture, %: 24.5
 Passing No. 4 Sieve, %: 100
 Passing No. 200 Sieve, %: 55.6

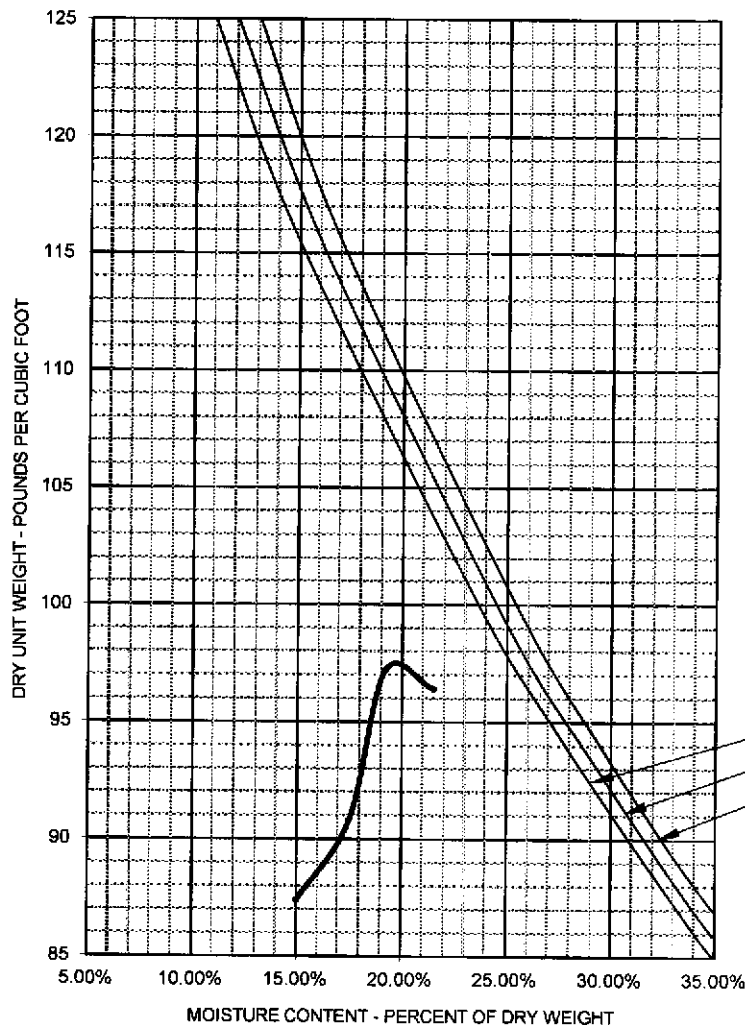
Soil Description:

Brown Clayey Sand

Date Tested :	6/5/2016
Maximum Dry Density(pcf)	97.2
Optimum Moisture Content (%)	19.2
Wash 200%	52.7

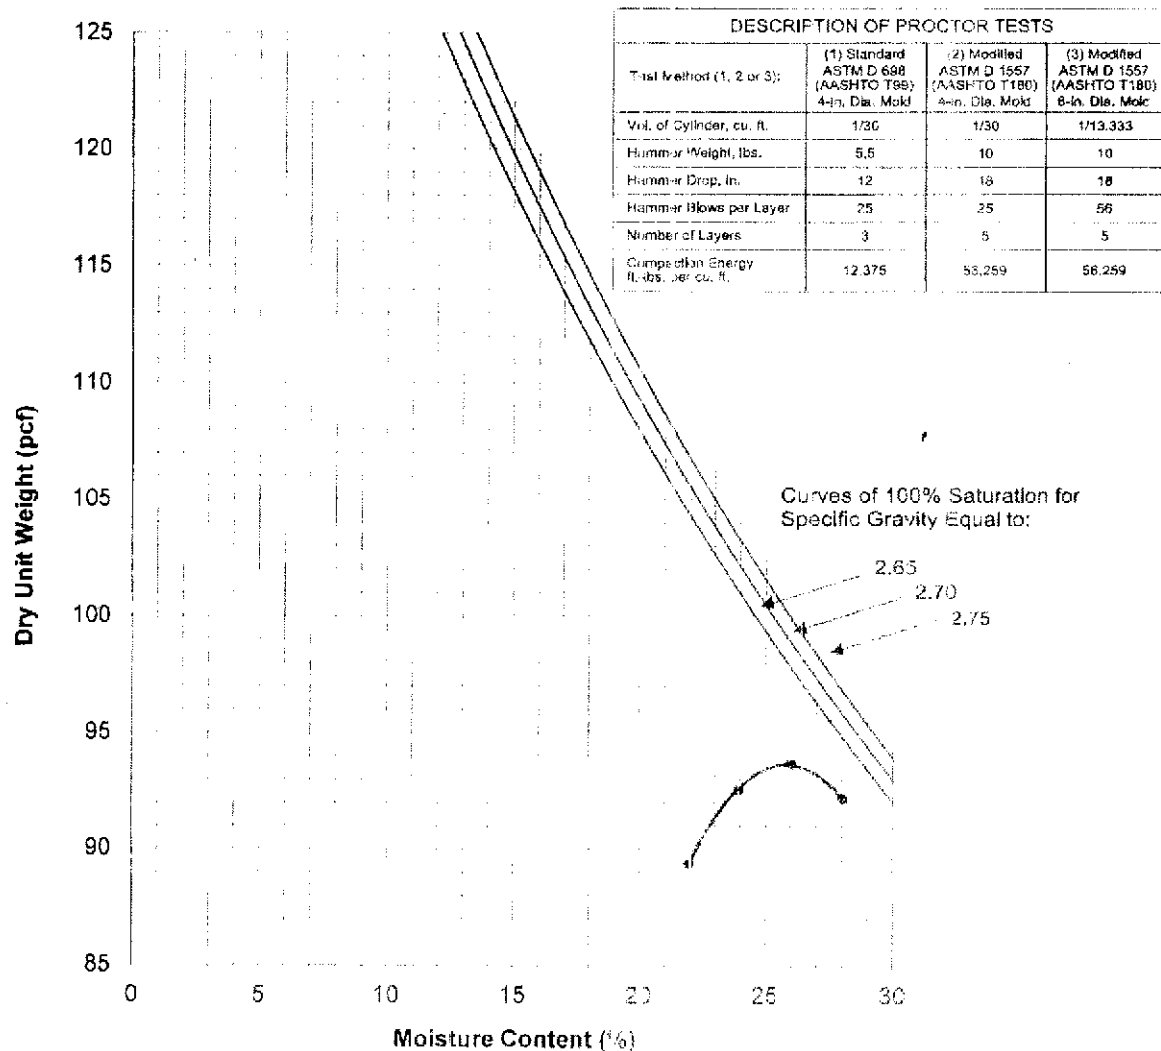
SUMMARY OF TEST RESULTS

Lab Number: 16-P-048
 Test Method: AASHTO T-99 (2)
 Maximum Dry Density, pc³: 94.0
 Optimum Moisture, %: 26.0
 Passing No. 4 Sieve, %: 100
 Passing No. 200 Sieve, %: 54.3

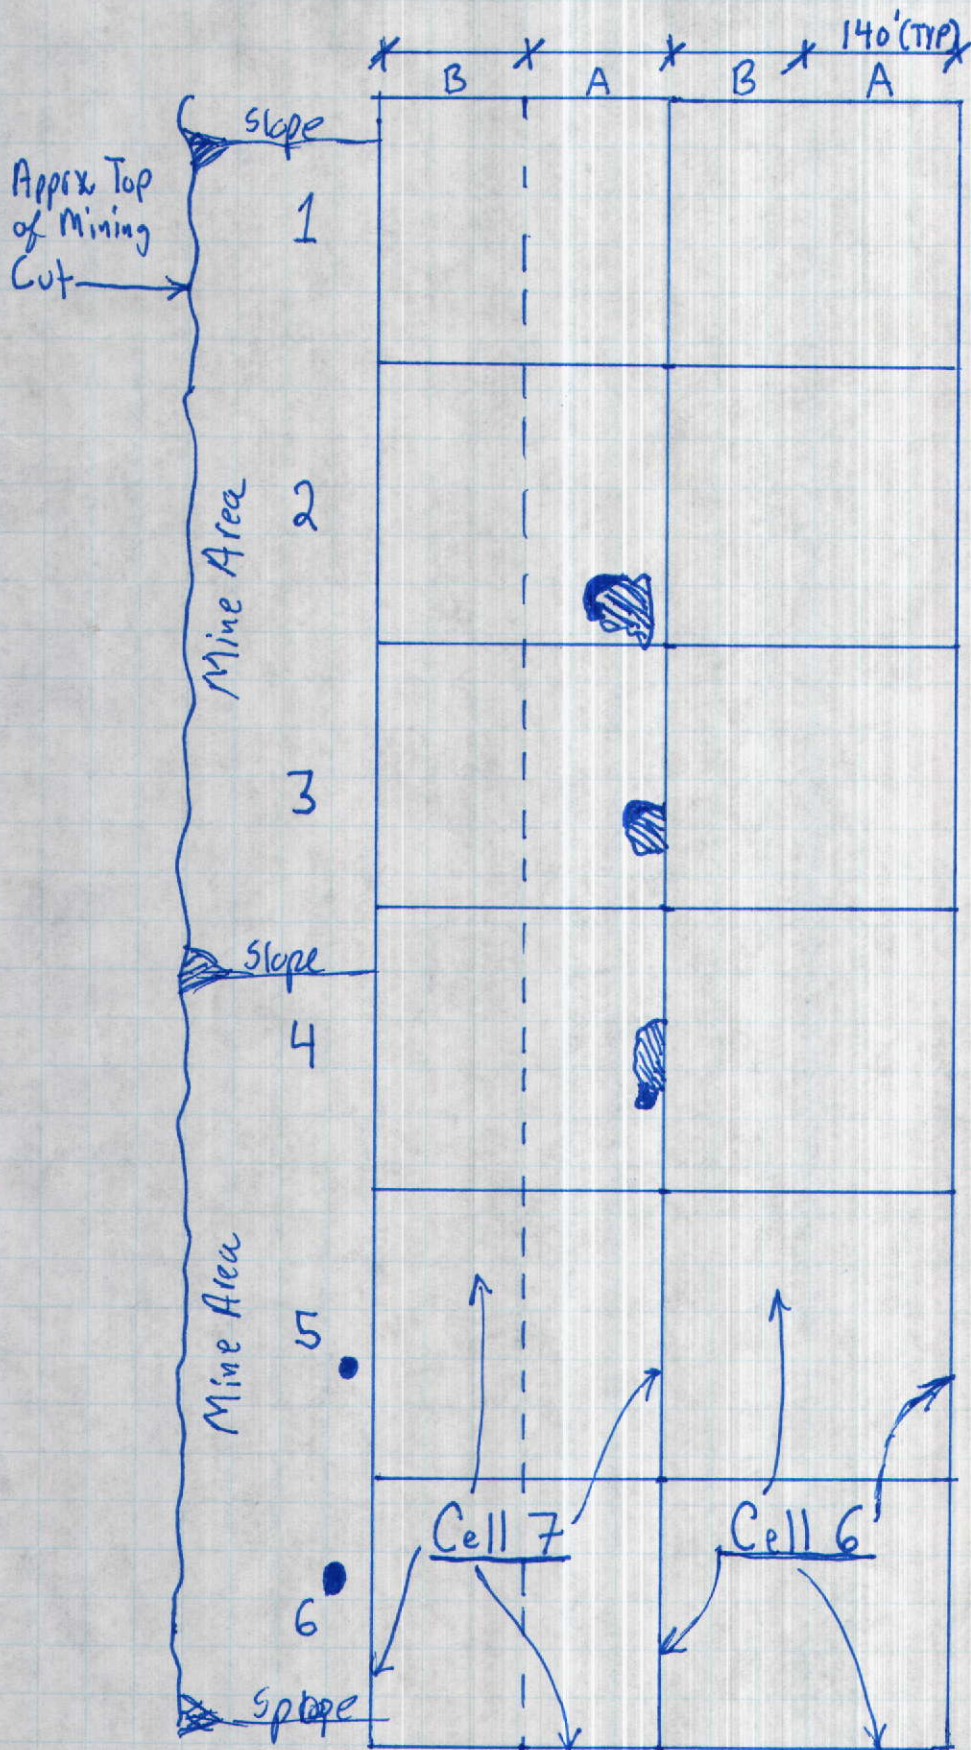
N
1" = 200'

Details and elevations of limerock observed during the construction of Cell 7 are based on the daily field observations performed by John Arnold, P.E. This includes the limerock that was observed west of Cell 6, as reported in the Cell 6 completion report submitted to the FDEP. The locations of limerock encountered during the mining and construction of Cell 7 are shown on Figure 1. The lateral and vertical extents of the limerock are based on relative observations and field measurements made from construction grade stakes installed using monuments set by the land surveyor, Simmons and Beall, Inc. On a weekly basis approximately 10 to 20 grade control stakes were installed in the work area to facilitate construction and observation activities. Elevations refer to NGVD '29 datum.

Limerock in Cell 7 A-2 was encountered at latitude $28^{\circ} 19' 56''$ N, longitude $82^{\circ} 08' 06.8''$ W. As excavation of the overburden progressed westward, the extent of the limerock was revealed to be approximately 100' long by 50' wide. The limerock was firm to hard with a clay mantel. No soft zones or voids within the limerock were observed. The limerock pinnacle/outcrop maximum elevation was 112' NGVD (+/-) and minimum elevation of approximately 81' NGVD (+/-). Limerock exposed at this location was over-excavated by 3' to construct the 3' thick clay barrier layer.

Limerock in Cell 7 A-3 was encountered at latitude $28^{\circ} 19' 55''$ N, longitude $82^{\circ} 08' 09.43''$ W. As excavation of the overburden progressed westward, the extent of the limerock was revealed to be approximately 75' long by 30' wide. The limerock was firm to hard with a clay mantel. No soft zones or voids within the limerock were observed. The limerock pinnacle/outcrop maximum elevation was 110' NGVD (+/-) and minimum elevation of approximately 81' NGVD (+/-). Limerock exposed at this location was over-excavated by 3' to construct the 3' thick clay barrier layer.

Limerock in Cell 7 A-4 was encountered at latitude $28^{\circ} 19' 51''$ N, longitude $82^{\circ} 08' 09.19''$ W. As excavation of the overburden progressed westward, the extent of the limerock was revealed to be approximately 110' long by 30' wide. The limerock was firm to hard with a clay mantel. No soft zones or voids within the limerock were observed. The limerock pinnacle/outcrop maximum elevation was 115' NGVD (+/-) and minimum elevation of approximately 81' NGVD (+/-). Limerock exposed at this location was over-excavated by 3' to construct the 3' thick clay barrier layer.

Limerock was encountered west of Cell 7 B-5, in the mine area at latitude of $28^{\circ} 19' 49''$ N, longitude $82^{\circ} 08' 09.29''$ W. This limerock approximately 15' x 15', was mined out between approximate elevations 94' to 105' NGVD, and was capped with approximately 3' of clay. This location is not within the landfill footprint, but was capped with clay to block the potential for surface water intrusion into the limerock.

Limerock was encountered west of Cell 7 B-6, in the mine area at latitude of $28^{\circ} 19' 46''$ N, longitude $82^{\circ} 08' 09.30''$ W. This limerock approximately 20' x 18', was mined out between approximate elevations 96' to 110' NGVD, and was capped with approximately 3' of clay. This location is not within the landfill footprint, but was capped with clay to block the potential for surface water intrusion into the limerock.

Limerock Found During Cell 6 Construction. Refer to Cell 6 CQA Report and Related RAIS.

Limerock Found During Mining West of Cell 7
