Subject:Trail Ridge Landfill Seep RepairNotification of Disturbance to Clay Cap for Leachate Seep Repair

TRAILRIDGE LANDFILL SEEP REPAIR ENLARGED SITE LAYOUT

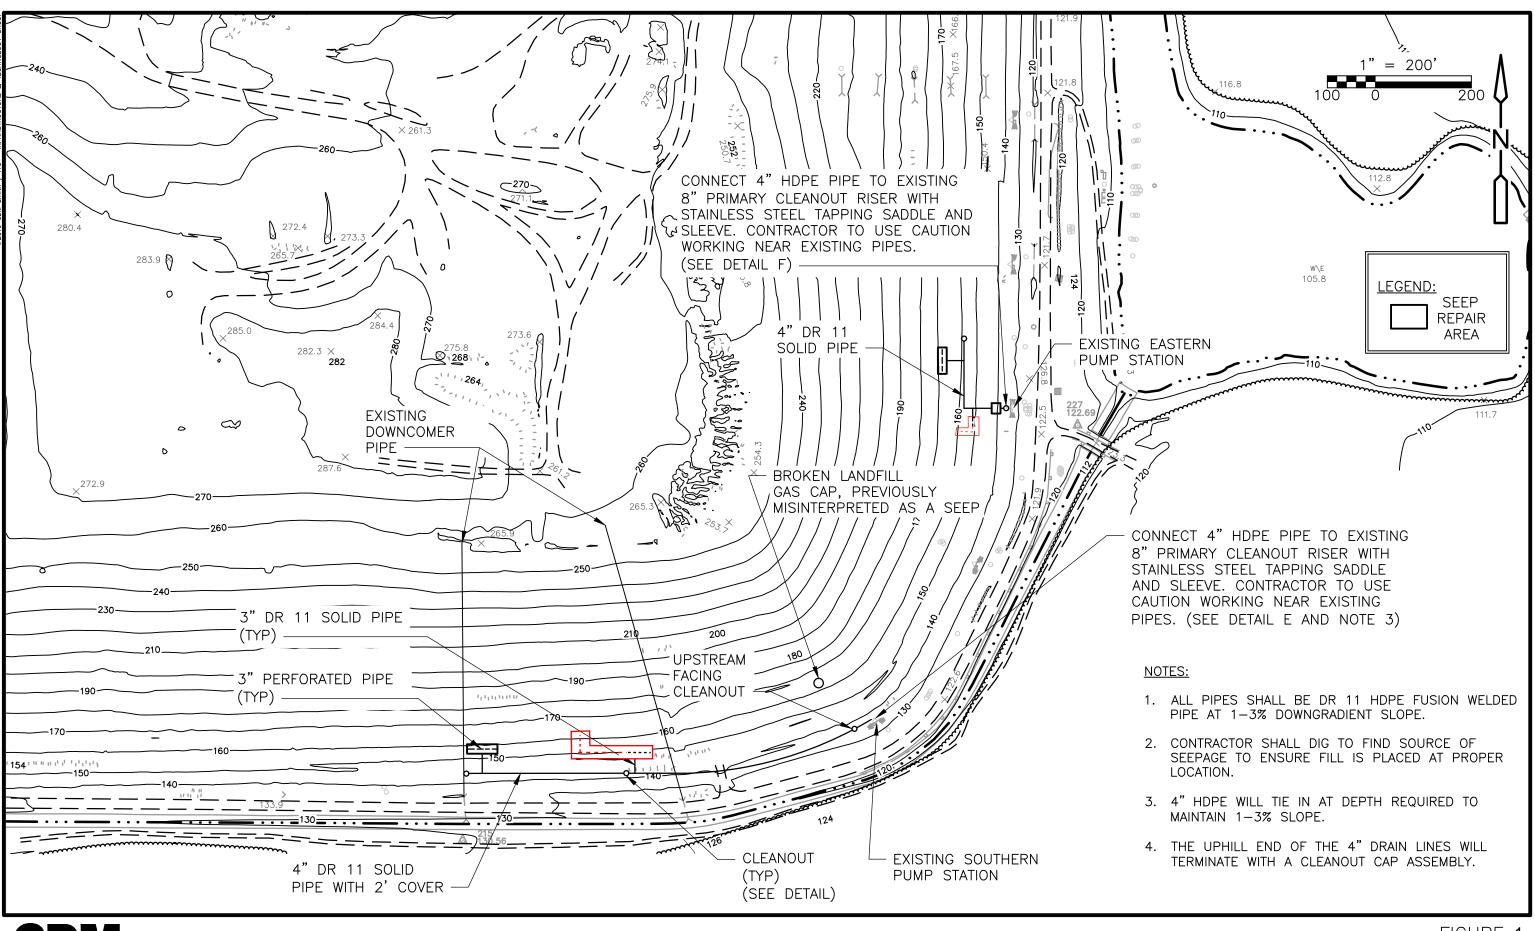
FIGURE 1

After recent completion of four seep repairs at Trail Ridge Landfill (TRLF) in Duval County, Florida, Waste Management staff noticed a collapse of a small area near one of the previous seep repairs likely caused by excess moisture, and an area of increased moisture was noted on the east face of the hill. A field inspection was performed by CDM Smith, Waste Management personnel, and the contractor hired by Waste Management to perform the seep repairs on May 7<sup>th</sup>, 2019. The inspection confirmed that additional investigation should be performed at the two locations and repairs made based on the results of the investigation. These proposed seep repairs will disturb the existing cap and will act as an extension of the previous repairs (see **Figure 1**). The work will include the following at both locations:

- 1. The existing seep repair rock bed will be dug up using an excavator and uncovered to expose the perforated pipe beneath the fabric and stone.
- 2. The perforated pipe will be extended west and then north (up slope) at the southern seep location, along with the stone and fabric material.
- 3. Similarly, at the second location (east side of landfill), the perforated pipe will be extended up slope to increase the size of the rock bed.
- 4. Each excavation will be repaired with the excavated layer materials, additional clay where needed, 2 feet of topsoil, and sod at each of the disturbed locations. Each of the soil layers will be placed and compacted.
