Subject: Status Report of Methane Gas Migration Investigation
J.E.D. Solid Waste Management Facility
Osceola County, Florida
Permit Nos. SC-0197726-004 and SO49-0199726-005

PROJECT				J.E.D. SOLID WASTE MANAGEMENT FACILITY ST. CLOUD, OSCEOLA COUNTY, FLORIDA			
TITLE				PROBE LOCATION MAP			
PROJECT No.		083-82734.8		FILE No.		08382734E002	
DESIGN	DEG	11/11/10	SCALE	AS SHOWN	REV.	0	FIGURE 1
CADD	BCL	11/11/10					
CHECK							
REVIEW

Subject: Landfill Gas Migration Investigation – Closure Cap Integrity Evaluation and Repair
Omni Waste of Osceola County, LLC
J.E.D. Solid Waste Management Facility
St. Cloud, Osceola County, Florida

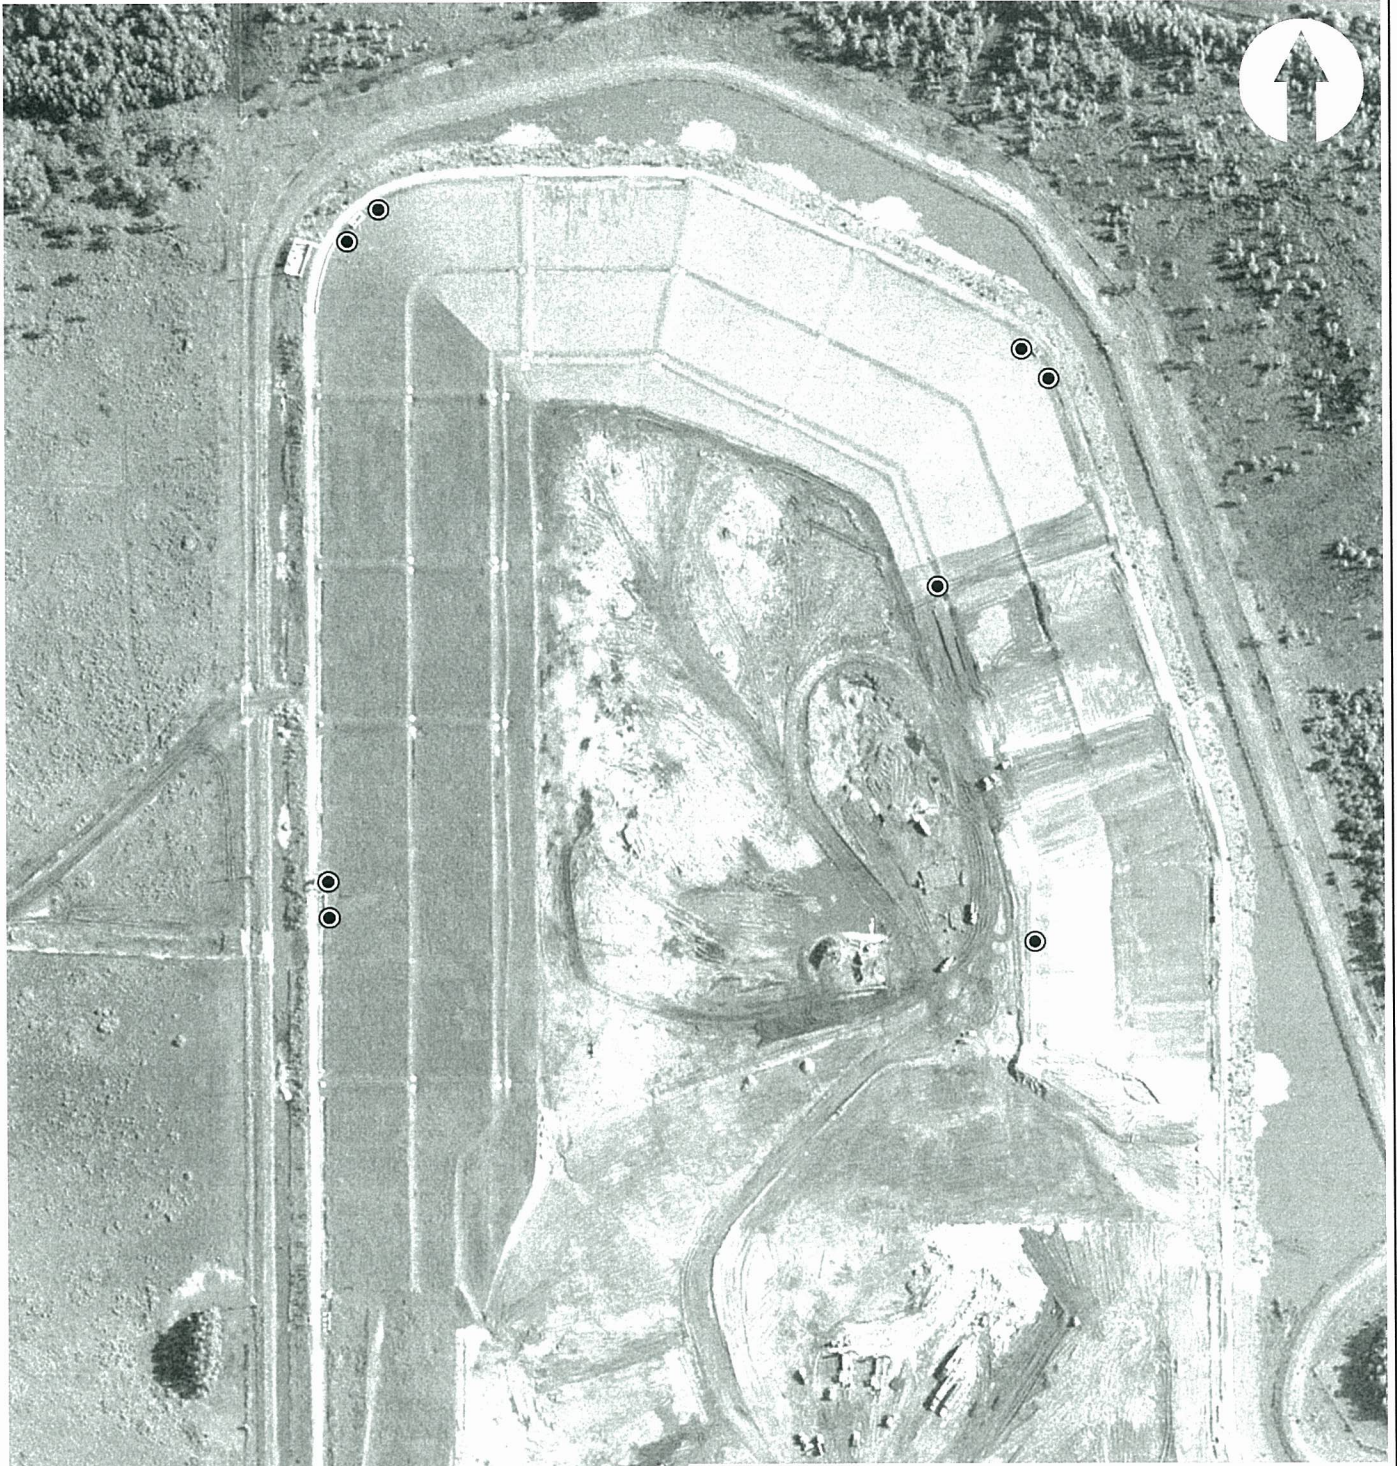
**LOCATIONS OF LINER REPAIRS
CELLS 1,2, 4**

REPAIRS WERE COMPLETED IN AREAS NOTED AS PART OF SURFACE EMISSIONS MONITORING (SEM).

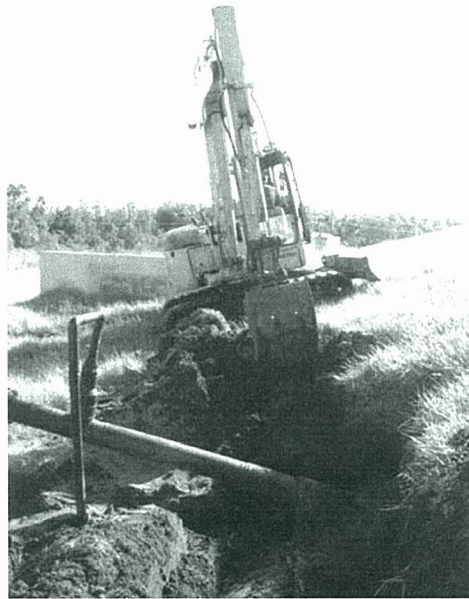
Comments: Excavation on south side of Cell 1 Sump area at location where a high surface emission reading was recorded with FID.

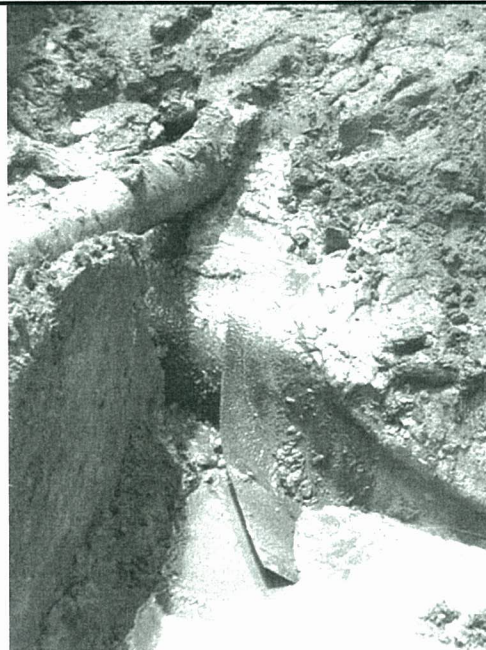
Photograph No. 4

Comments: North side of Cell 1 Sump area. Closure Cap over vertical sump area not welded to base liner system in anchor trench.

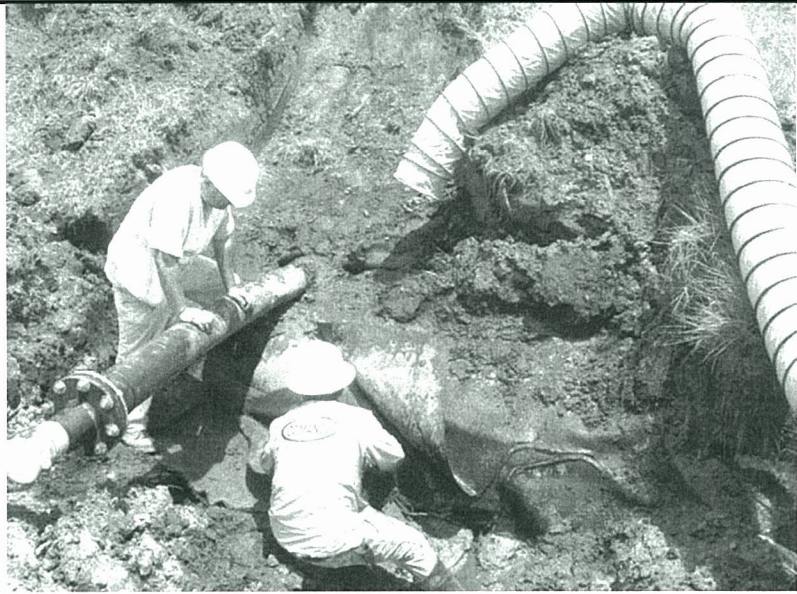
Comments: Preparations for extrusion welding the sump closure cap with the base liner.

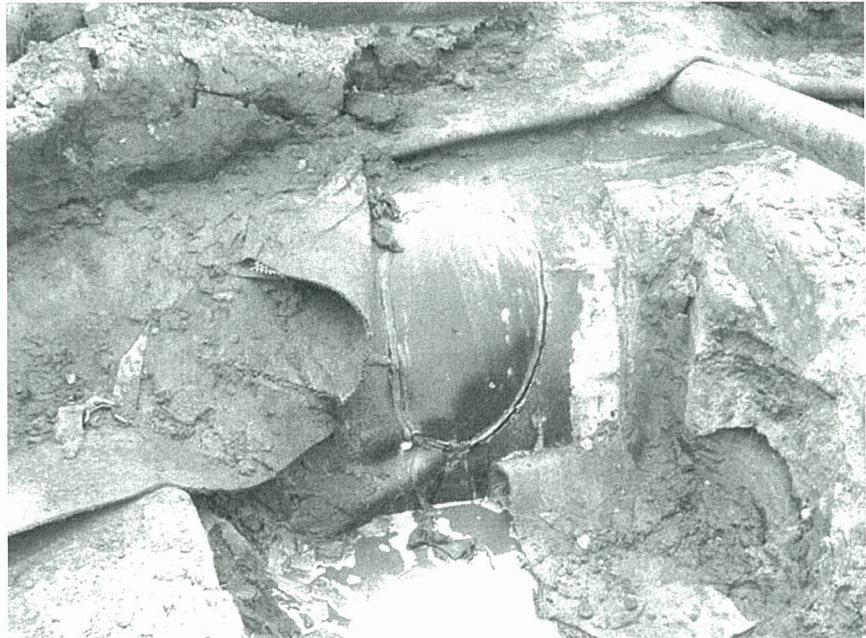
Photograph No. 6

Comments: Extrusion welded patch to close up the approximate 2-ft long un-welded section of the sump area closure cap and the Cell 1 base liner.

To cut off the landfill gas flowing through this opening, the Cell 1 primary geocomposite (gray colored material in Photo No. 3) was cut using a hook blade and pulled back. The approximate 2-ft long section was extrusion welded. The landfill gas pressure beneath the liner made it possible to check the seam by applying a soapy water solution to the weld. Bubbles identified leaks in the repair. Repairs to the extrusion weld were made until no bubbles were observed (Photo No.6). A visual examination of the exposed geomembrane liners and application of soapy water to exposed extrusions welds showed no other leaks (Photo No. 7). While exposed, the boots on the adjacent clean-out pipes were also checked with the soapy water solution. No leaks were found. Prior to backfilling a four gas meter (LEL, oxygen, hydrogen sulfide, and carbon monoxide) was used to screen the area. No readings, with the exception of oxygen, were recorded. The area was promptly backfilled after completion of the repairs (Photo No. 8). The backfilled area was regraded and sodded.

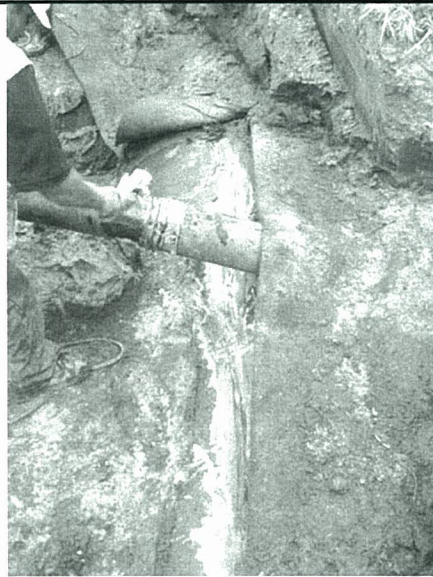
Comments: Soapy water is used to test extrusions welds for leaks.

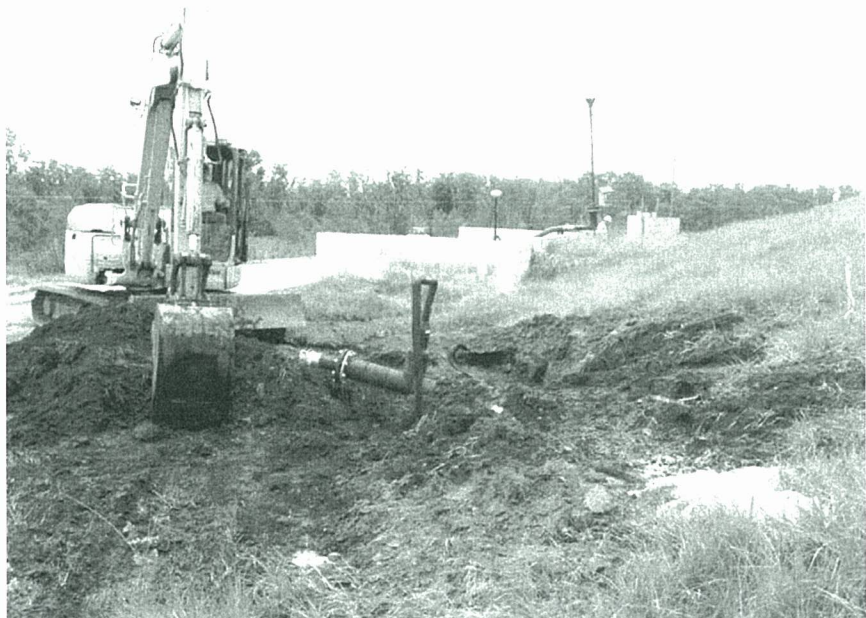
Photograph No. 8

Comments: Area on south side of Cell 1 sump area is backfilled after completion of liner repairs.

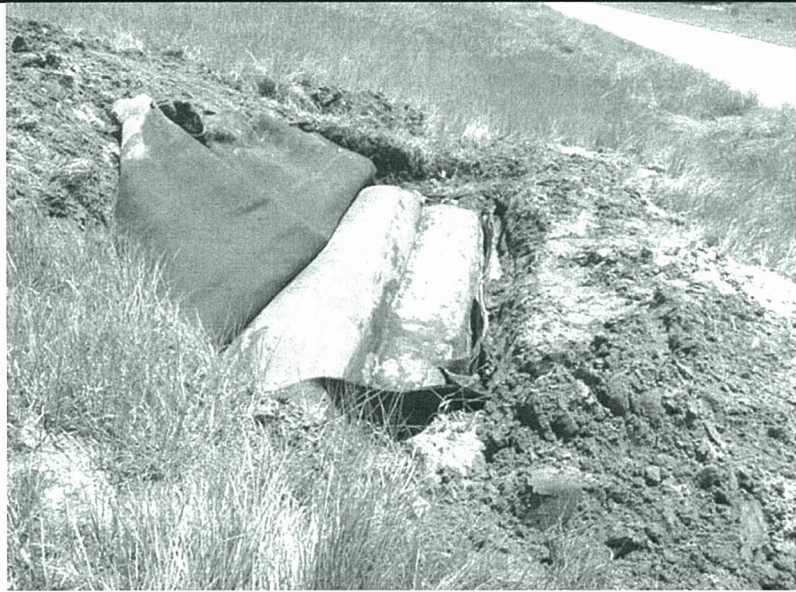
Comments: Area located to the south side of the Cell 4 sump area where a high surface emission reading was recorded with FID.

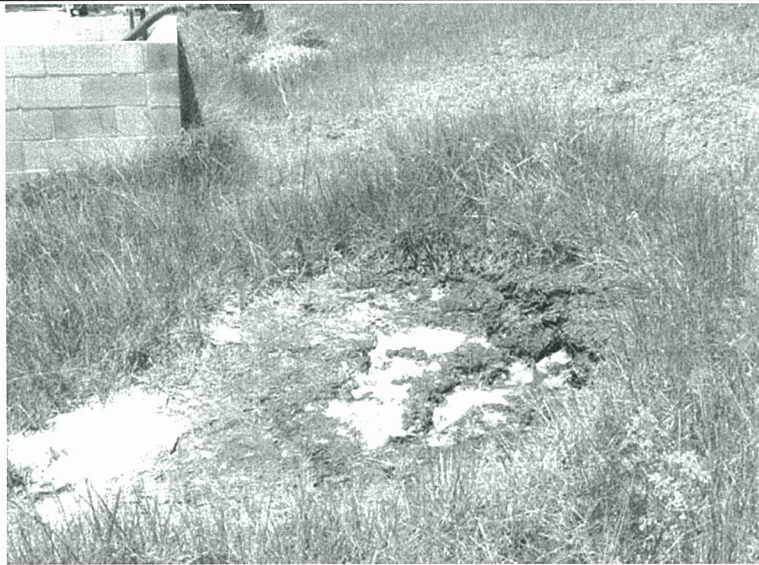
Comments: Distressed vegetation on south side of Cell 4 sump area.

On June 23, 2010 ERC laborers also exposed the geosynthetics approximately 50-ft south of the Cell 4 sump area where a high FID reading was recorded during the quarterly surface emissions monitoring. Prior to exposing the area, distressed vegetation was visually evident similar to what is shown in Photo No. 11, which was taken approximately 20-ft south of the Cell 4 sump area. No leaks in the geosynthetics were located and the landfill gas built up beneath the closure geomembrane “ballooning” the closure geomembrane (Photo No.’s 9 and 10). This area was left open while the investigation proceeded closer to the Cell 4 sump area to the location shown in Photo No.11.

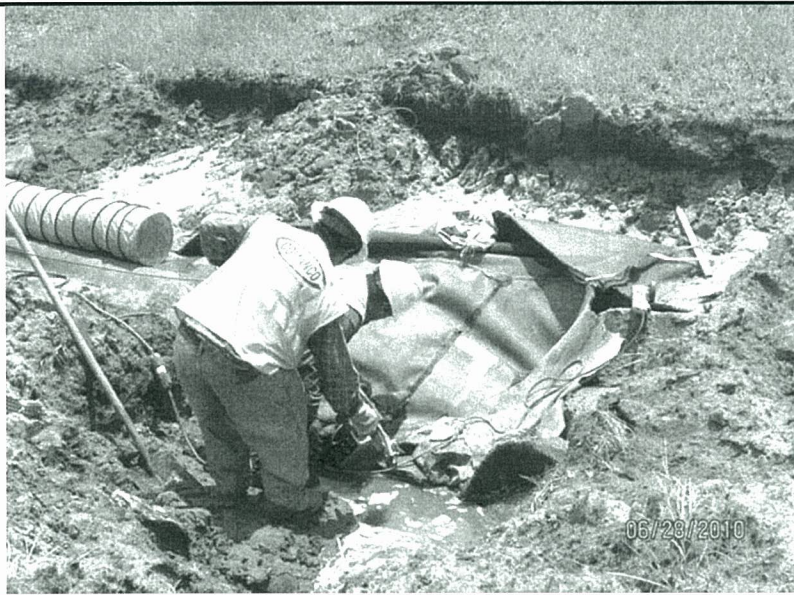
Comments: Liner crew tack welds the seam to be extrusion welded with Lyster heat gun.

The repair procedure for the two areas near the Cell 4 sump was the same as that for described previously for the Cell 1 sump area (Photo No.’s 13, 14, and 17). As part of the investigation work at Cell 4, the geosynthetics were exposed along the entire length of the Cell 4 control panel pad (Landfill side) to check for any other potential leaks. No additional leaks were found. Prior to backfilling the open excavation areas at the Cell 4 sump area, a four gas meter (LEL, oxygen, hydrogen sulfide, and carbon monoxide) was used to screen the area. No readings, with the exception of oxygen, were recorded. These open excavation areas were promptly backfilled after completion of the repairs (Photo No. 18). The backfilled area was regraded and sodded.

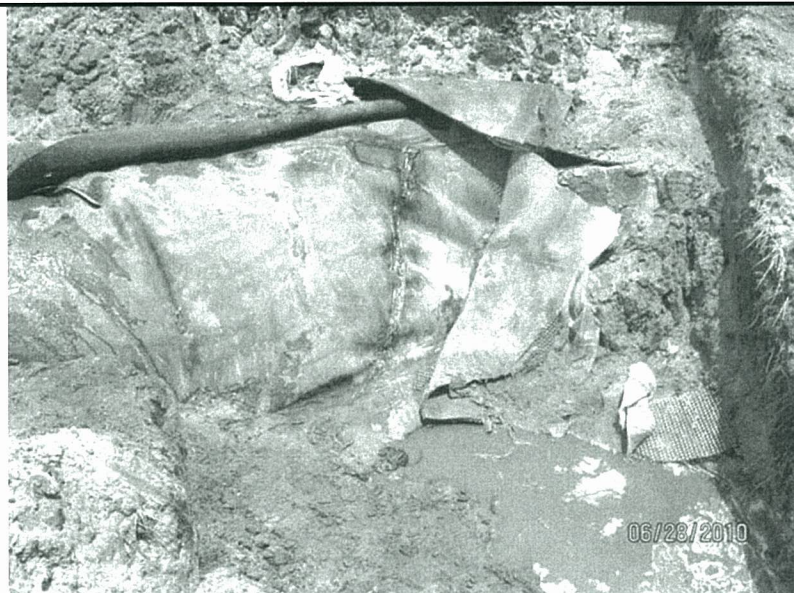
Photograph No. 14

Comments: Cell 4 sump area closure cap extrusion welded to the Cell 4 base liner on south side of Cell 4 sump area.

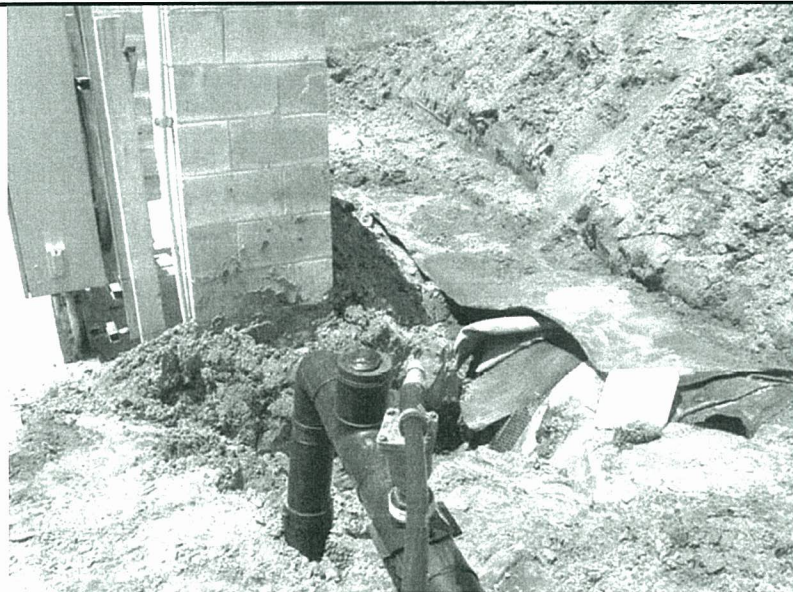
Comments: Cell 4 base and closure geomembrane liners exposed adjacent to the Cell 4 control panel.

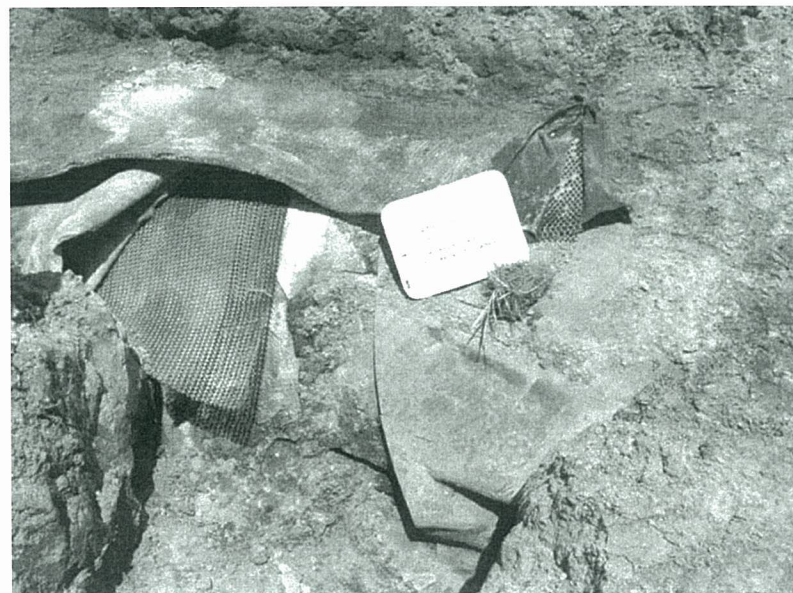
Photograph No. 16

Comments: Cell 4 closure cap over the vertical sump area not welded to the Cell 4 base liner in the anchor trench on north side of sump area.

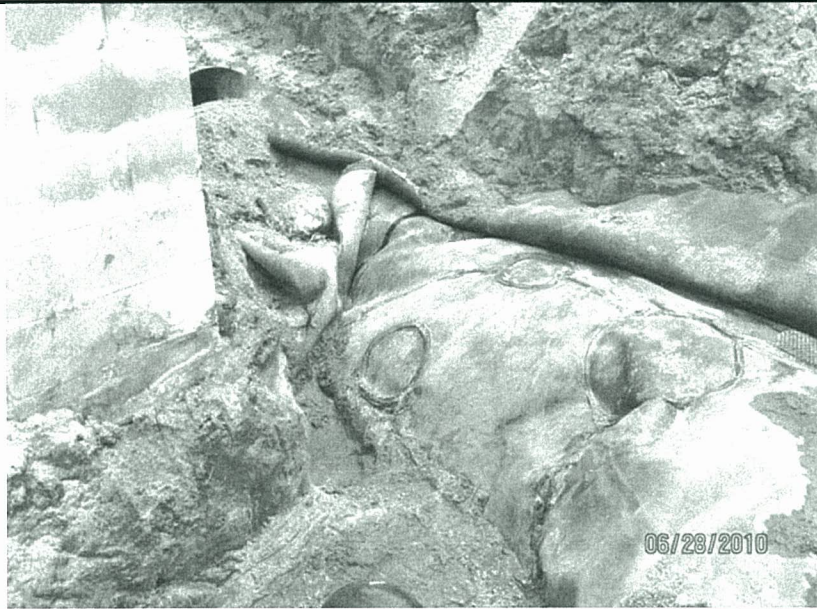
Comments: Repairs made on north side of the Cell 4 sump area adjacent to the control panel pad.

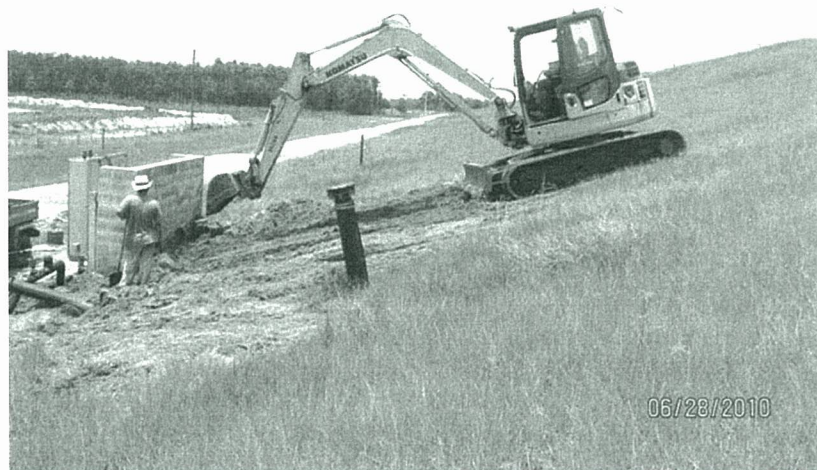
Photograph No. 18

Comments: Backfilling of area behind Cell 4 control panel after completion of repairs.

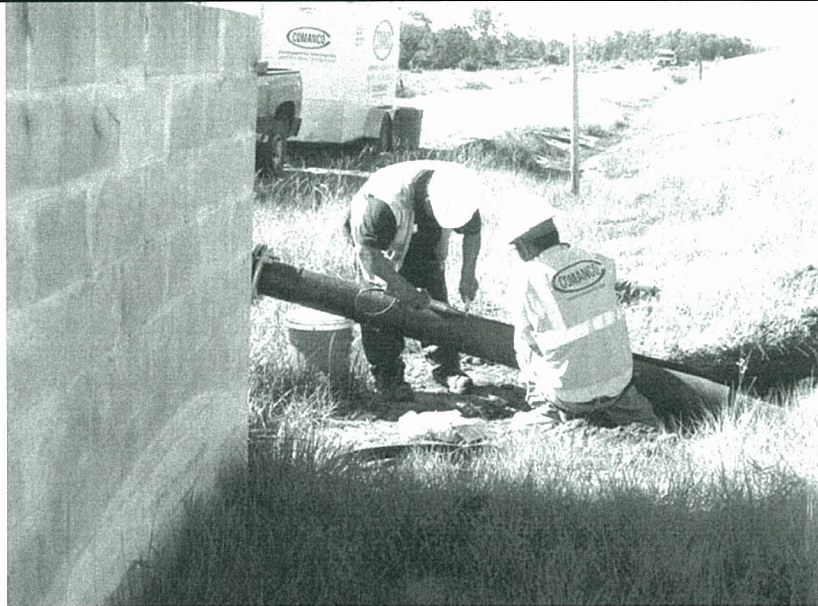
Comments: Repair of boot around leachate clean-out pipe located on the south side of the Cell 2 sump area.

At the Cell 2 sump area, distressed vegetation was visually observed around the 6-in diameter HDPE leachate collection clean-out pipe located on the south side of the Cell 2 sump area. The closure pipe boot was exposed and a soapy water solution was used to check for leaks. A leak was found on the pipe boot weld where the neoprene gasket and stainless steel band secured the boot to the pipe. The band and gasket were removed and the boot was extended above the level of the protective cover (Photo No. 19). A new neoprene gasket and stainless steel band were used to secure the boot at the top of the boot extension. At the completion of the work, the boot was again checked with a soapy water solution and no leaks were found.

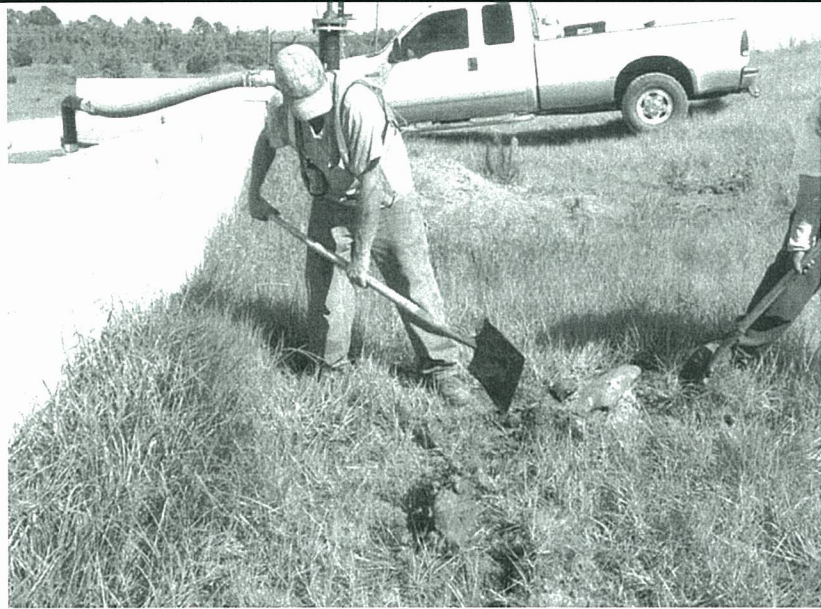
Comments: Piece of liner is observed on ground surface behind Cell 2 sump. Hand shovels used to dig out around the liner.

While working at the Cell 2 sump area, a piece of geomembrane liner was visually observed on the surface of the closure vegetation (Photo No. 21). ERC laborers utilized flat headed shovels to carefully dig around the geomembrane until the entire area was exposed (Photo No. 22). The damaged closure liner was repaired using an approximate 5ft by 6 ft extrusion welded patch (Photo No. 23). The extrusion welds were non-destructively tested using the vacuum box as shown in Photo No. 24. No additional leaks were found and the area was backfilled, regraded and sodded.

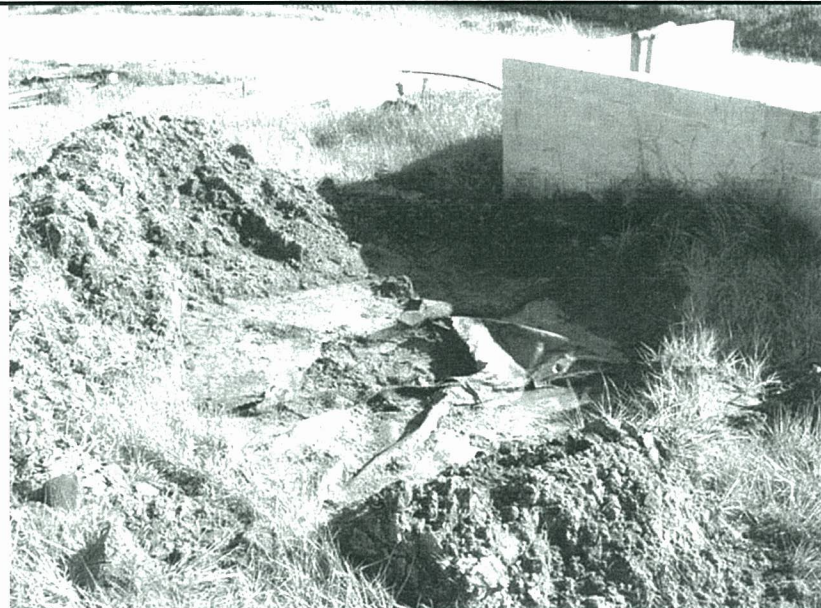
Photograph No. 22

Comments: Damage to the closure geomembrane liner behind Cell 2 sump area.

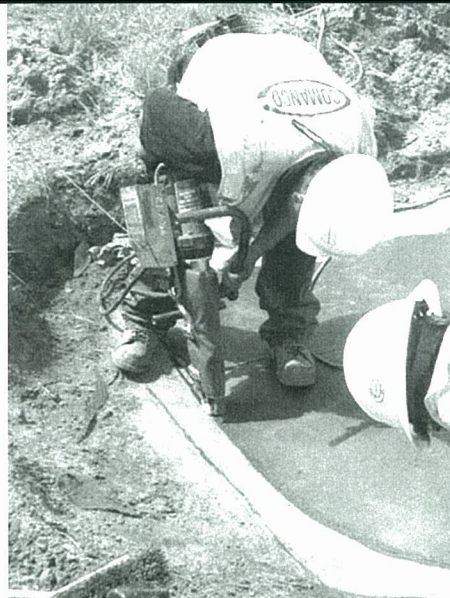
Comments: Extrusion welding patch on closure liner behind Cell 2 sump area.

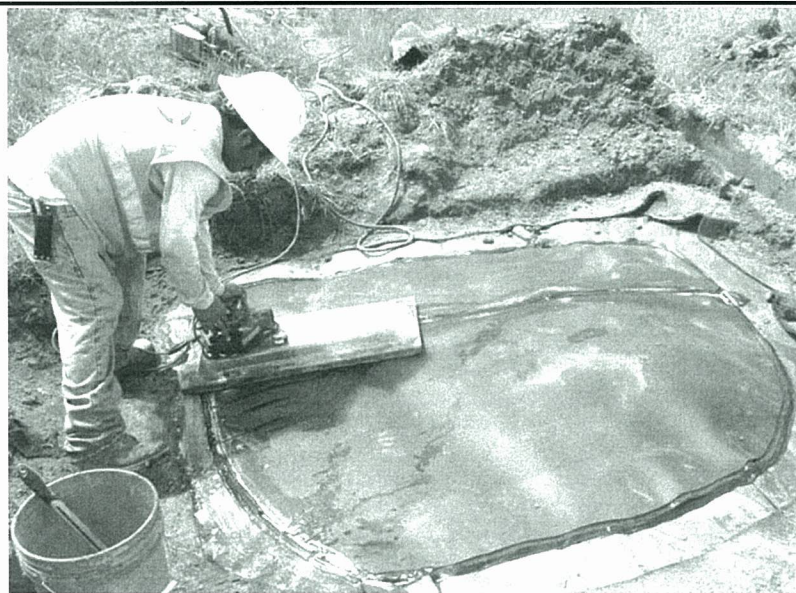
Photograph No. 24

Comments: Vacuum box testing of extrusion welded patch on closure liner behind Cell 2 sump area.
