TANK CLOSURE REPORT AND IRA/LIMITED CAR

AT THE FORMER CHAPMAN CONSTRUCTION PROPERTY
7202 EAST 8TH AVENUE AND ORIENT ROAD
FOR UNIVERSAL WASTE AND TRANSIT, INC.
TAMPA, FLORIDA
FDEP FACILITY NO.298625016
HSA PROJECT NO. 6-94-1067

*January, 1995*

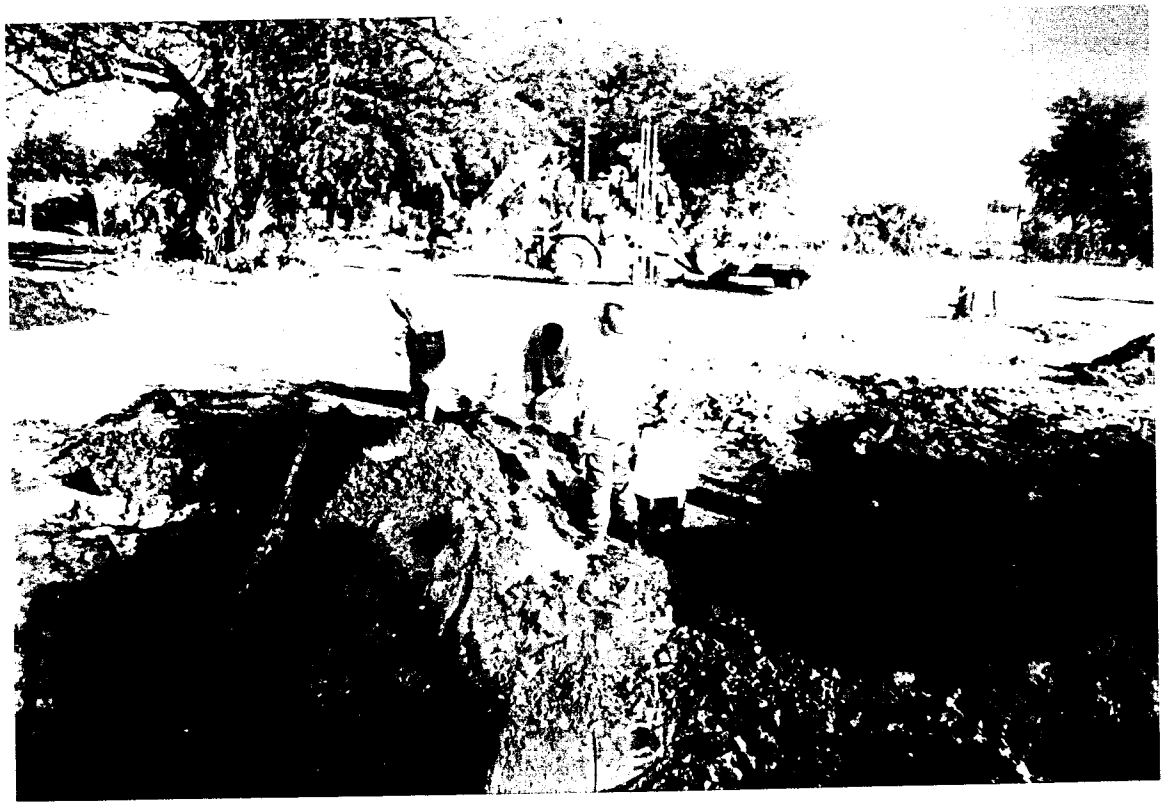
#1 UST Area Prior To Excavation

#2 Degassing UST's With Dry Ice

#3 UST Excavation Area

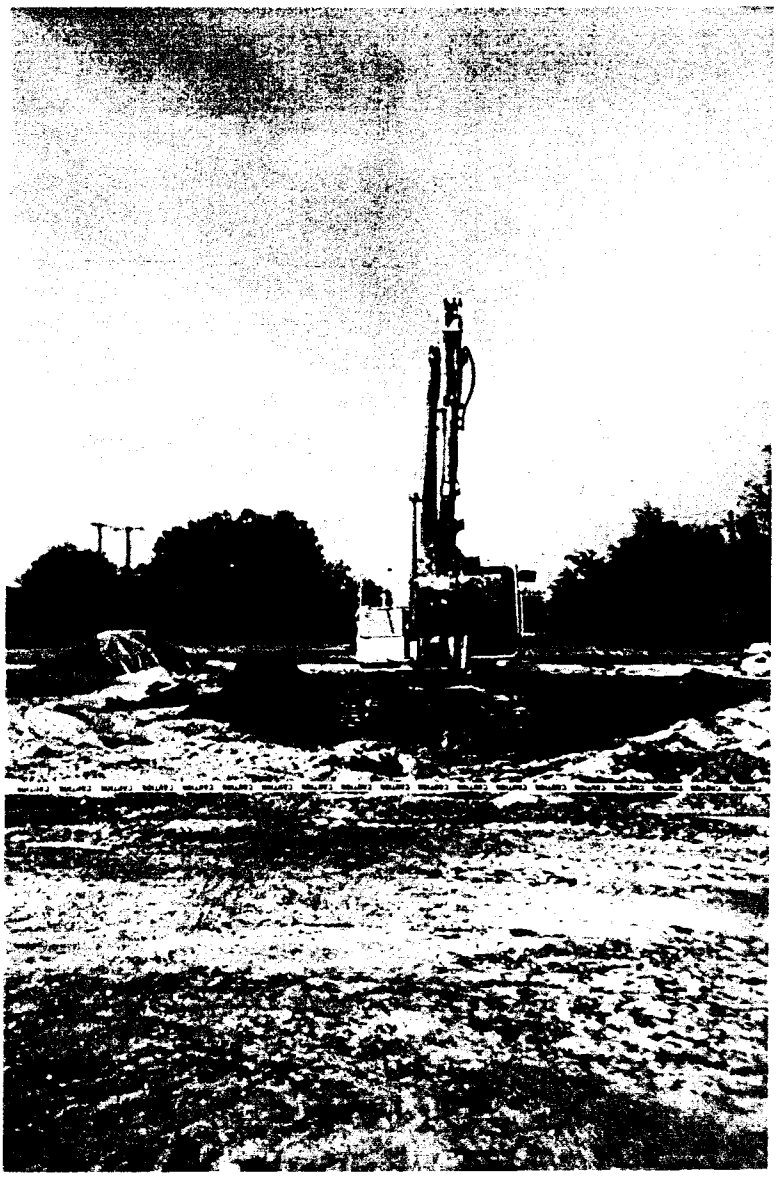
#4 UST Labeled For Disposal

#5 UST's Being Properly Cleaned Prior to Disposal

#6 UST Excavation Area Being Backfilled
