From:	Maurice R Hogg
To:	Reis, Juliana
Cc:	Maria T Rodriguez; Lillian F Deprimo
Subject:	RE: CEMEX Miami Cement Plant & SCL Quarry (EPAID FLD981758485) - Exit Interview (Submittal 1 of 2)
Date:	Tuesday, January 5, 2021 4:37:41 PM
Attachments:	image004.png image005.png image006.png

This email serves as an exit interview for the Compliance Evaluation Inspection (CEI) conducted on Thursday, December 17, 2020, by the Florida Department of Environmental Protection (FDEP) to determine this facility compliance with the hazardous waste Federal and state regulations.

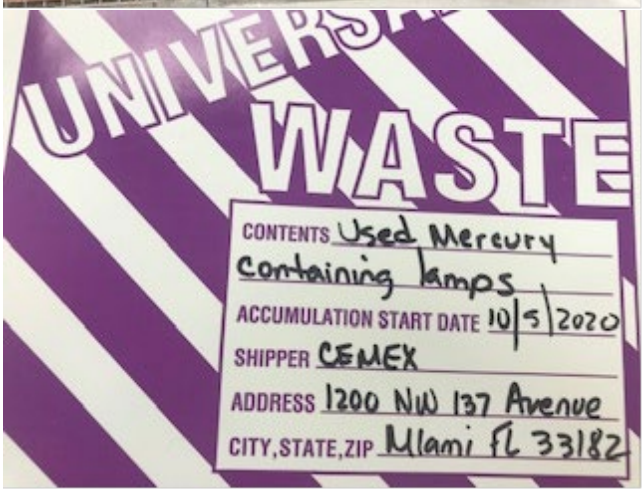
7. Universal Waste Lamps

The photos below taken 12-22-20 , demonstrate that item **7 Universal waste lamps – 40 CFR 273.13(d)** of the CEI has been resolved. The spent mercury containers have been properly closed and sealed to prevent breakage, and labeled as specified.

7. **Universal waste lamps – 40 CFR 273.13(d)**
    a. Provide pictures of the spent mercury lamps containers (attached picture) properly closed and sealed in order to prevent breakage.
        Spent mercury lamps shall be specifically labeled as "universal waste-mercury-containing lamps", "waste mercury-containing lamps" or "used mercury-containing lamps".
    b. Provide a corrective action picture of spent mercury lamp's containers properly labeled.
